Health Consultation

GSA FLEET MANAGEMENT MOTOR POOL PARCEL
(a/k/a LOT NO. 2, BLOCK 675 at 870 THIRD AVENUE)

BOROUGH OF BROOKLYN, COUNTY OF KINGS, NEW YORK 11232

June 3, 2011

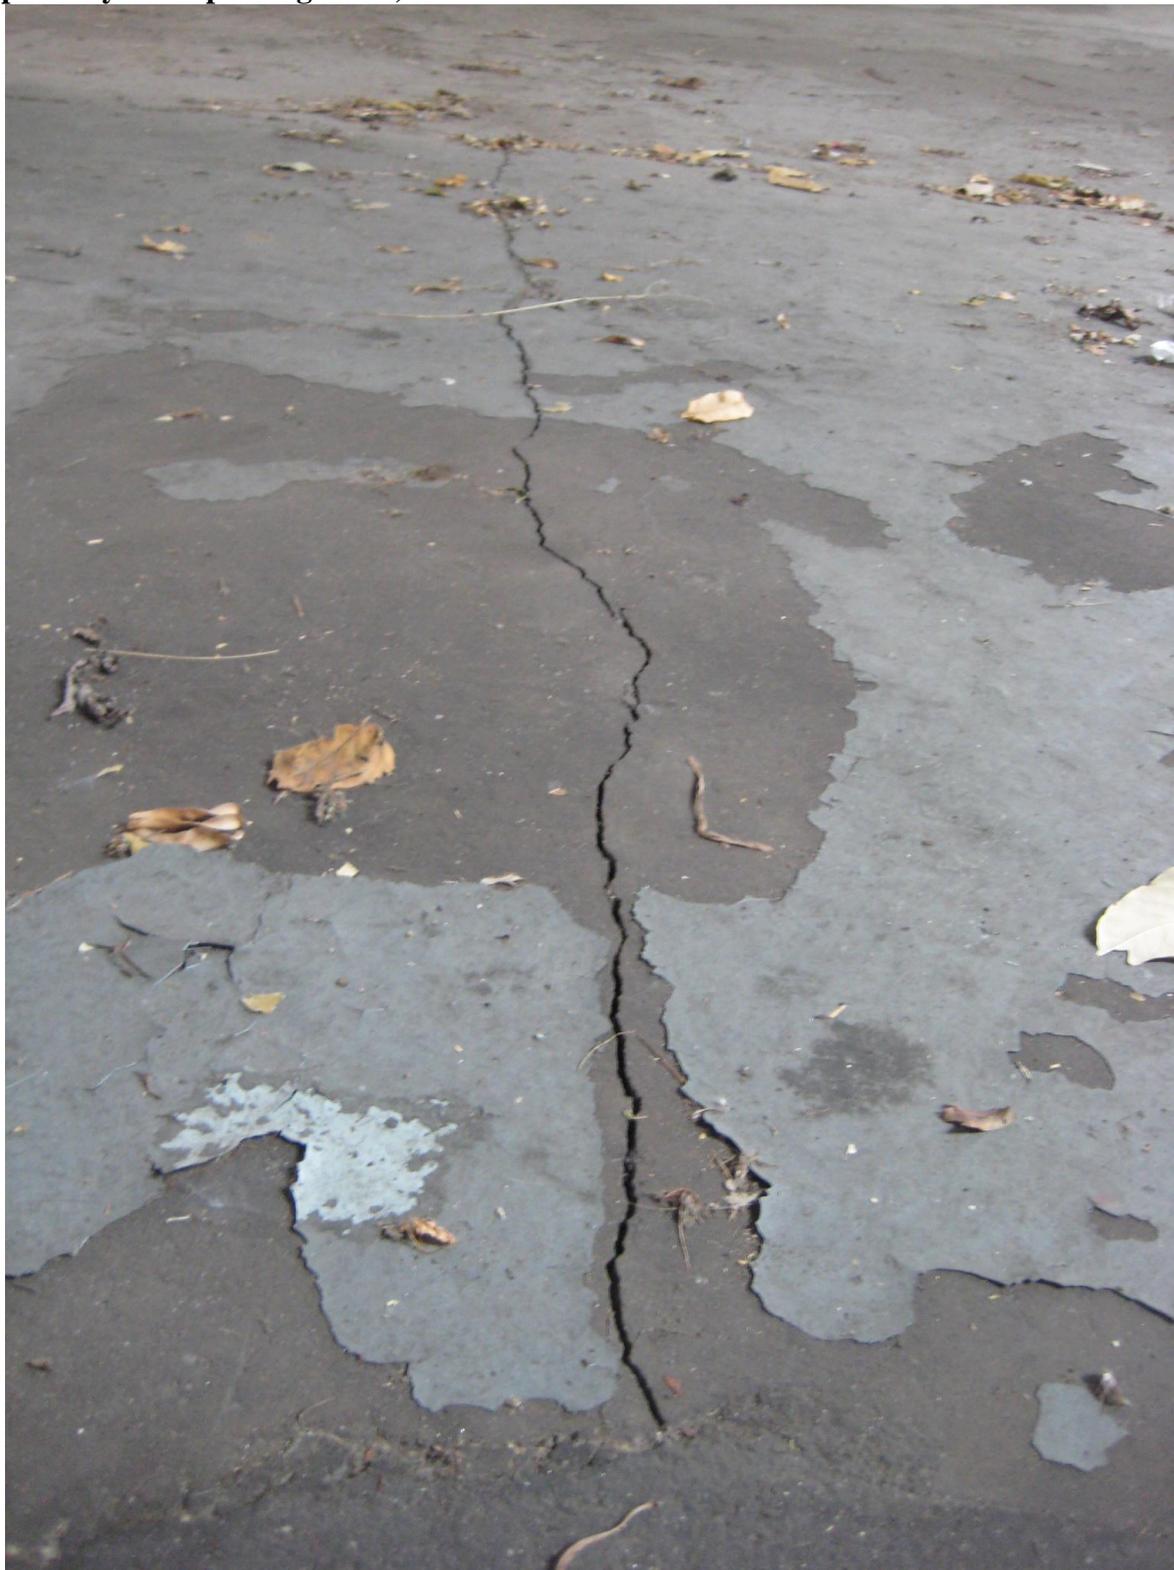
- structural information – cracks and pits observed in concrete slab (Fig. B.1.)
- magnetometer data – indicates subsurface utility conduits
- site geology data – uncontrolled fill contains sand, gravel and construction debris
- hydrogeology – nearby tidally influenced area may cause water table fluctuations
- stained soils observed beneath concrete flooring of the building (Fig. B.7.)
- SVOCs above screening levels in soil and groundwater sampling data (external to the building)

Figure B.1. Concrete flooring inside the building (cracks can be a potential preferential pathway for vapor migration)

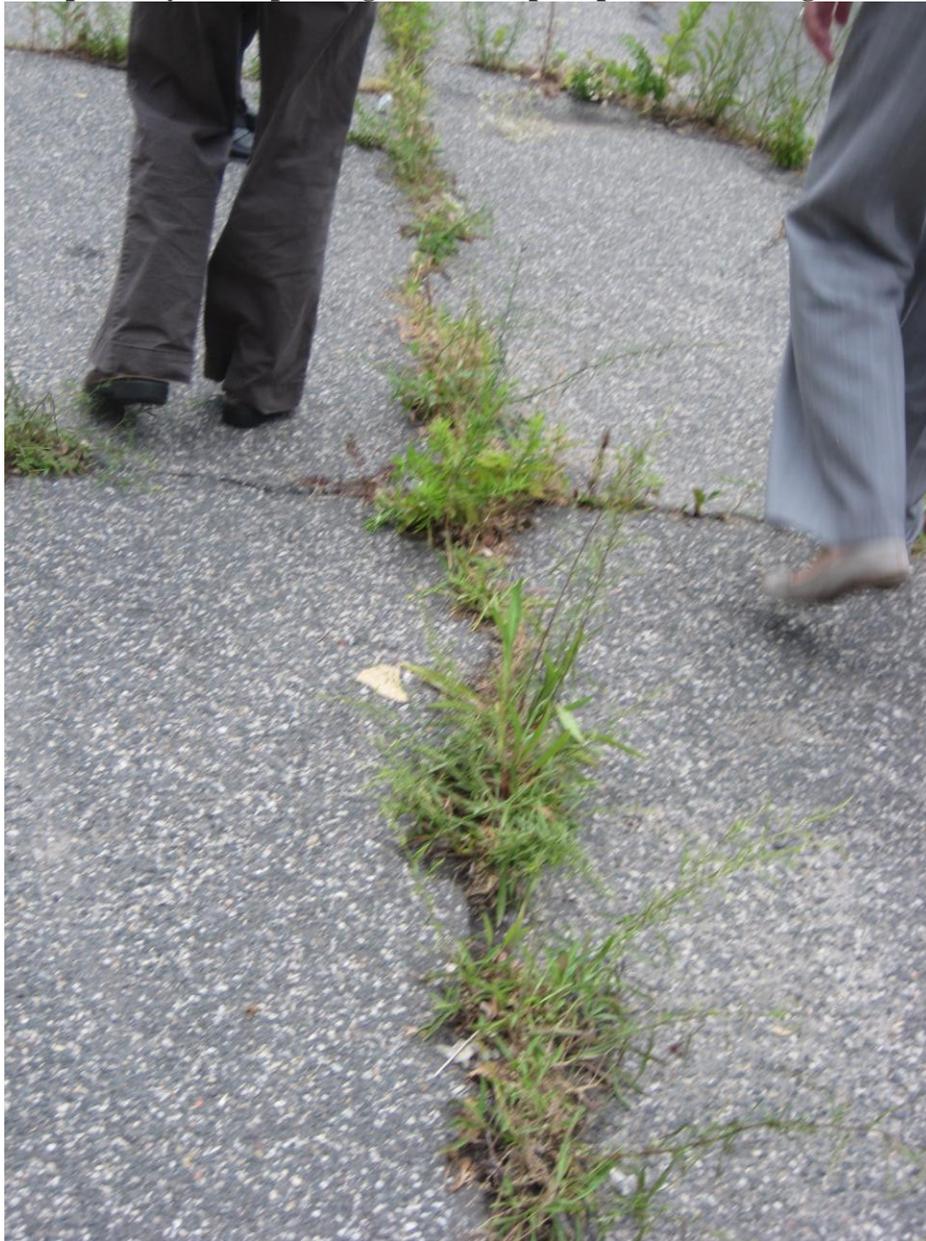
Figure B.2. Concrete cover outside the building (vegetation that penetrates the concrete show a possible pathway for vapor migration and precipitation recharge)

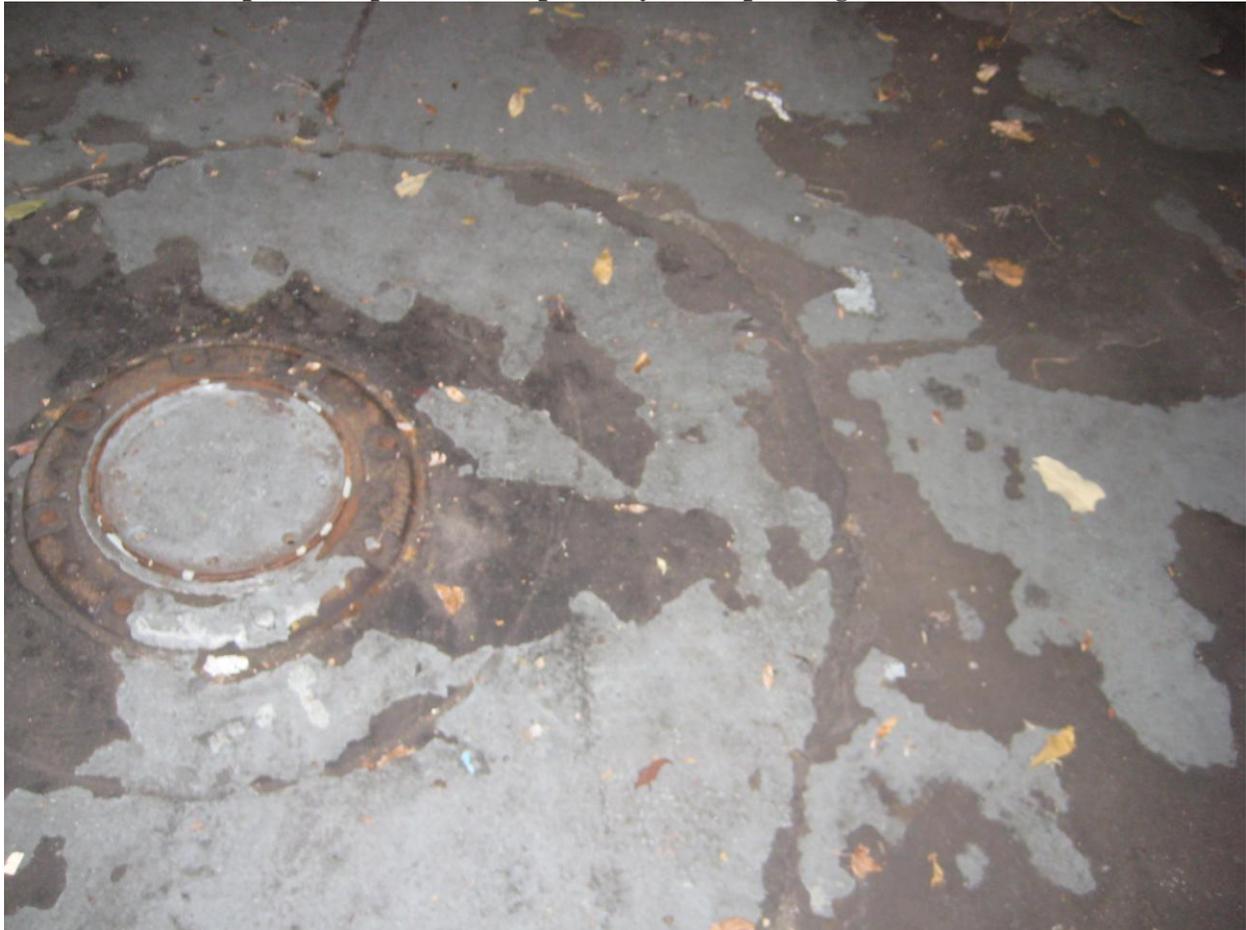
Figure B.3. Concrete flooring with manhole inside the building (structures that span the concrete can be a potential preferential pathway for vapor migration)

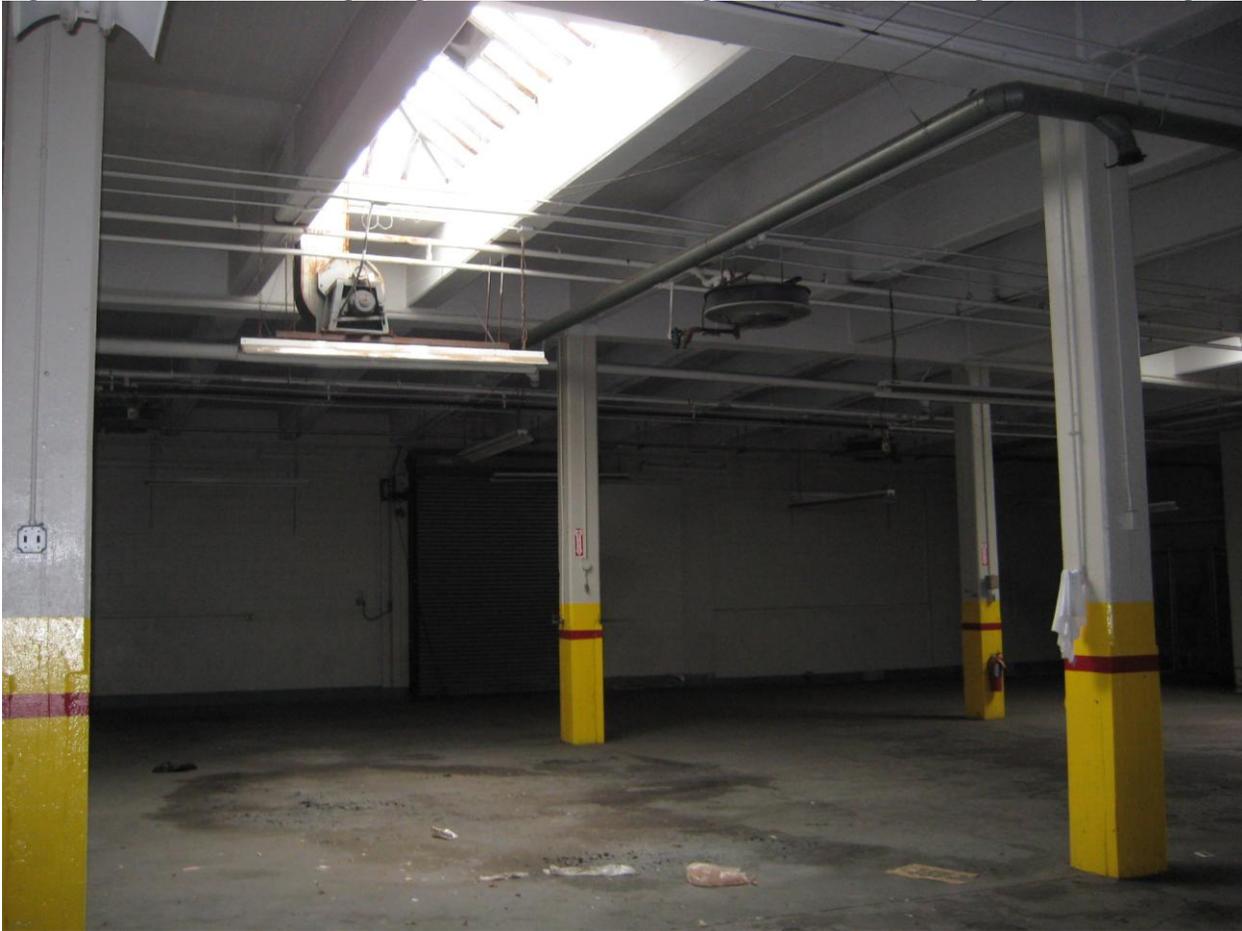
The on-site building was equipped with fluorescent lighting (Fig. B.4.). Ballasts for fluorescent lighting fixtures predating 1980 contain PCBs (EPA 2010a). Many structures built before 1978 contain lead based paint (EPA 2010b). Additionally, suspect asbestos containing material (ACM) was observed by ATSDR's site team in the interior of the building onsite (Fig. B.5.).

A strong odor similar to an auto repair shop was present in the GSA Motor Pool building during the ATSDR site team visit. Staining was visible on the concrete flooring (Figure B.4.), and some areas of the walls were crumbling (Figure B.8.). These observations indicate that chemicals may have permeated the structure. Many sensitive populations, such as asthmatics, can have reactions to strong odors that are otherwise non-hazardous (<http://www.cdc.gov/asthma/triggers.html>).

Fluorescent light ballasts manufactured prior to 1980 may contain PCBs (EPA 2010). PCB production was banned in the U.S. in 1977, so phase out of the use of PCBs in fluorescent light ballasts occurred in the 1980's and 1990's. The typical life-expectancy of fluorescent light ballasts is approximately 10 to 15 years. So ballasts installed during the most recent use of the building in 2000 are likely in need of replacement.

Figure B.4. Fluorescent lighting ballasts and staining of concrete flooring inside building

- 4) Replace fluorescent lighting ballasts that may contain PCBs.
- 5) Take precautions to avoid or minimize exposure if construction or other activities at the site require removal of the slab.

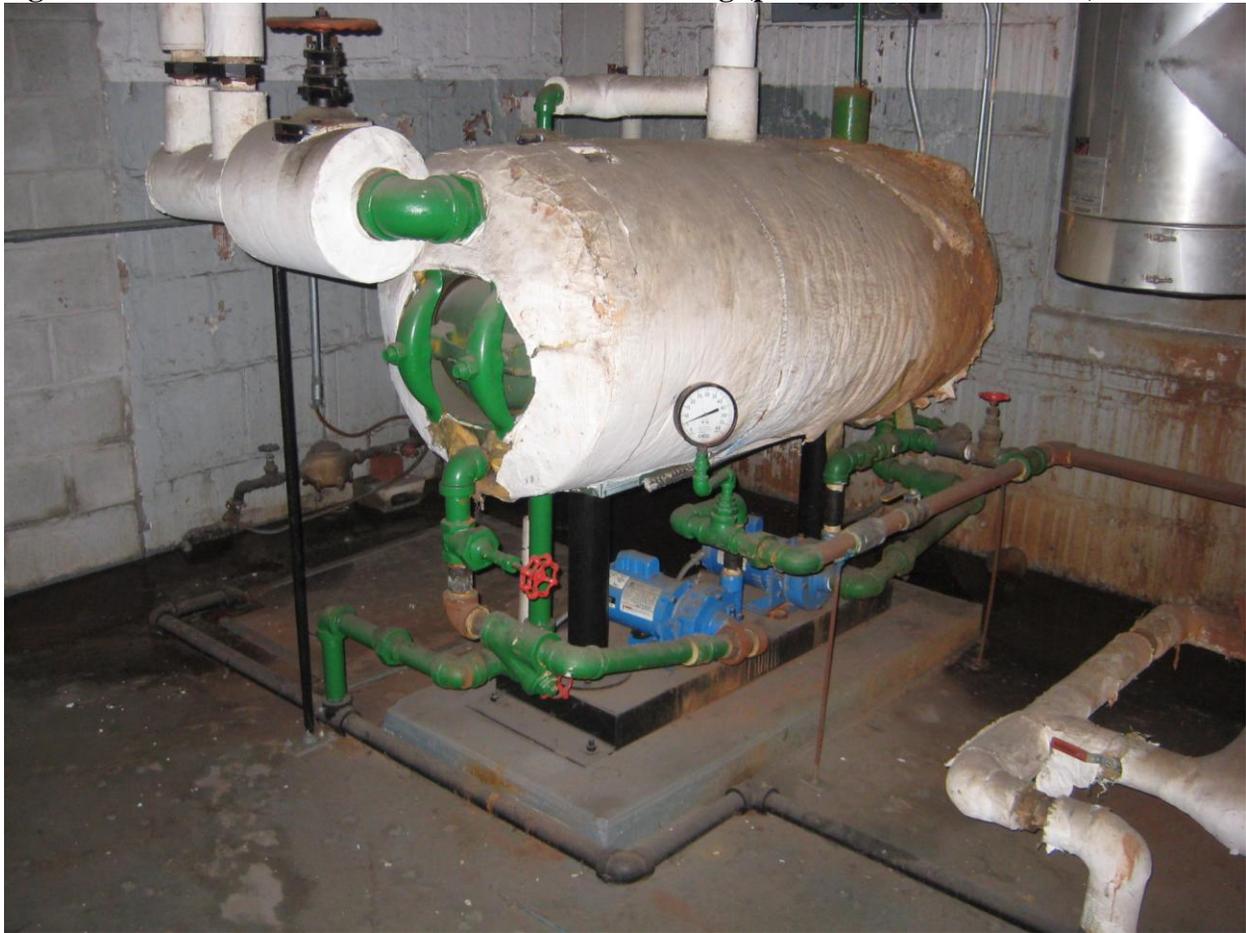
Figure B.5. Old insulation material inside the building (potential asbestos source)

An asbestos assessment (inspection, test, or survey) at the GSA Motor Pool site should be conducted by a National Emissions Standards for Hazardous Air Pollutants (NESHAP) certified asbestos consultant, architect, consulting engineer, state-certified inspector, certified industrial hygienist, or EPA certified company experienced in asbestos assessment (HUD 1999). The Asbestos Control Bureau of the Division of Safety & Health in the NY Department of Labor oversees all work on asbestos containing structures, including the licensing and certification of all persons working on asbestos projects (NYDOSHS 2007). Repair or removal should be performed by trained professionals. Repair usually involves either sealing (encapsulation) or covering (enclosure) asbestos material. Building owners are required by federal regulation to notify occupants and workers of asbestos containing materials in buildings (29 CFR 1926.1101(k)(2)(ii)(D)). EPA provides tips on hiring qualified professional asbestos testing and remediation personnel (<http://www.epa.gov/asbestos/pubs/ashome.html>). The New York City Department of Environmental Protection Asbestos Control Program provides rules for all asbestos abatement activities occurring within the City of New York (http://www.nyc.gov/html/dep/pdf/asbestos_rules_11_16_2009.pdf). Additionally, the Occupational Safety and Health Administration (OSHA) specifically regulates workers potentially exposed to asbestos occupationally (<http://www.osha.gov/SLTC/asbestos/index.html>).

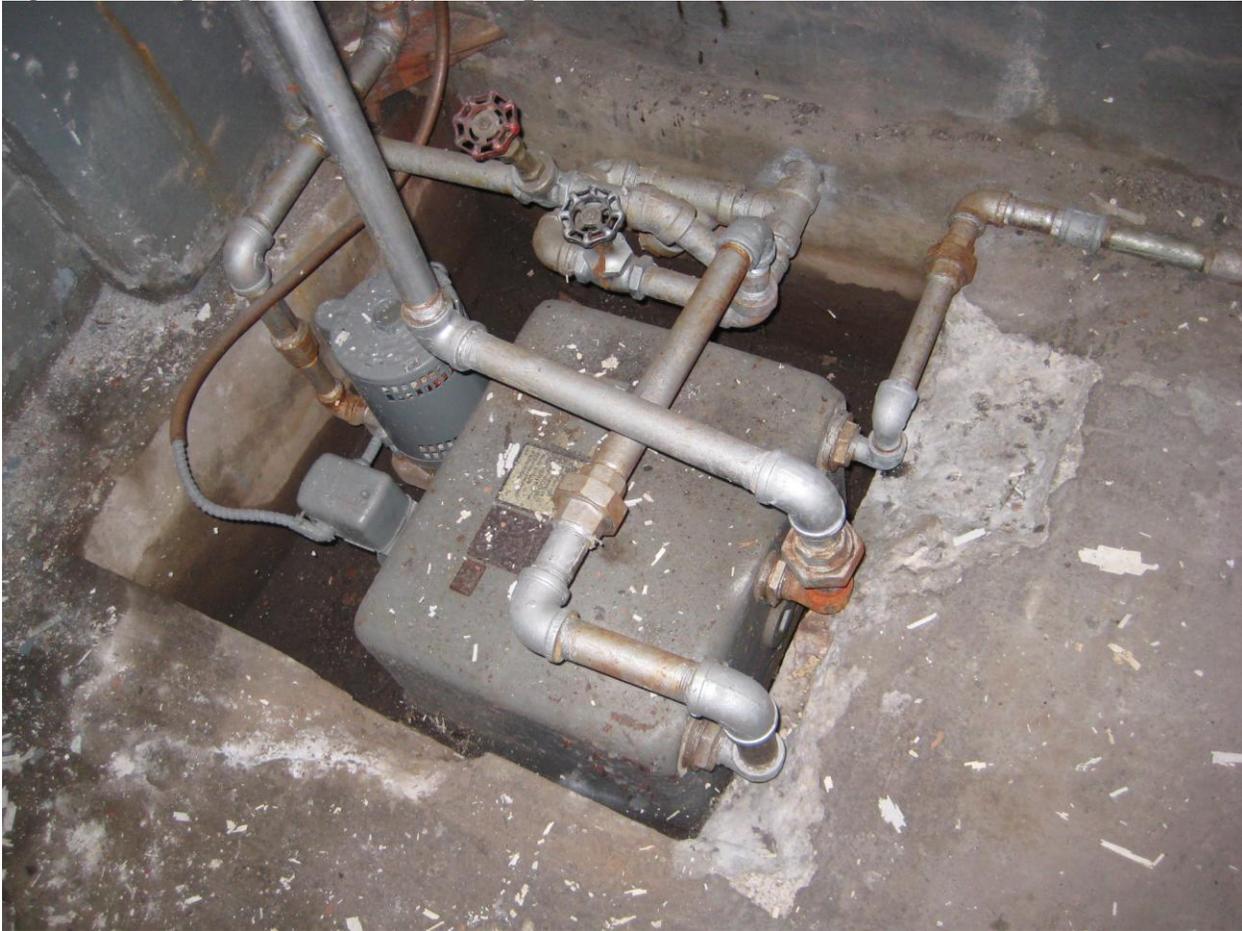
Basis for Decision 3. The GSA Motor Pool site is covered by a concrete slab. Therefore, direct soil exposure is not expected to occur unless construction or other activities remove sections of the slab. A few open pits at utility and construction access points were observed during ATSDR's site visit in July 2010. These localized areas are presumed to be temporary pending renovation.

Figure B.6. Open pit and utility access point in concrete slab

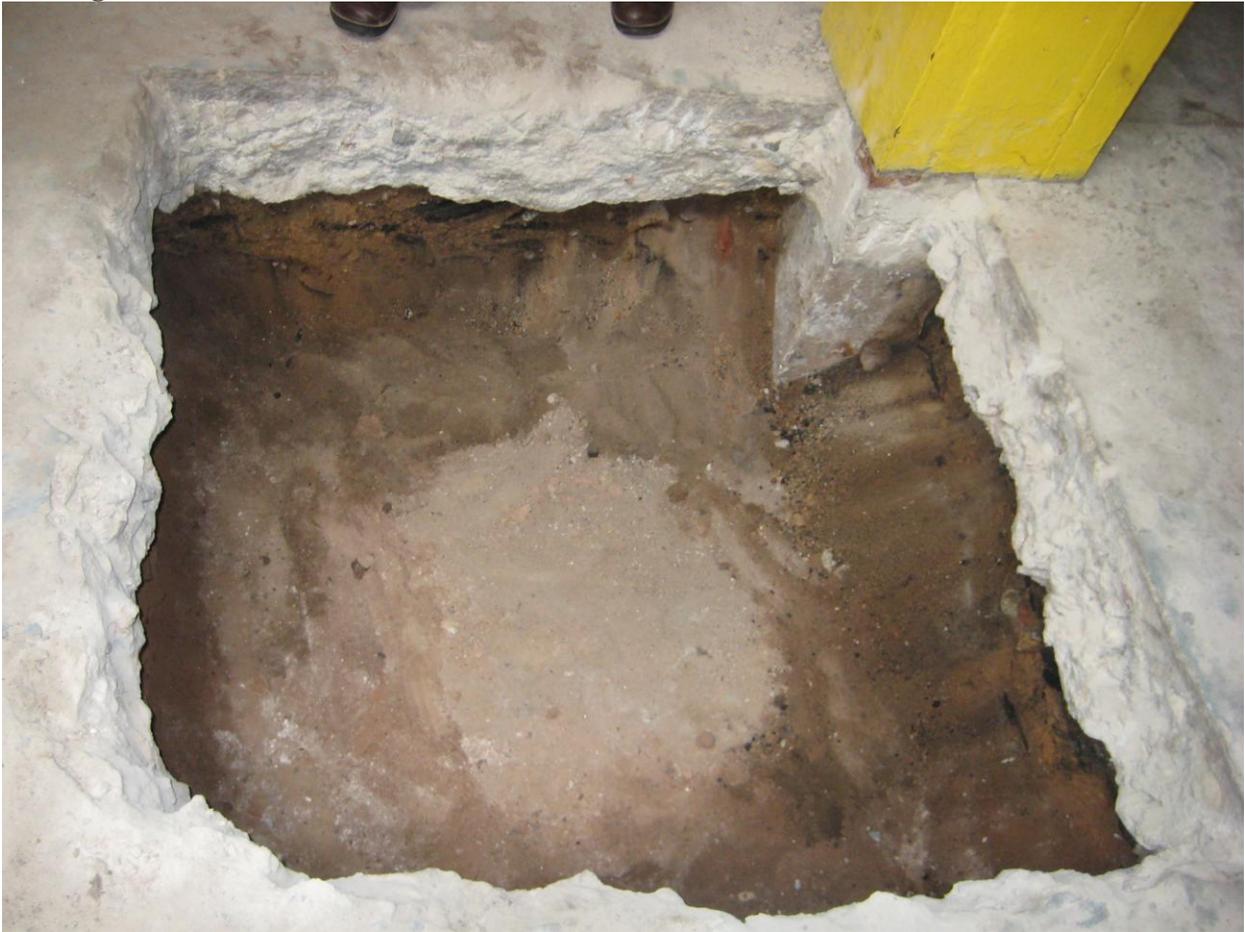
- SVOCs are present below the concrete slab on-site and are likely on neighboring sites from other sources. Vapors and soil have not been sampled beneath the building, but soil staining in an excavated area of the concrete in the building indicates that contaminants were released to the sub-slab area from long-term motor pool operations in the building. People are not expected to come into contact with harmful levels of subsurface vapors migrating into the structures at the GSA Motor Pool site if

Figure B.7. Subsurface and concrete excavation around pylon within building (note soil staining)

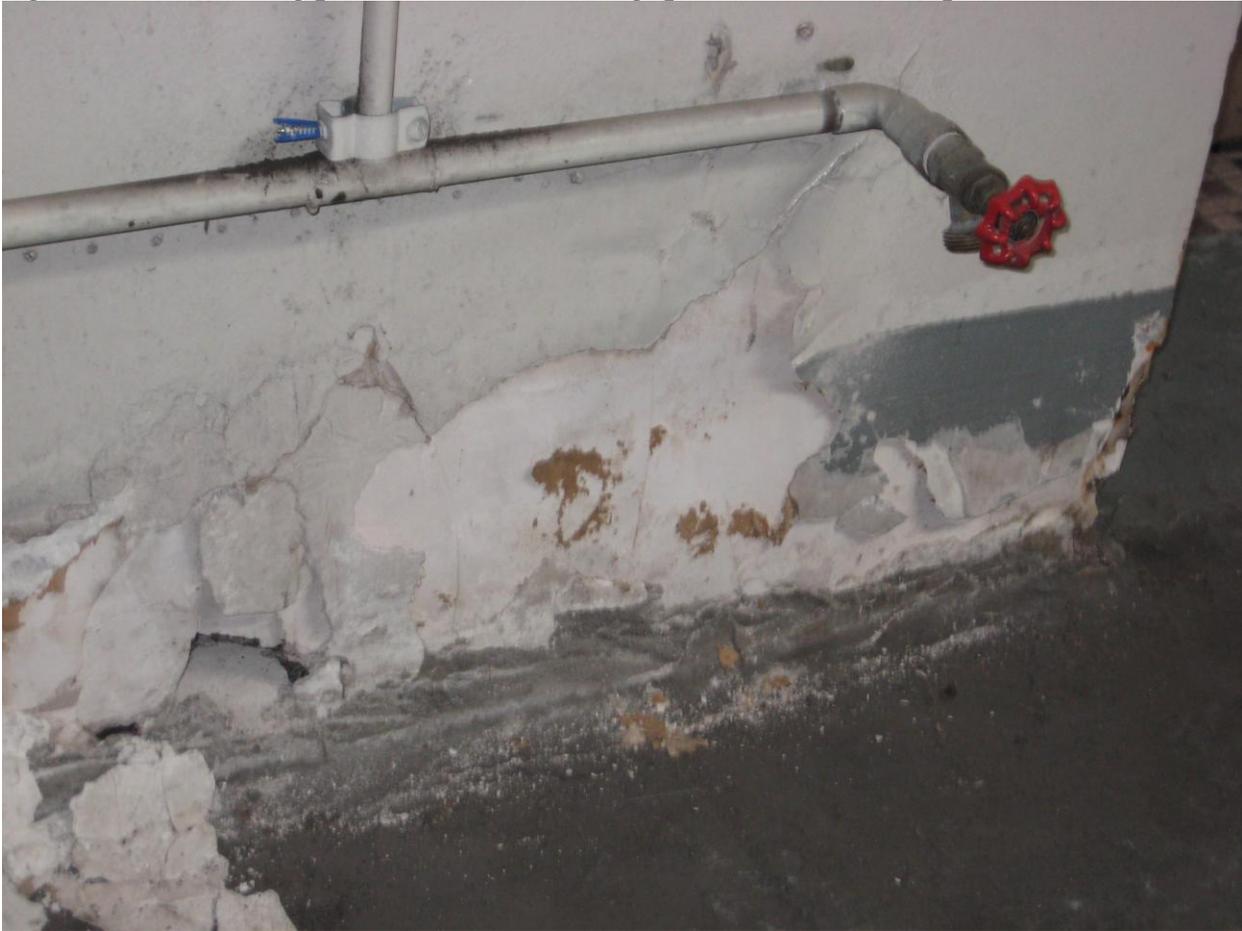
Old buildings often contain lead in the paint and plumbing, which may result in lead exposures. The timeframe of construction and renovation of the existing building at the GSA Motor Pool site make it likely that lead based paint and plumbing are present. Certified personnel should assess and address lead hazards in the GSA Motor Pool site building. If a lead hazard is identified, there are methods available to prevent health hazards from exposure: interim controls and hazard abatement.

Figure B.8. Crumbling paint inside the building (potential lead based paint source)

- If indoor air contaminants, odors or staining remain, more extensive cleaning or replacement of building infrastructure may be necessary.
 - Surfaces with signs of compromised integrity, such as crumbling, may have deteriorated from a chemical, acidic or alkaline reaction. Removal and replacement of these surfaces is advised.

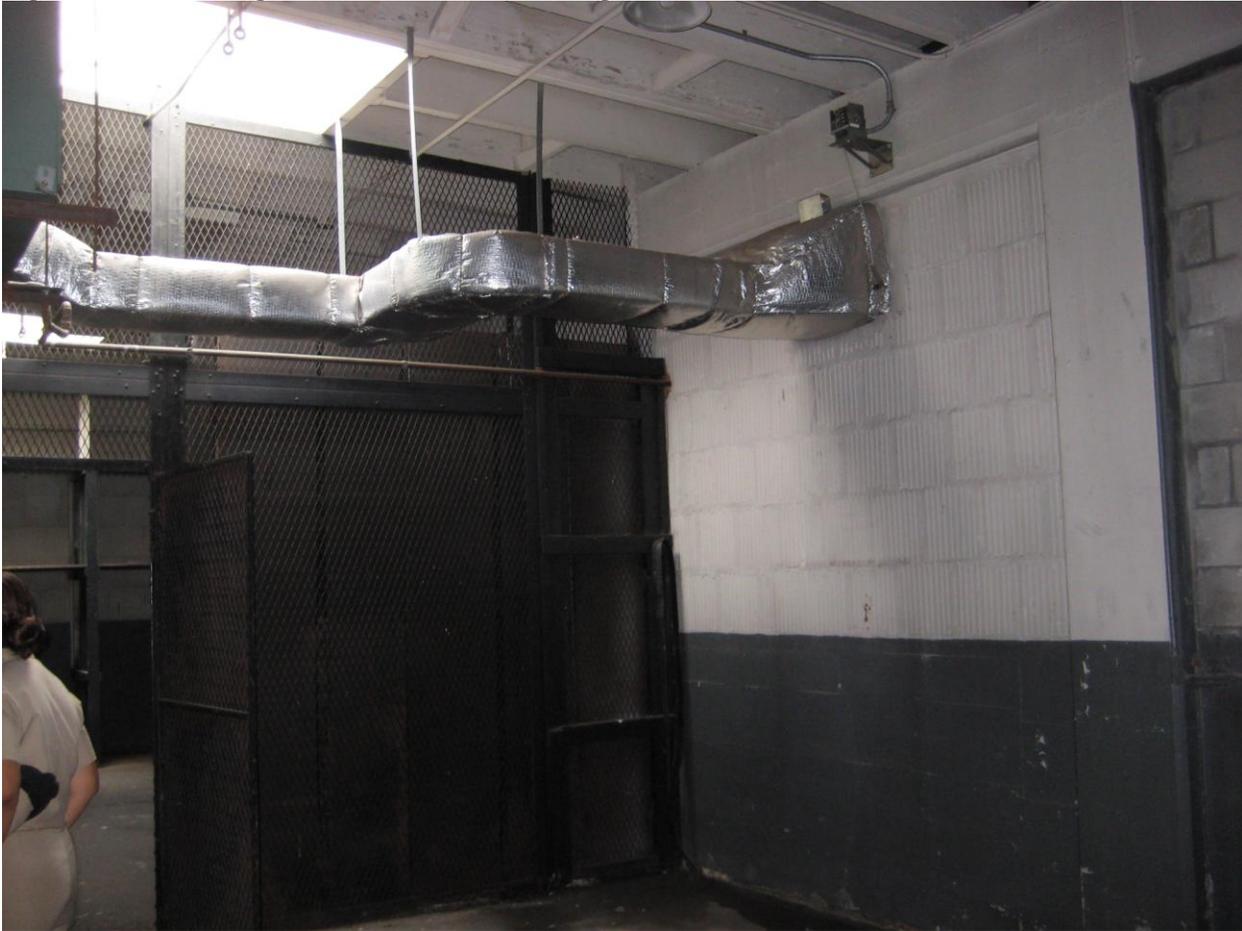
Figure B.9. Existing ductwork in the building on-site

- Drains, sumps and plumbing may require flushing or replacement to be freed of contaminants.
 - Replacing or cleaning ventilation ductwork is advised to prevent reintroduction of particulate matter and absorbed vapors. Air out and ventilate the building thoroughly until free of hazardous air contaminants and odors.
