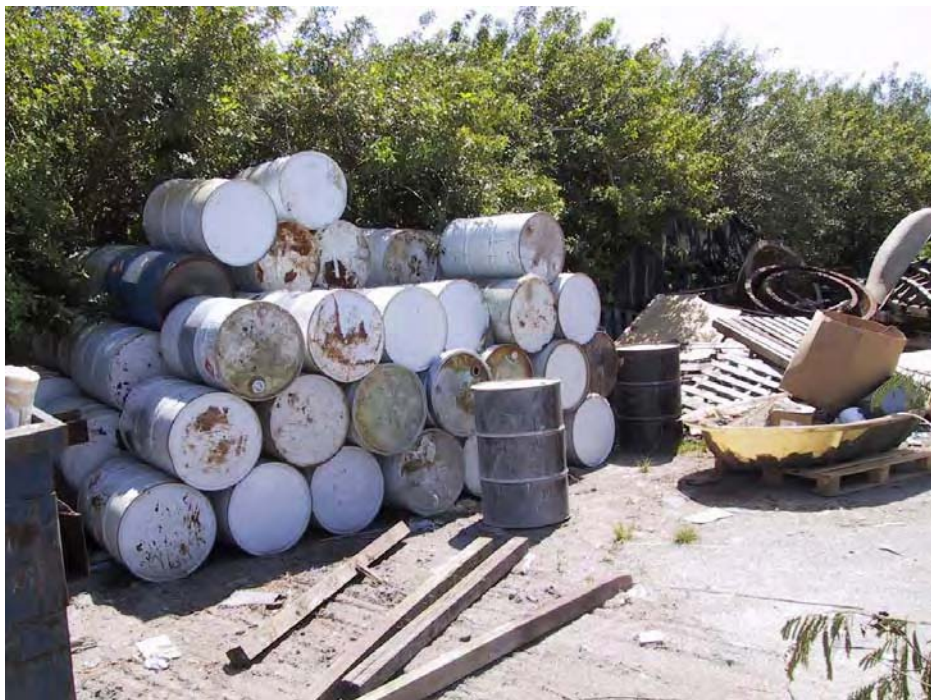
Photo 4. Chemical drums at Tampa Fiberglass

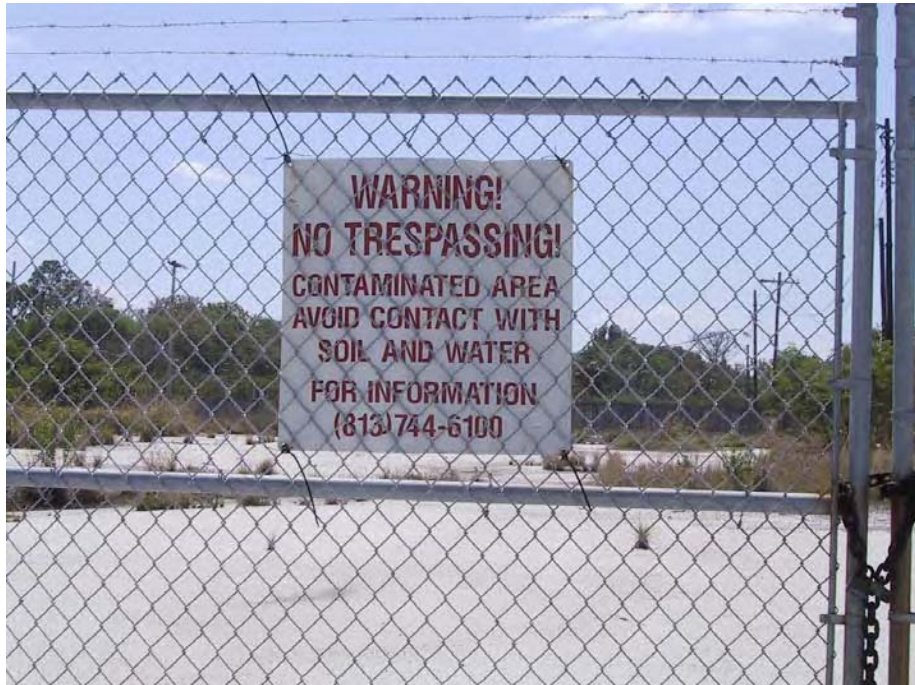
Photo 5. Fence and warning sign at Chloride Metals, Inc.

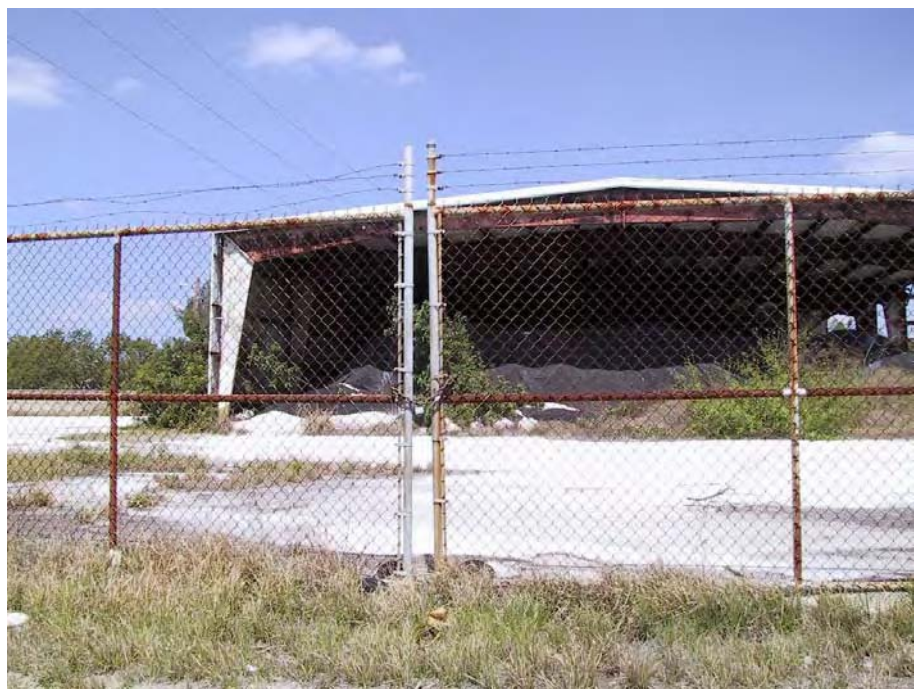
Photo 6. Cover over stored soil at Chloride Metals, Inc.

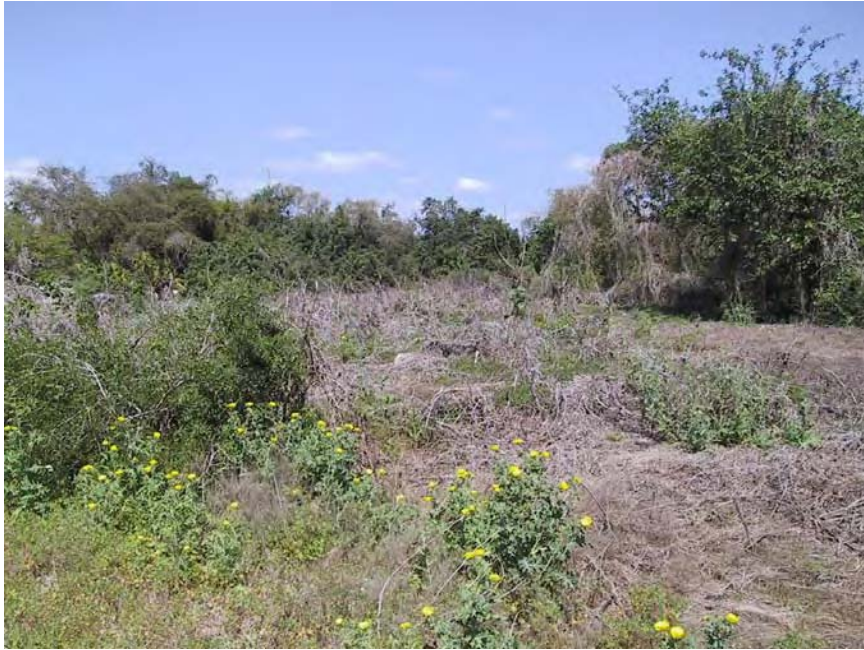
Photo 9. Vegetation on northern part of dump site.

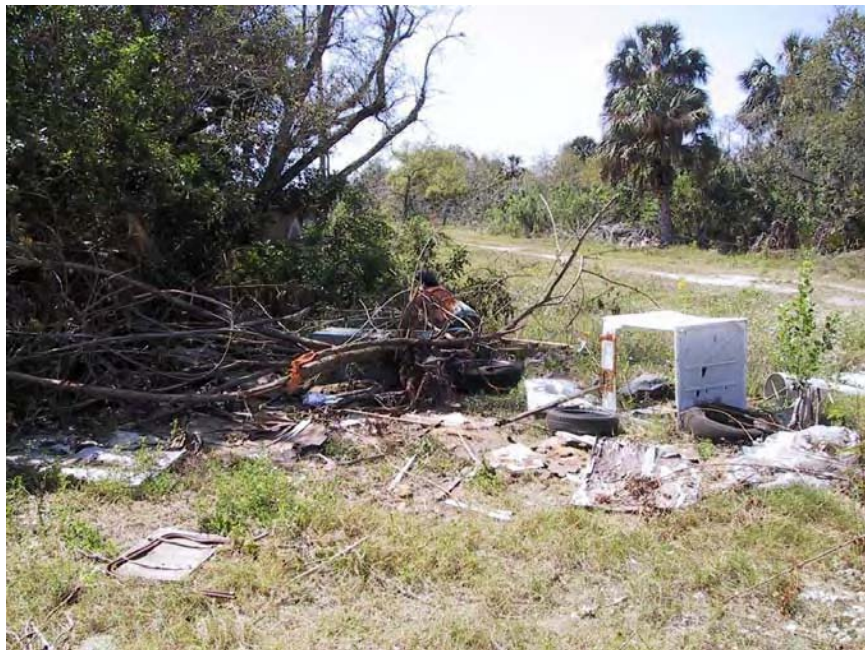
Photo 10. Discards on northern part of dump site.

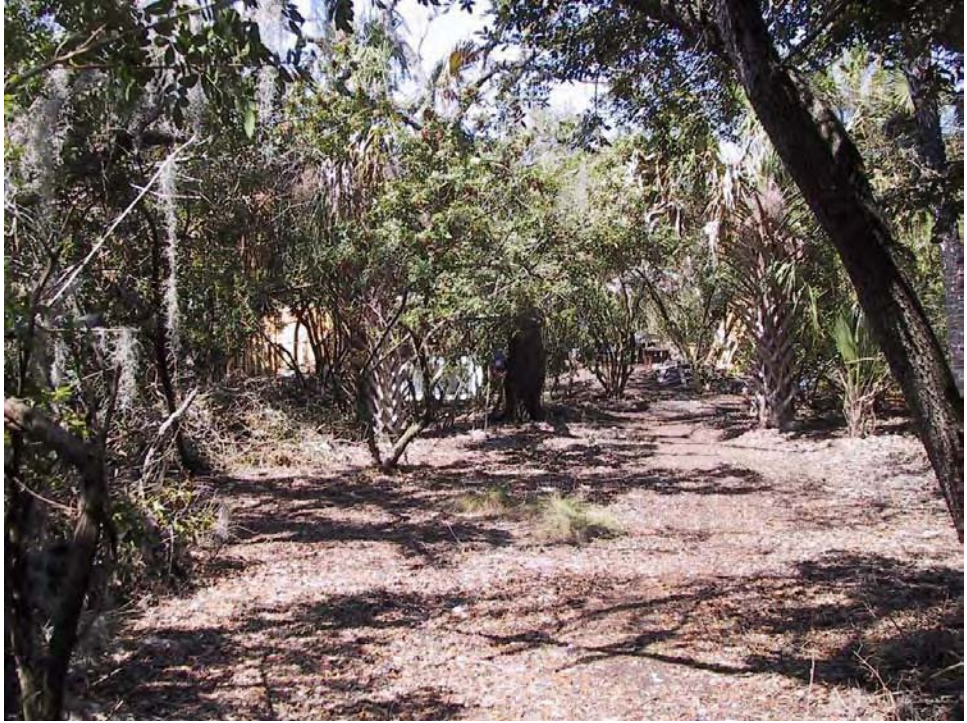
Photo 11. Dwellings on the northern part of the site.

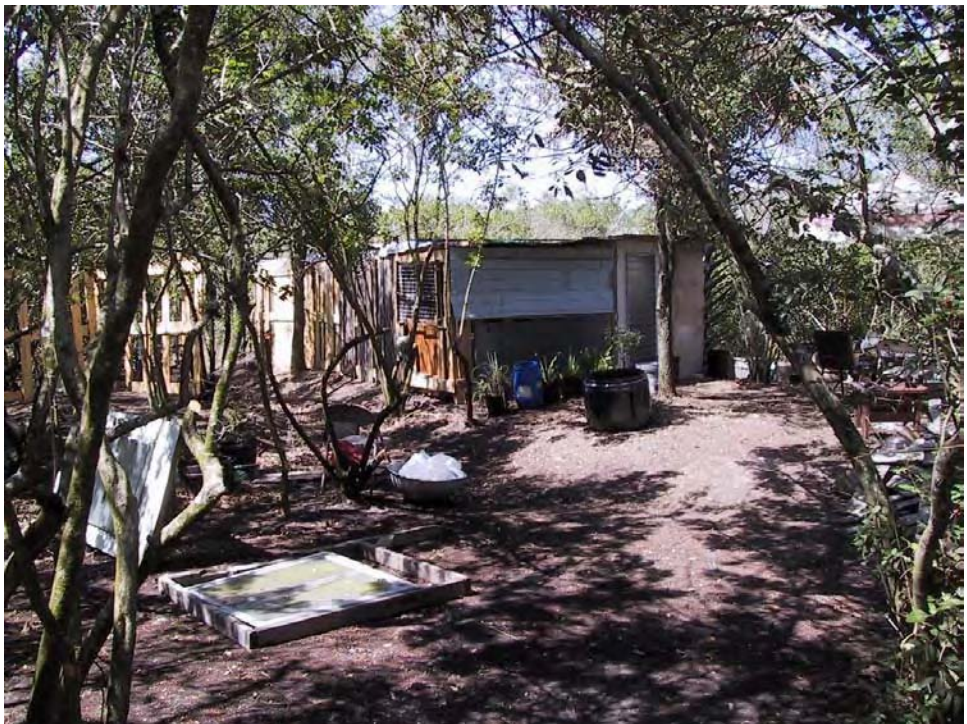
Photo 12. Close-up of the dwellings.

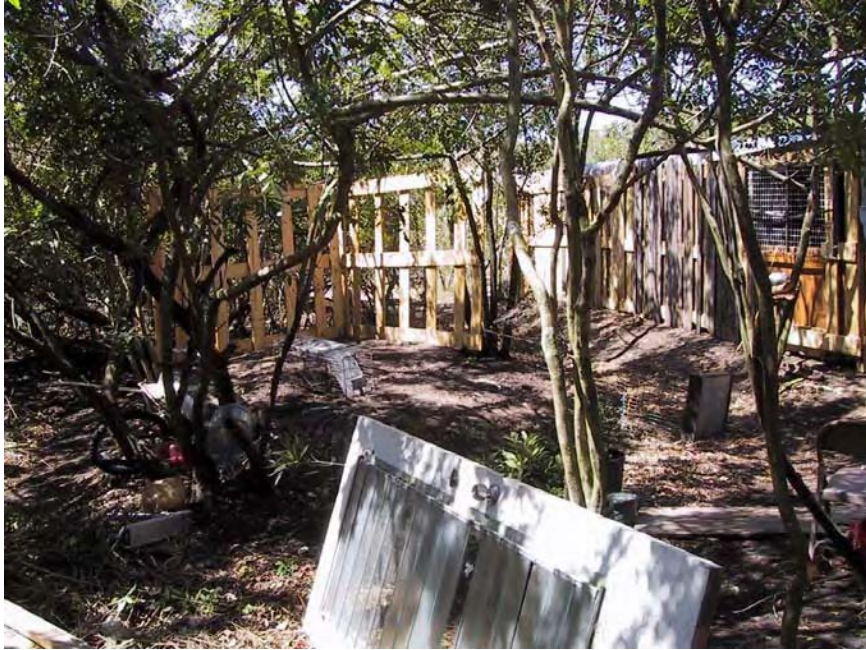
Photo 13. Dwellings are constructed of castoff materials.

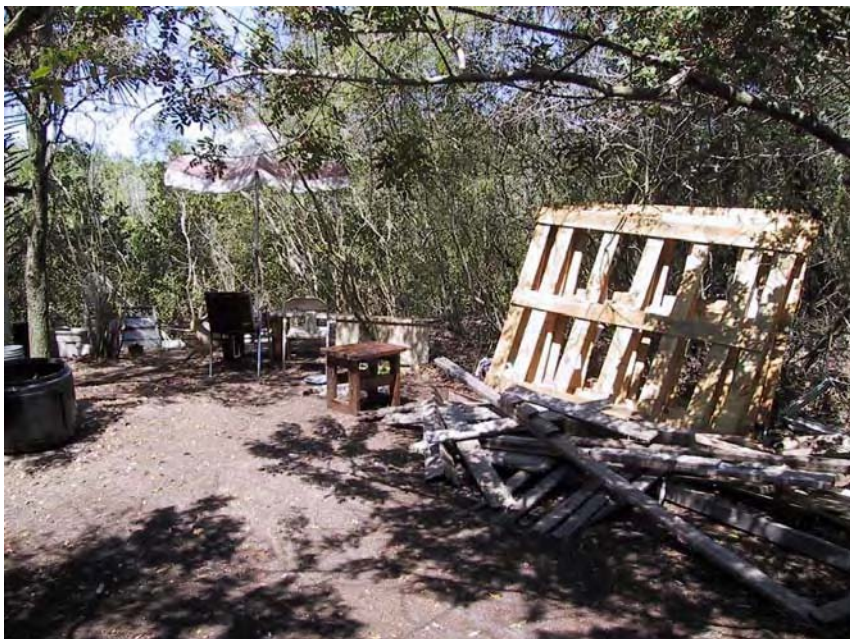
Photo 14. Outside sitting area; photographer also reported seeing a boat that they did not photograph.

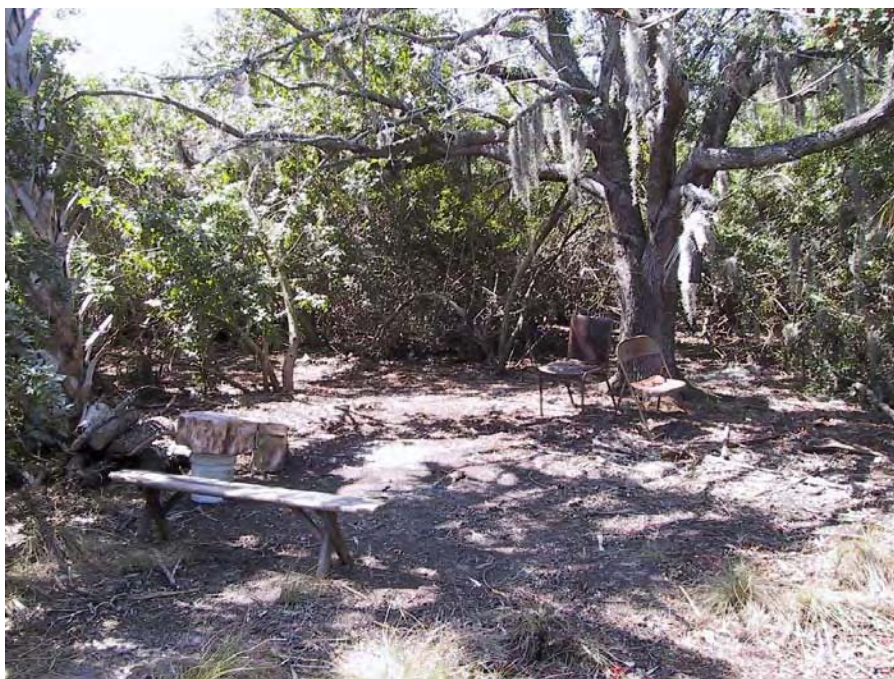
Photo 15. Fire pit and chairs.

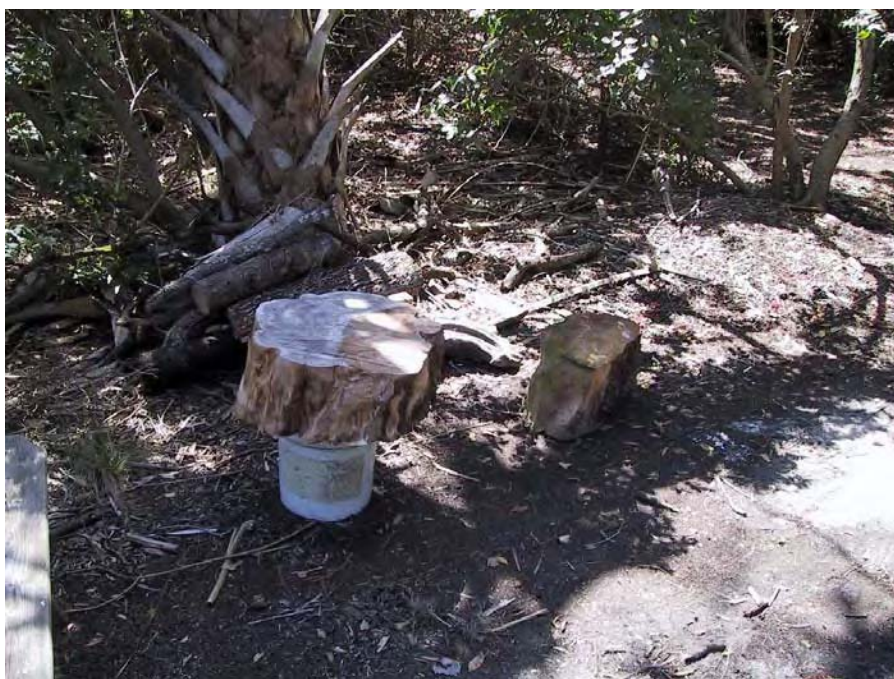
Photo 16. Makeshift chairs.

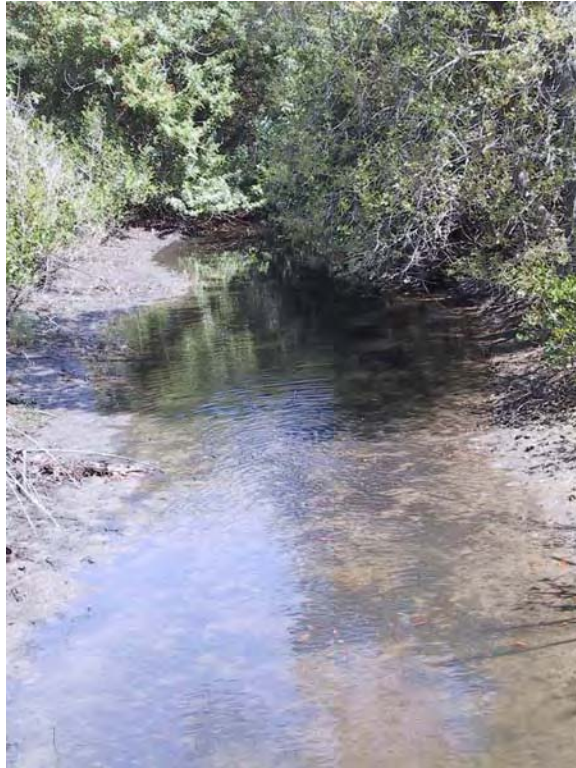
Photo 17. Small wetlands on the northern part of the site.
