Health Consultation

GILA CROSSING PRESBYTERIAN CHURCH

DISTRICT 6, GILA RIVER INDIAN COMMUNITY,
MARICOPA COUNTY, ARIZONA

MARCH 11, 2005

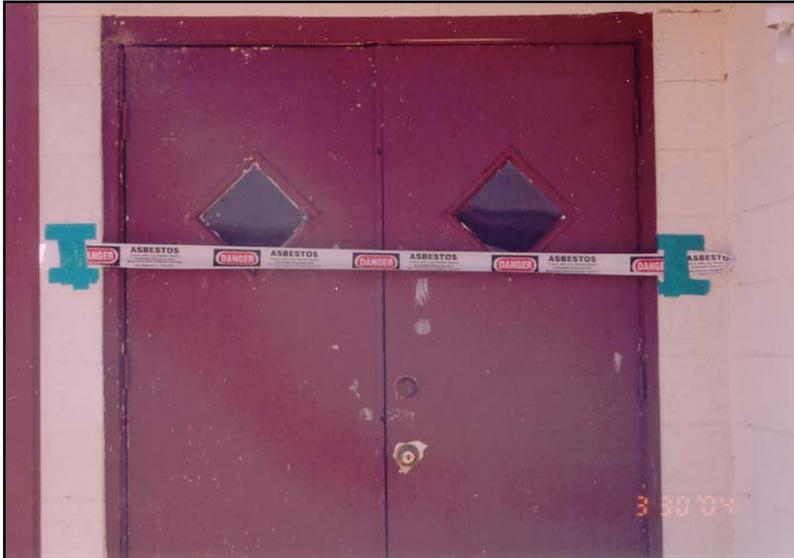
Figure 3:

Asbestos caution tape covers front door of main entrance of Gila Crossing Presbyterian Church

Currently, no one is allowed inside the Gila Crossing Presbyterian Church unless they have received proper asbestos training or the asbestos remediation is complete. A remediation service has been chosen, but the funding has not been secured to continue the remediation of the interior of the church. The exterior of the church must undergo post-soil sampling to determine if remediation is complete. Also, the Gila Crossing Presbyterian Church property boundary must be sampled to determine if asbestos may have reached neighboring properties.

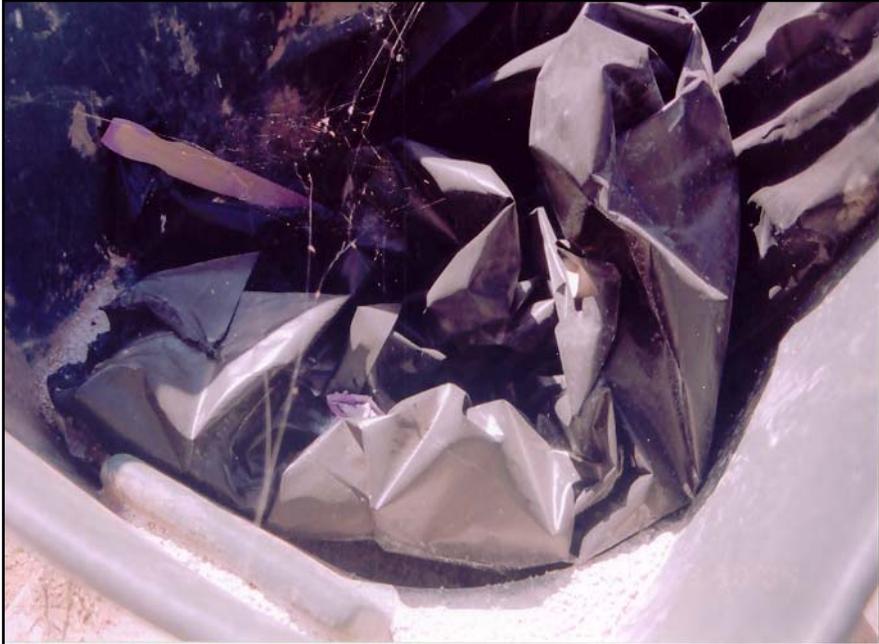
Figure 5:

Asbestos Containing Material (ACM) is in lower center of garbage can which was located outside of church

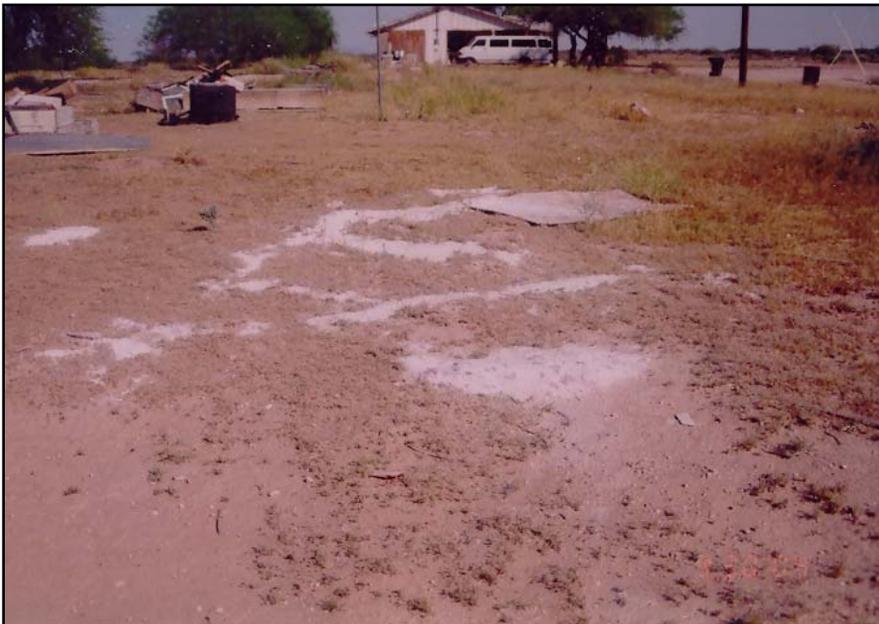
Figure 6:

In the background is the groundskeeper's residents. In the foreground is white asbestos on the soil east of church

On May 18, 2004, two asbestos samples were taken from the groundskeeper’s residence and the results were negative (8).
