# Letter Health Consultation

CHARLES BATCHELDER COMPANY SITE

NEWTOWN, CONNECTICUT

RE: Charles Batchelder Company Site  
Newtown, CT  
Health Consultation Letter Update 2012

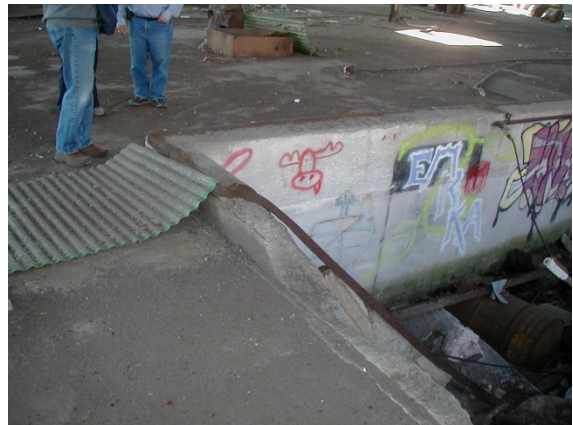
- Open pits are present inside several buildings. This was also observed in 1997.
- Two large tanks (with sections cut out on the ends) were observed. Oily water filled the bottom of both tanks. These tanks were observed in the same condition in 1997.

Open Pit

- Eliminate safety hazards at the Site as quickly as is reasonably achievable.
- Eliminate exposure to the piles of baghouse fines and dross located throughout the site.

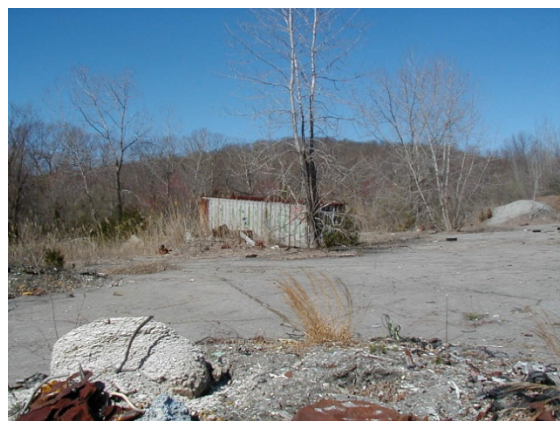
- Large piles of baghouse fines and dross (i.e. metal waste) are located throughout the site. One pile is located inside the large building on the eastern part of the property. The pile was partially covered with a geotextile membrane.

Debris (foreground), metal waste pile (background)

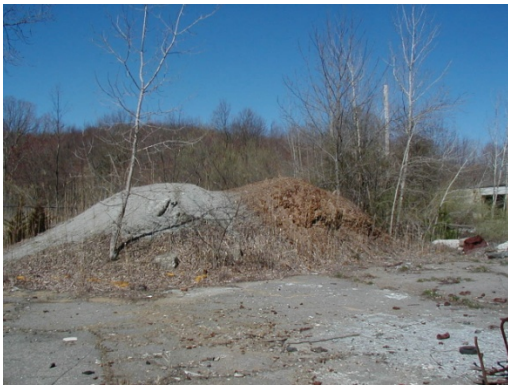
- The material in the metal waste piles was observed to be extremely fine-grained, almost the consistency of flour. On the day of the site visit, the weather was not windy, but tiny particles could be seen in the air around the metal waste piles.

Metal waste pile

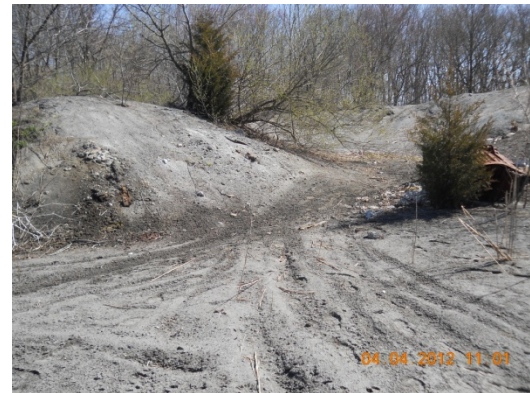
- Tire tracks (most likely from a dirt bike, motorcycle or all-terrain vehicle) were visible on the large piles of metal waste in the eastern portion of the site. Tire tracks were also visible inside the large building on the eastern part of the property. One of the town representatives on the site visit stated that as recently as two weeks prior to the site visit, he had witnessed trespassers at the site and had required them to vacate the property. In 1997, tire tracks were also observed on and around the metal waste piles.

Tire tracks leading to/from pile

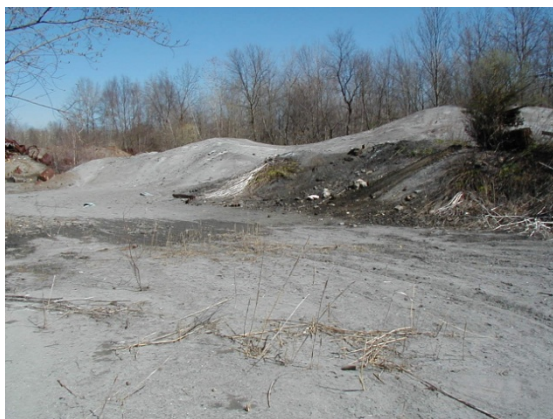
Largest metal waste pile, with tire tracks

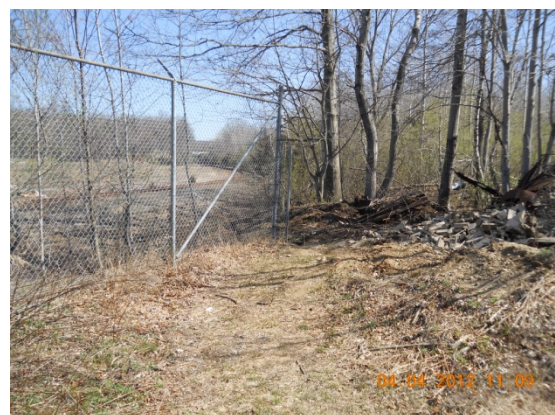
- A large section in the northeastern portion of the perimeter fence was cut away. Soon after the site visit, CTDPH was informed by the Town of Newtown that they had repaired the breach in the fence.

Missing portion of perimeter fence

- Place chemical and safety hazard warning signage on the perimeter fencing as soon as is practicable. Signage and perimeter fencing should be inspected periodically to ensure that the fencing has not been breached and the signage has not been removed.
