Health Consultation

Evaluation of Environmental Exposures at the
GAMBELL FORMERLY USED DEFENSE SITE (FUDS)
NATIVE VILLAGE OF GAMBELL
GAMBELL, ALASKA

JULY 24, 2017

U.S. DEPARTMENT OF HEALTH AND HUMAN SERVICES
Agency for Toxic Substances and Disease Registry
Division of Community Health Investigations
Atlanta, Georgia 30333

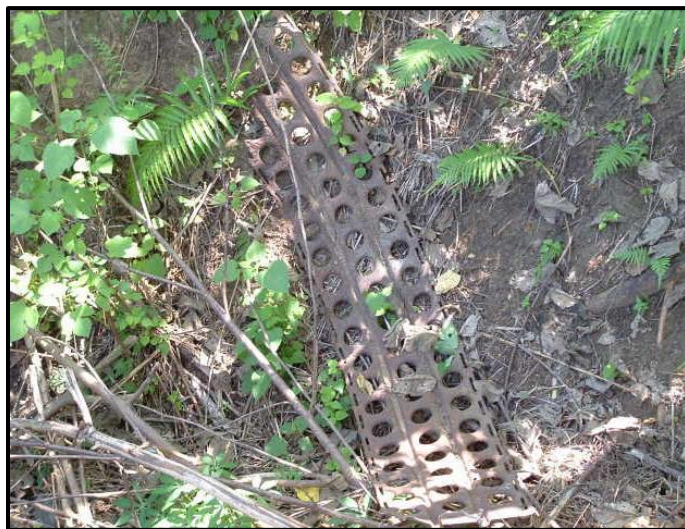
Figure 2: Example of weathered Marston matting

Buried debris that was not eligible for cleanup under the FUDS program was addressed through the Native American Lands Environmental Mitigation Program (NALEMP), funded through the Department of Defense, to clean up construction debris and small remaining quantities of hazardous substances. The USACE cleanup of the Gambell FUDS was completed in 2007 and 2008, when all of the associated contaminated sites were determined to be “Cleanup Complete” [ADEC 2013]. However, NALEMP continues to be funded on an annual, as-needed basis to address metal debris and other non-FUDS issues.

Freezing and thawing can cause heavy objects to rise to the surface, and additional metal objects once buried might resurface, creating a physical hazard. Residents are concerned about the potential for ATV and snowmobile accidents caused by collision with the debris. Metal cables and other debris in the past have surfaced and presented a physical hazard.

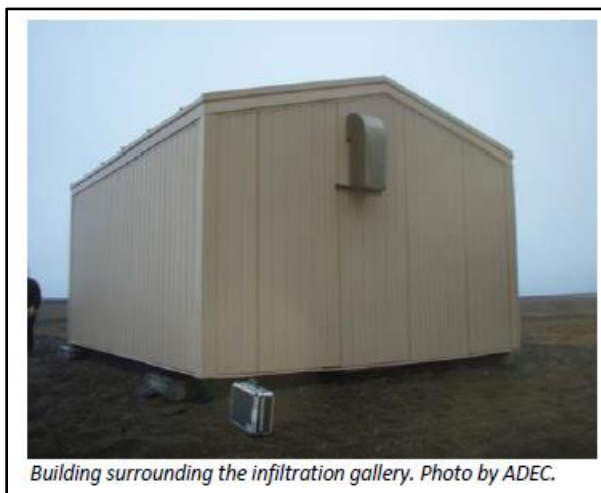
Figure 4. Infiltration Gallery Building

Before well water was available for the village, an infiltration gallery was built near the foot of Sevuokuk Mountain in 1992 and used as a seasonal potable water source for village residents of Gambell (Figure 4) [MW 1995; BCS 2006a, 2006b, 2007]. Surface water likely seeps into the below-ground water collection system, making it susceptible to contamination. A small spring in the area is thought to be recharged by surface and subsurface flow from the base of the mountain. During the winter, the gallery freezes and is not useable. The pipes that connected the gallery to the village water supply have been capped and the gallery is currently available as a back-up supply [MW 1999].

² An infiltration gallery is a man-made conduit built in permeable earth for collecting groundwater. Collected water is then pumped to a storage tank, treated as needed, and distributed [World Health Organization 1996].

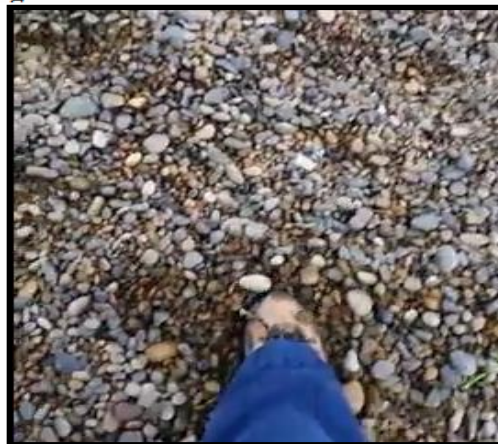
Figure 5. Gambell's Ground Surface Gravel

The Gambell spit is mostly rocky, without plants, except for a few patches of beach grass. The village is built primarily on basalt gravel, typically, 2–6 cm (0.5–3 inches) in diameter, with slightly smaller gravel on the beach [USGS 1971]. The gravel has smooth edges resembling river rocks and is unconsolidated and free moving. The gravelly, sandy beach soils are well drained [Munter 1992]. The large gravel is often referred to as cobble. Patches of sand and soil are found in only a few locations, intermingled among rock at the base, slope, and top of Sevuokuk Mountain, and provide a substrate for the grasses, shrubs, heaths, sedges, mosses, and lichen [MW 1995]. Local transportation on the gravel spit is best by all-terrain vehicles (ATVs) [E&E 1993]. Walking on the gravel is difficult and takes much effort [Jolles 2002].

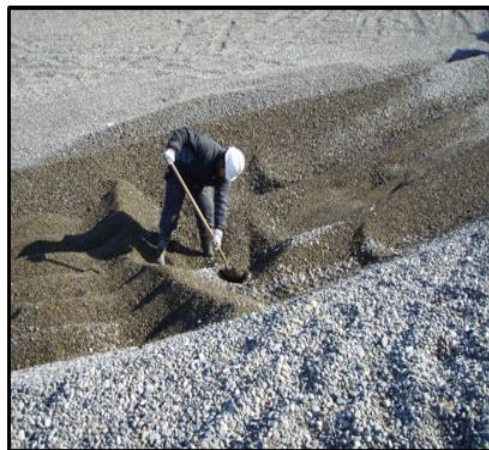
Figure 6. Gravel Beneath the Surface

- Moisture and even standing water is present in the gravel just below the first few inches of the surface. This increases the solubility and opportunity for natural attenuation or

degradation of organic contaminants. It also reduces the likelihood that inorganic contaminants would stick to hands.
