Health Consultation

EXCELSIOR PARKLAND DUMP

CITY OF EXCELSIOR, HENNEPIN COUNTY, MINNESOTA

**Prepared by the
Minnesota Department of Health**

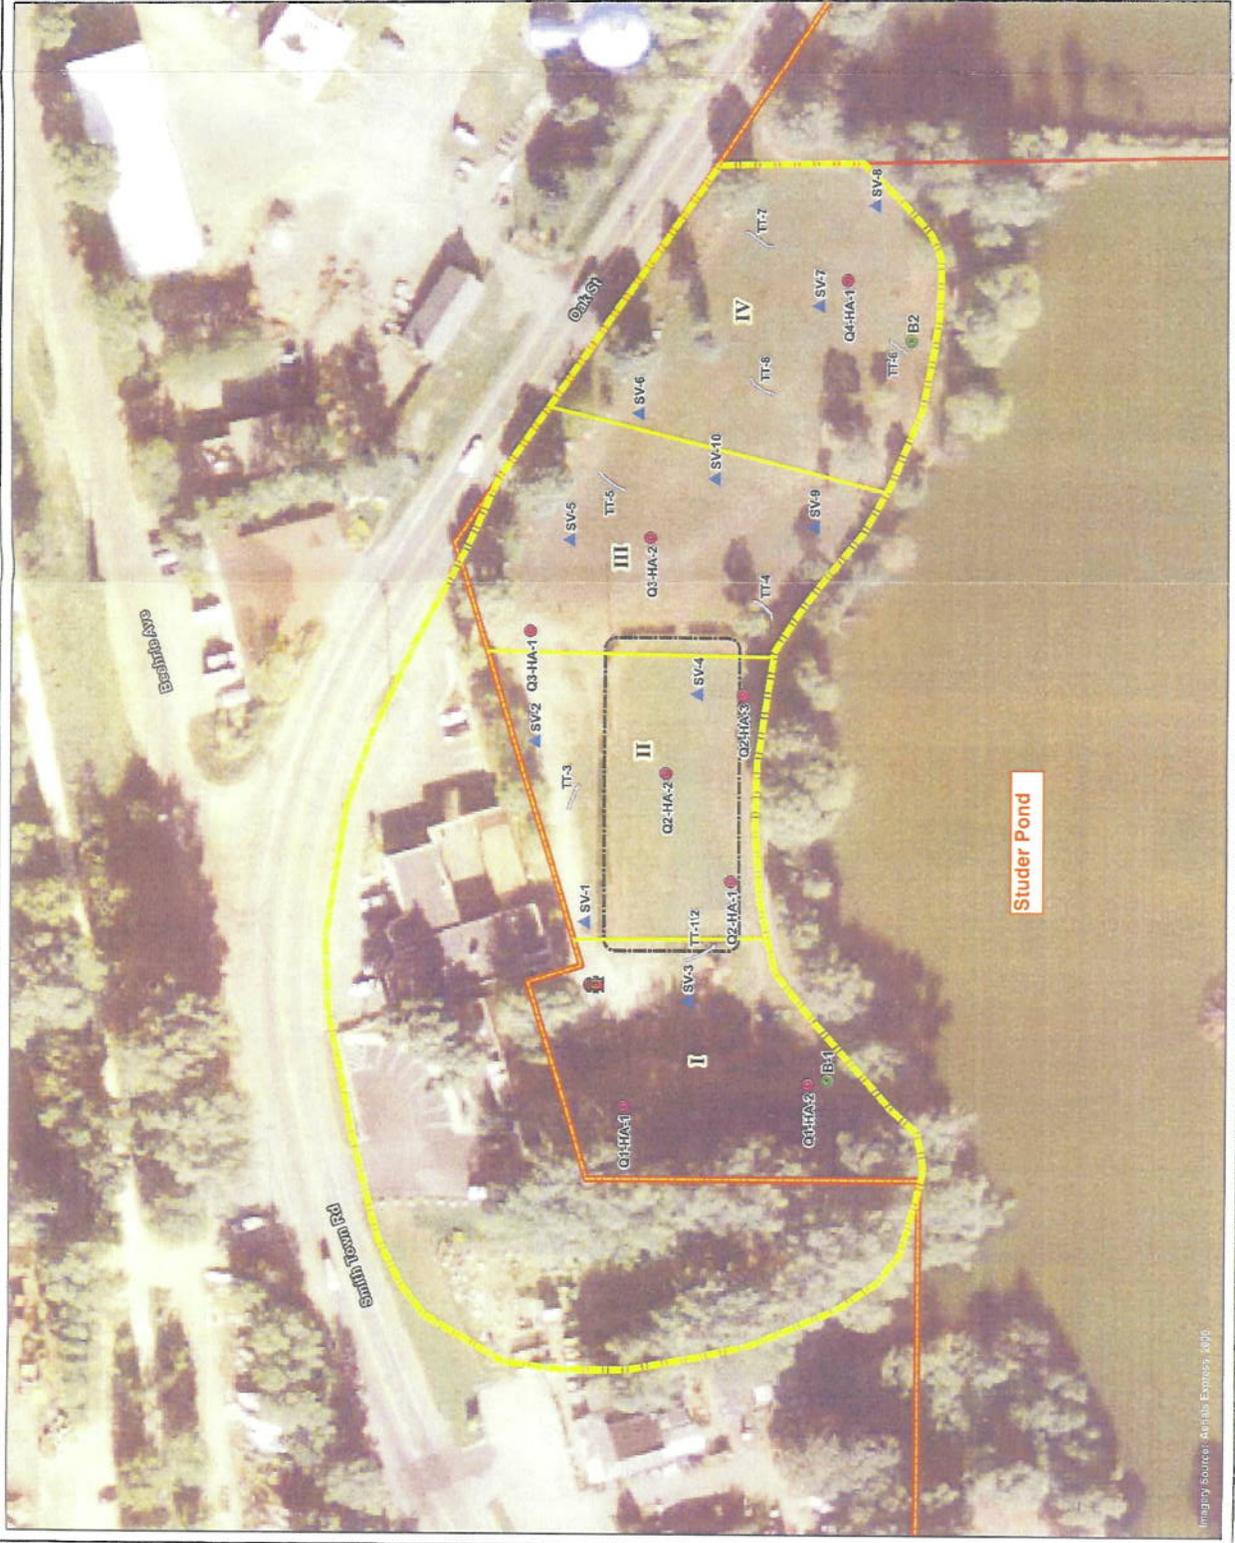
Figure 2

Available geologic information provided by Barr indicates that surface soils at the site consist of one to four feet of silty sand, gravel, and sandy clay lying over waste materials (Barr 2008a, Barr 2009). Soil borings and test trenches dug at the site confirmed the presence of waste materials (primarily ash, glass, metal, and asphalt) at depths of up to 16-18 feet. In one boring drilled through the waste, clay soils were found below the fill to a depth of 47 feet below ground. The locations of the test trenches and borings are illustrated in Figure 2.

Later during the initial environmental investigation at the site, ten dedicated soil vapor probes were advanced to 6-7 feet below grade to characterize soil vapor. The probe and sample locations are shown in Figure 2. Again, soil gases including carbon monoxide, hydrogen sulfide, oxygen, and methane were field monitored using direct-reading instruments. Four soil vapor samples (at SV-1, 2, 6, and 7) were also collected using stainless steel Summa canisters for analysis for VOCs using EPA Method TO-15 (Barr 2008a). Methane was detected in each of the borings, at levels up to 42.9 % by volume, well above the LEL of 5% by volume. The analysis of

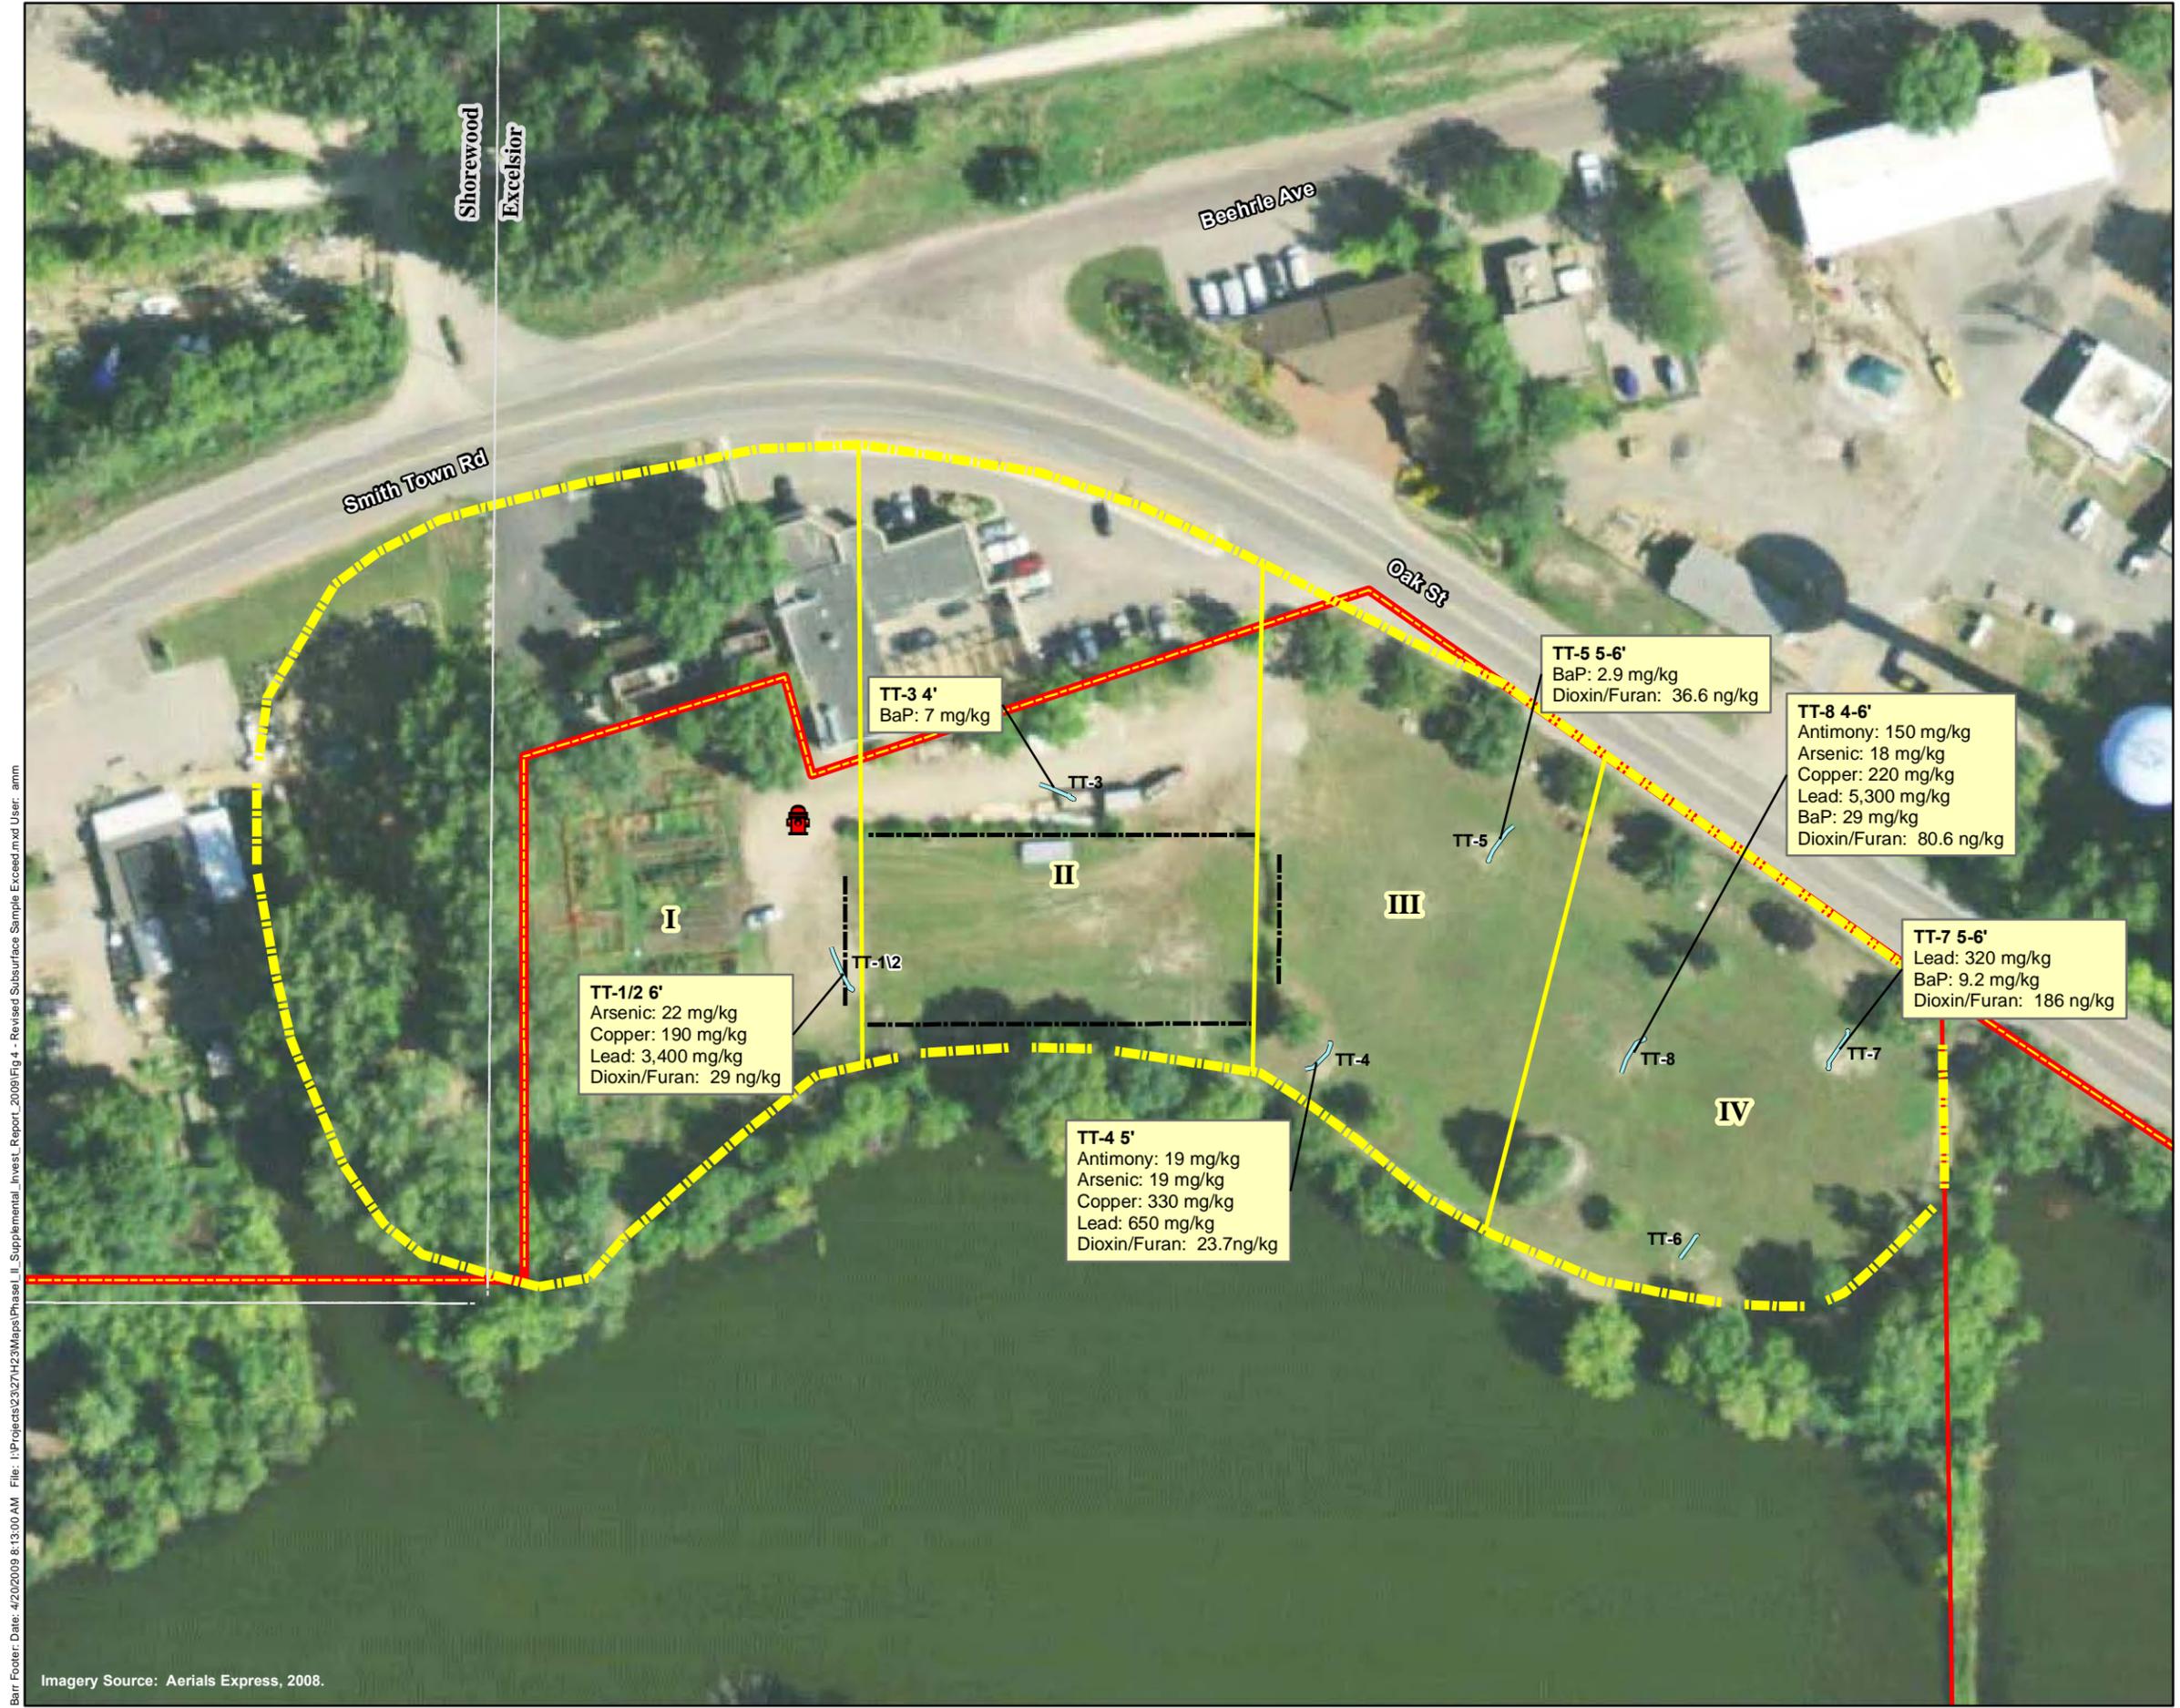
Figure 3

VOCs, and dioxins/furans. Only one VOC, naphthalene, was detected in subsurface soil, at levels less than one milligram per kilogram (mg/kg, or part per million (ppm)). Metals, PAHs, and dioxins/furans were commonly detected, and levels of each exceeded SRVs and/or SLVs in multiple samples. The exceedances (of SRVs) are shown in Figure 3; SLVs are listed in Table 1.

**REVISED SUBSURFACE SOIL
SAMPLE EXCEEDANCES
(> 4' below ground surface)**

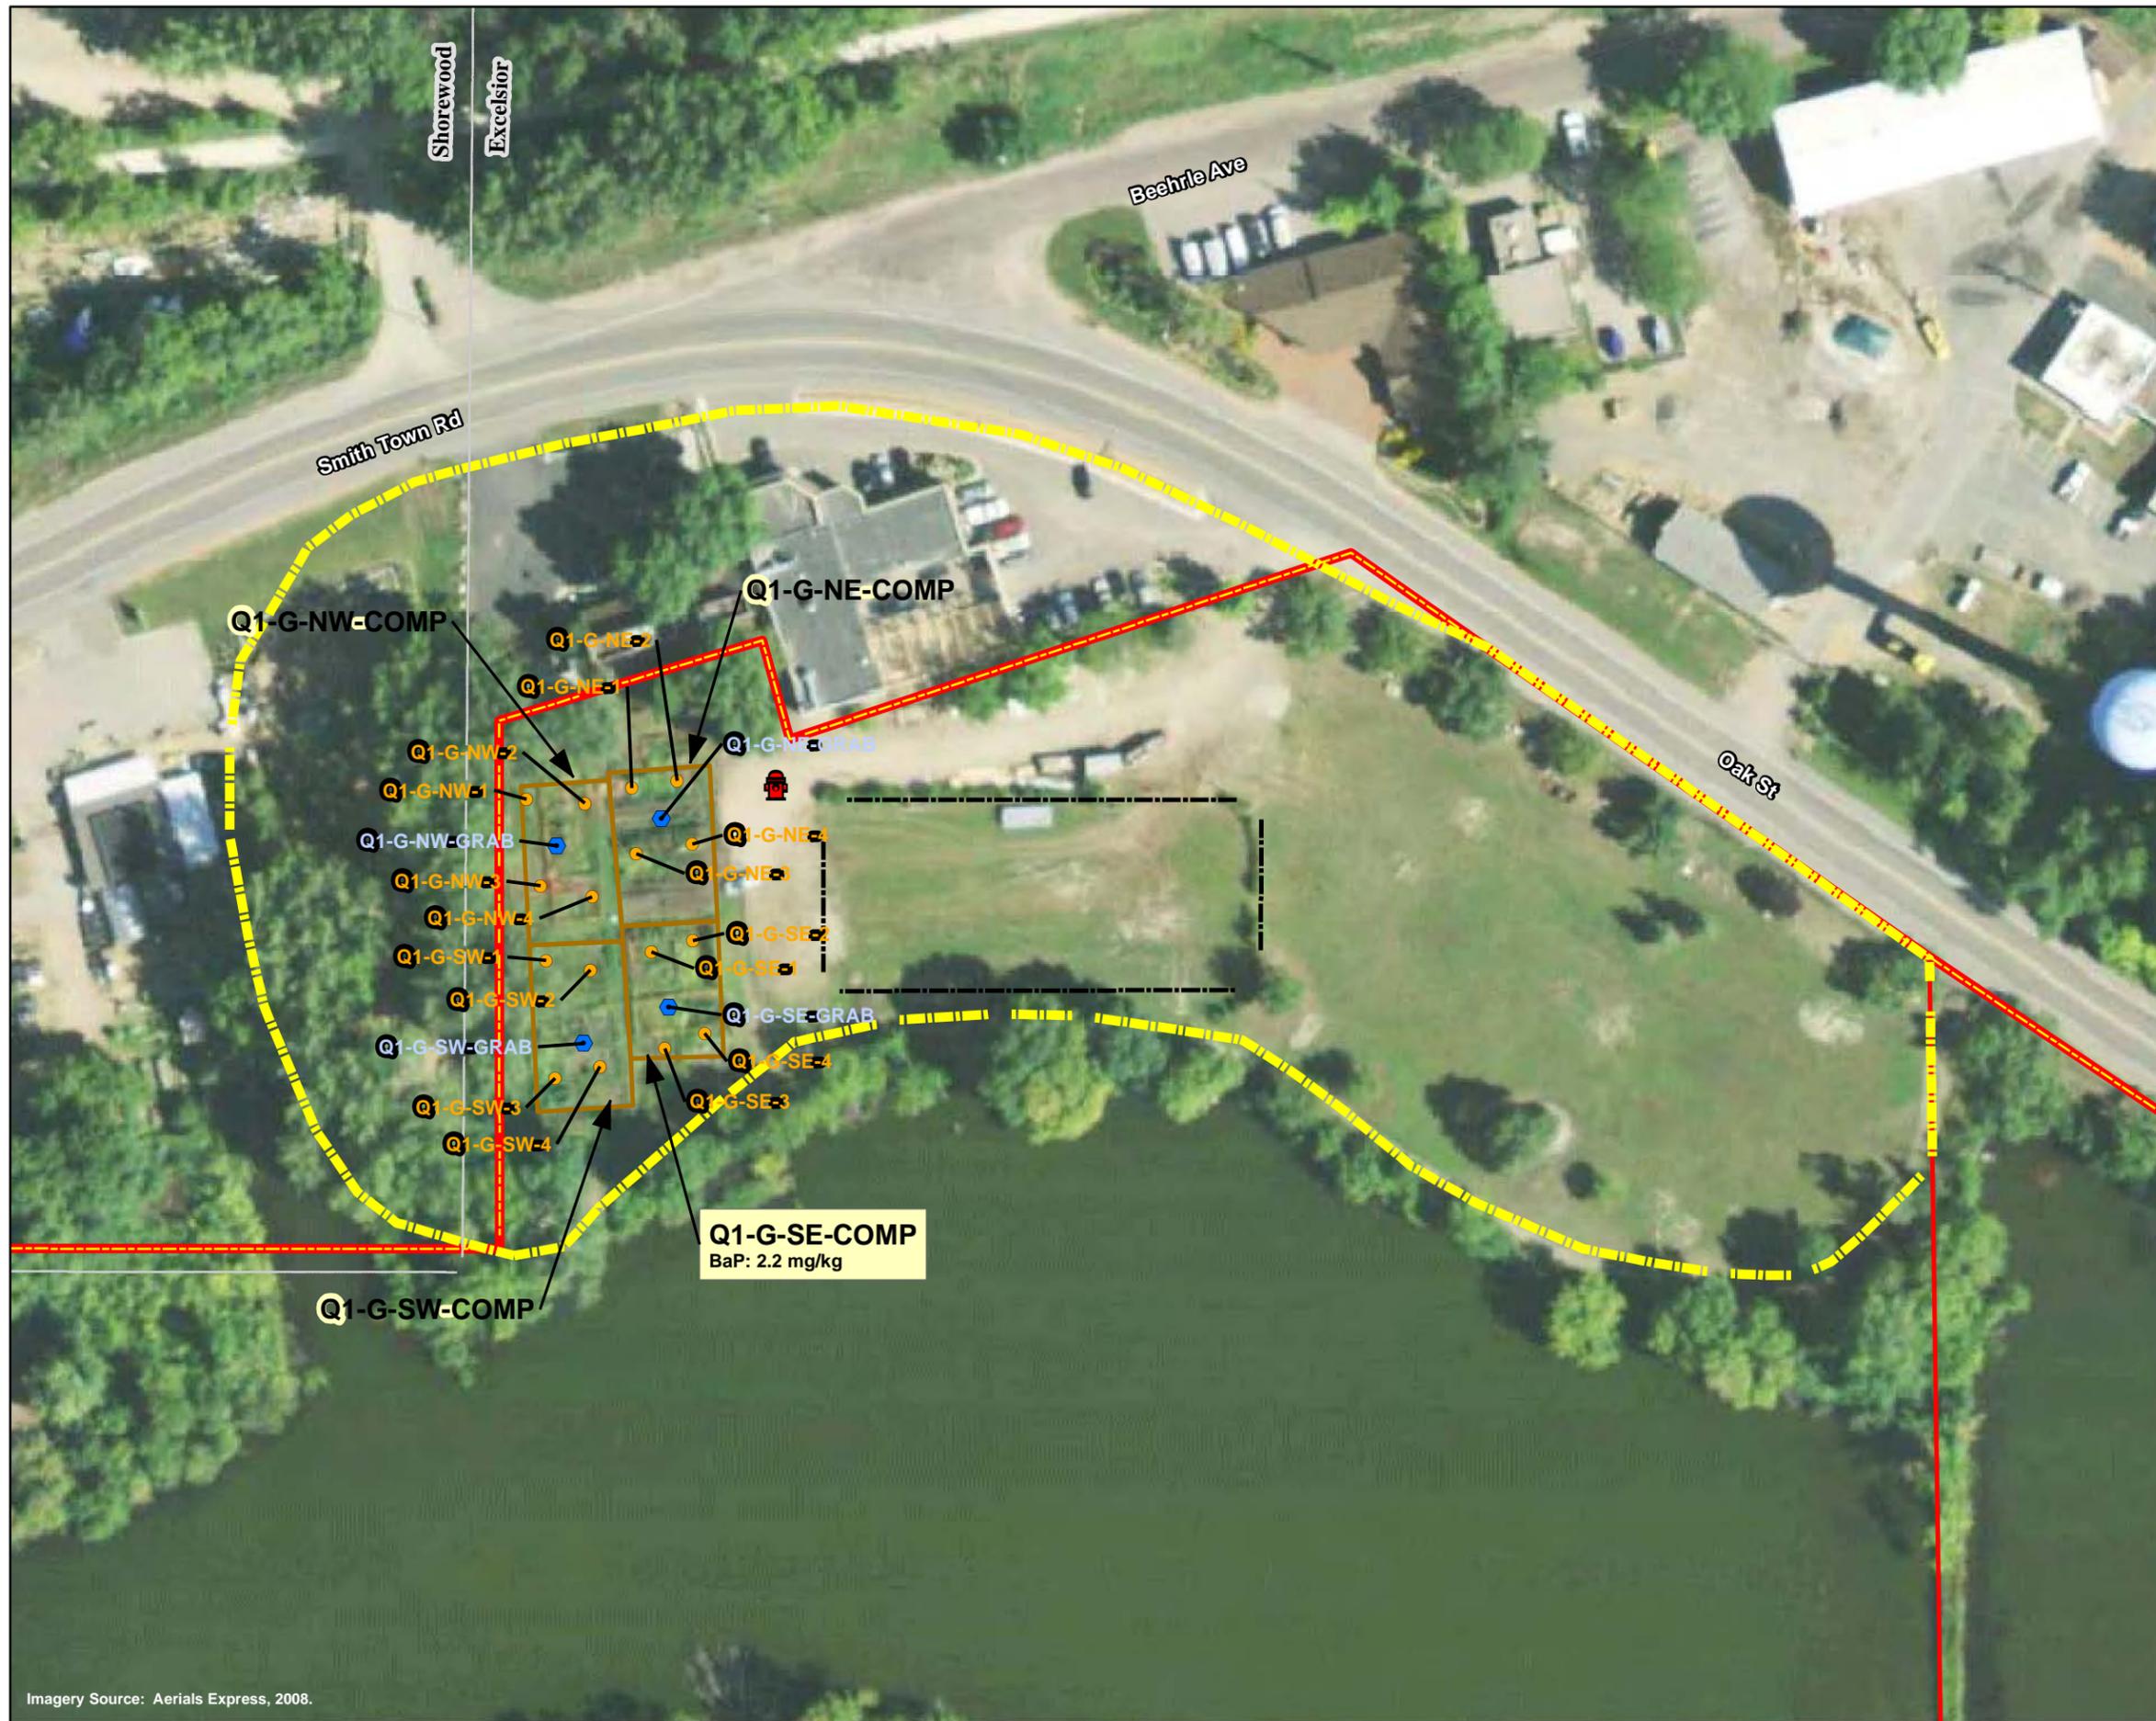
Because of the detections of elevated levels of PAHs in the composite soil samples from the community garden area (quadrant 1) of the site, in late 2008 the MPCA requested that additional surface soil samples from the garden be collected for chemical analysis (Barr 2009a). Samples were collected from the surface to a depth of 1.5 feet using a hand auger. The sample locations were determined by separating the garden area into four sub-quadrants (NW, NE, SW, and SE). Four discrete samples were collected and combined to form a composite sample from each quadrant for analysis for metals, PAHs, and dioxins/furans. A separate grab sample was also collected for VOC analysis from each quadrant. The sample locations are shown in Figure 4; the results are shown in Table 2.

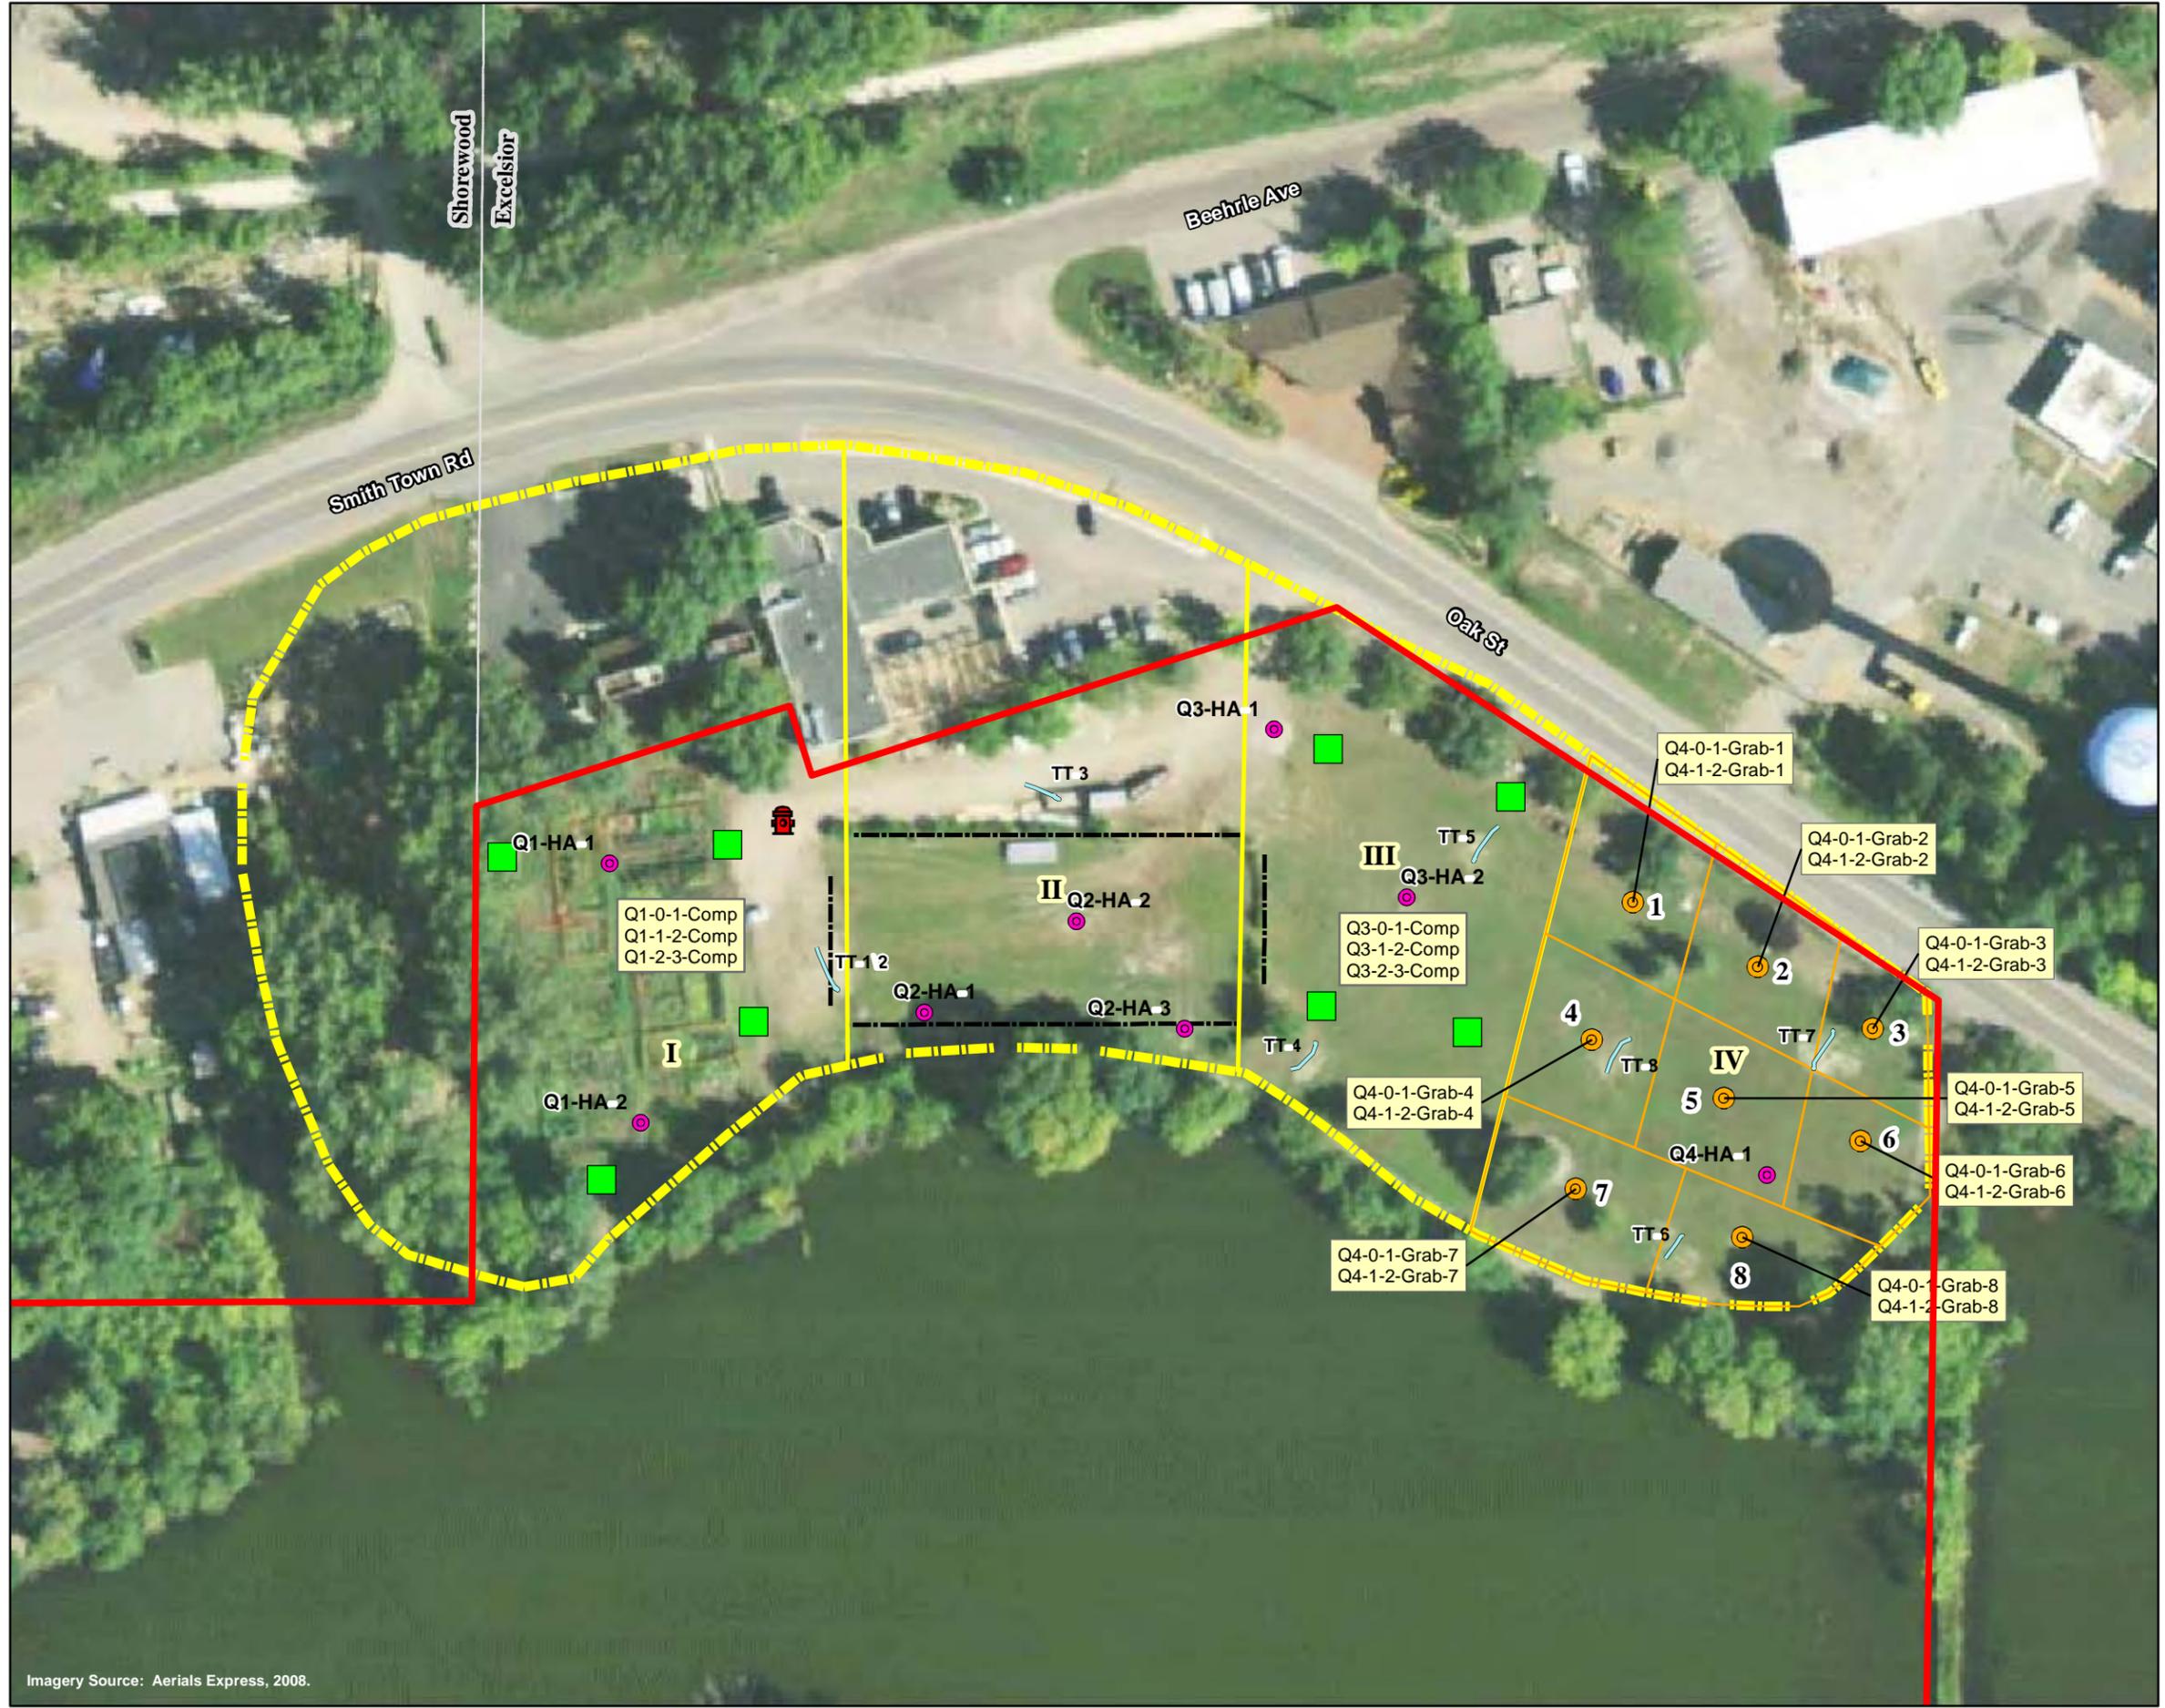
NEAR SURFACE SOIL SAMPLE LOCATIONS

The sample locations are shown in Figure 5; the data are presented in Tables 3a-3e. The results of the quadrant 1 soil sample analyses for PAHs showed that BaP equivalents ranged from 11-15 mg/kg, which exceeds the recreational SRV for BaP of 2 mg/kg (note: non-detect values were estimated at ½ the method detection limit, a conservative, health-protective approach). In quadrant 3, concentrations of dioxins/furans from the soil samples collected from the 0-1 foot and 1-2 foot depth intervals were below the recreational SRV for dioxins/furans (based on a calculation of 2,3,7,8-TCDD toxicity equivalency factors, or TCDD-TEQs) of 25 nanograms per

- Quadrant 1: Three composite soil samples from three depths (0-1, 1-2, and 2-3 feet) were collected from outside the community garden area and analyzed for PAHs.
- Quadrant 2: No samples were collected; previous work had not identified SRV exceedances.
- Quadrant 3: Three composite soil samples from three depths (0-1, 1-2, and 2-3 feet) were taken and analyzed for dioxins/furans.
- Quadrant 4: This quadrant was divided into eight subareas. Two grab samples were collected from each subarea (0-1 and 1-2 foot depth). Each of the eight subarea grab samples was analyzed for metals. Remaining soil from the 1-2 foot depth interval was analyzed for PAHs and dioxin/furans. For these analyses, two subarea samples were composited based on their location, resulting in four composite samples. The subarea samples that were composited were: 1 & 4, 2 & 5, 3 & 6, and 7 & 8.

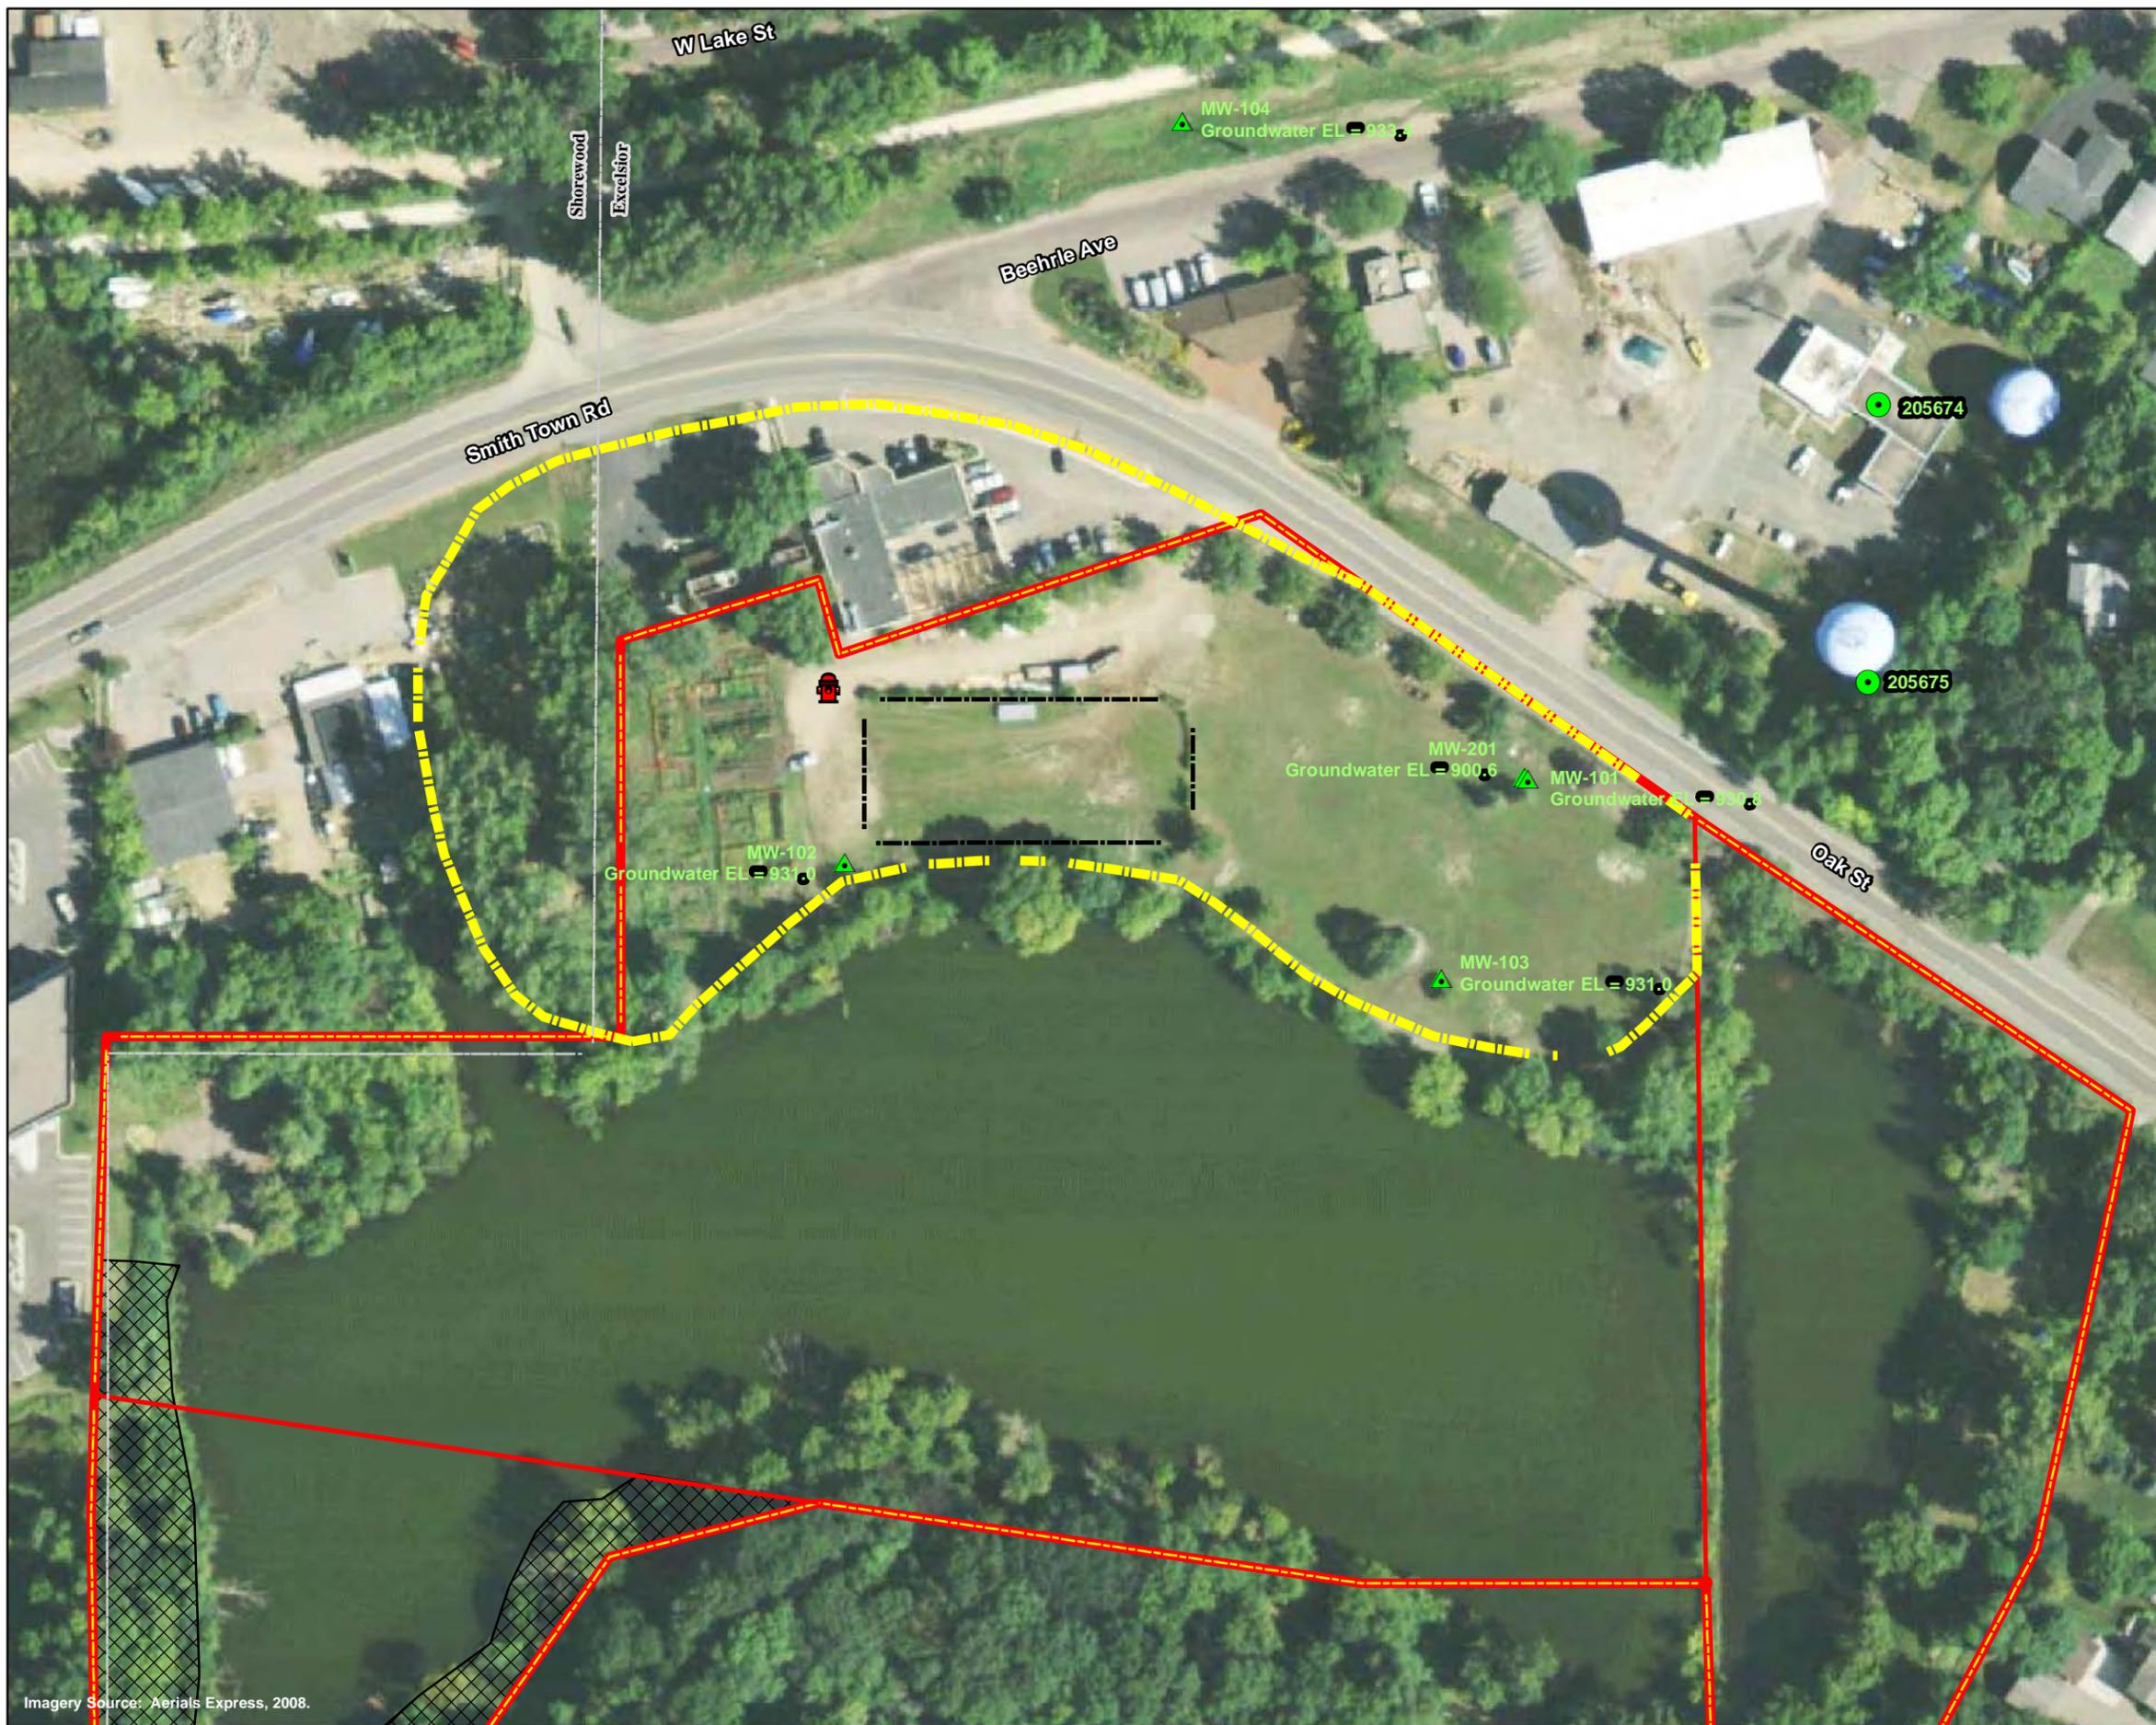
Barr Footer: Date: 4/20/2009 8:03:16 AM File: I:\Projects\2327\H23\Maps\Phase II Supplemental Invest Report 2009\Fig 6 - Monitoring Well Locations and GW Elevations.mxd User: amm

The second phase of site investigation included the installation of four permanent monitoring wells at the site and one up-gradient monitoring well with a hollow stem auger drill rig (Barr 2009a). Four of the wells (MW-101, MW-102, MW-103, and MW-104) were installed as shallow water table wells; one deeper well (MW-201) was installed to a depth of 50 feet to monitor deeper groundwater conditions below the waste at the site. The off-site well (MW-104) was installed northwest of Oak Street along a trail owned by the Hennepin County Regional Rail Authority. The well locations are shown in Figure 6.

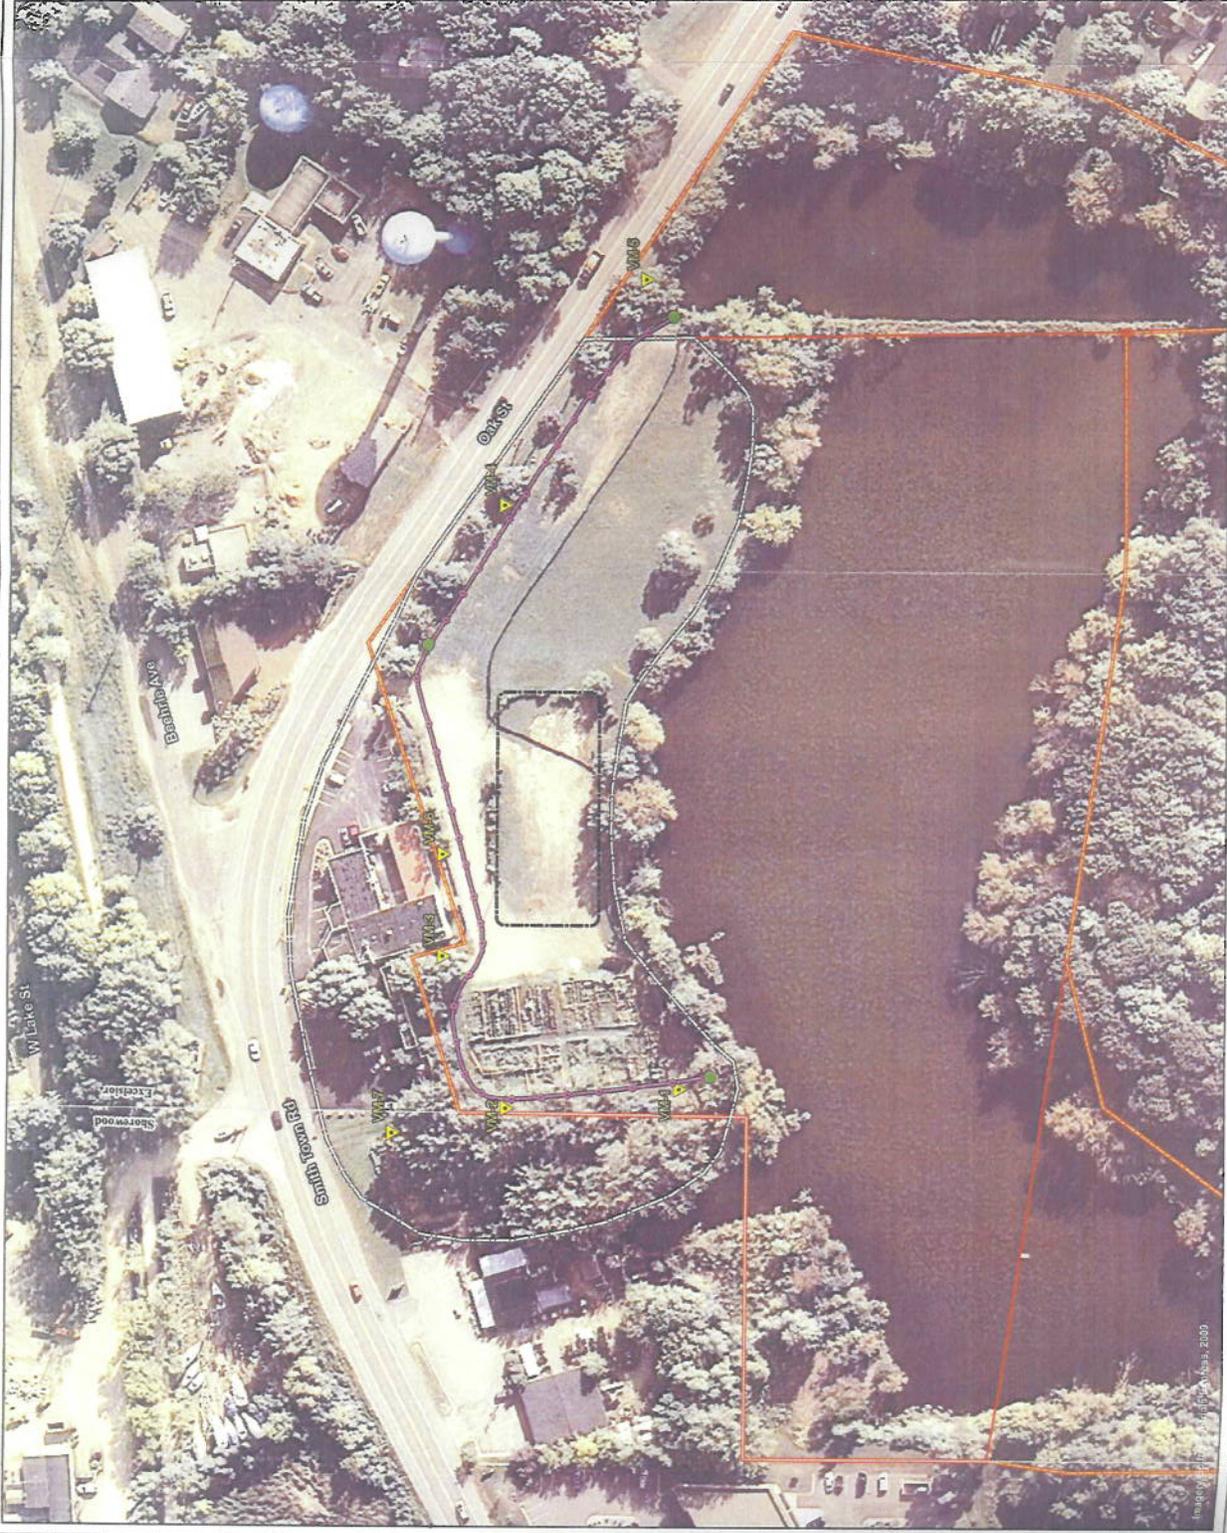
Figure 8

To monitor the performance of the passive vapor trench, seven permanent vapor monitoring points were installed near or just to the north of the trench. Their locations are shown in Figure 8. The locations were chosen in consultation with the MPCA and were intended to monitor conditions in areas that had previously shown elevated levels of methane. Samples were collected from the monitoring points immediately after construction of the trench, and after one, two, and four weeks. Additional samples were collected at two and four months post-construction. The vapor monitoring points were field-screened for methane and other indicator parameters, and samples were collected using Summa canisters for laboratory analysis for
