# Health Consultation

FORMER ARIZONA TANNING COMPANY SITE  
(a/k/a SANTAN TANNERY)

SANTAN INDUSTRIAL PARK, DISTRICT 4

MAY 21, 2010

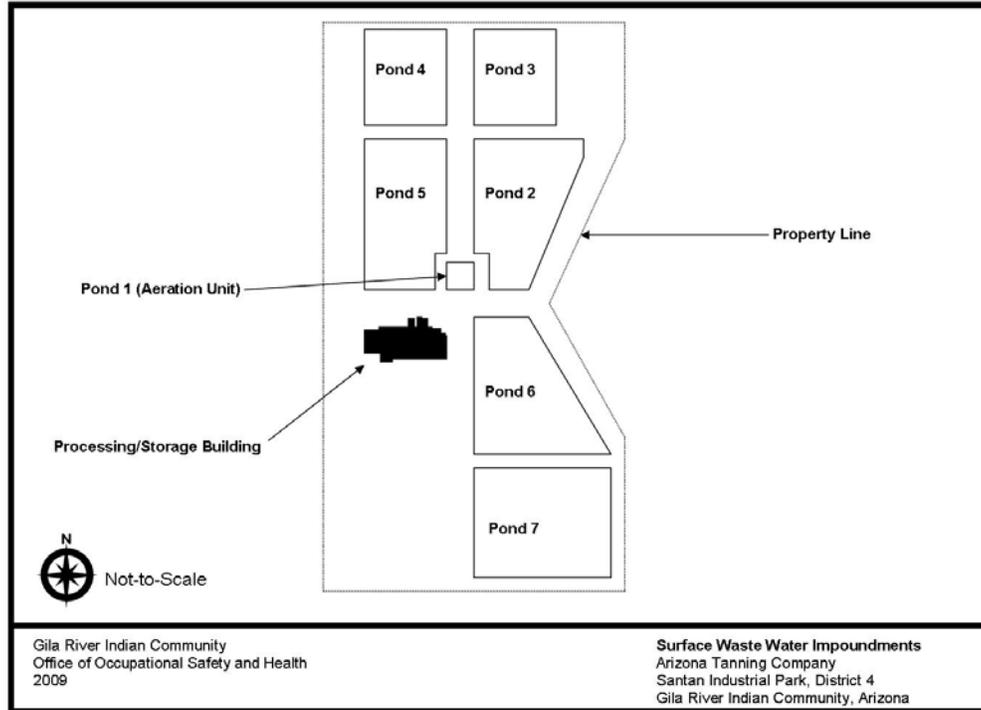
**Figure 2.**  
**Surface Waste Water Impoundments**  
**Arizona Tanning Company, Santan Industrial Park**  
**Gila River Indian Community, Arizona**

The facility located at the Santan Industrial Park once operated a processing/storage building (approximately 43,000 S.F.) and seven waste water impoundments. The seven waste water impoundments included six (6) waste water evaporation ponds (each approximately 3 acres in size) and one (1) aeration unit/pond (approximately 1/3 of an acre in size). Waste water from the tanning process was treated onsite by first filtering out fats and bio-solids, then oxidizing the remaining organic constituents in the aeration unit. After completing the oxidation process, waste water was then pumped to the six ponds and allowed to evaporate (Figure 2.). Once evaporation of the waste water occurred, the resultant dried sludge was removed from the ponds and disposed of onsite into what is described as a "sludge disposal unit" approximately one-half acre in size. The location of this onsite sludge disposal unit remains unknown.<sup>7</sup>

Because the waste water once produced by the Arizona Tanning Company was determined to be non-hazardous waste, EMCON proposed onsite disposal of the remaining sludge. As a result, the proposal called for the construction of a disposal cell which would consolidate the remaining sludge from the seven waste water surface impoundments into one existing impoundment and covering it with soil that made up the bermed walls. The proposal also called for locating the disposal cell within the northern waste water impoundment area.<sup>13</sup>

Final closure of the Arizona Tanning Company facility at the Santan Industrial Park was completed by EMCON in 1992. As proposed in their 1991 closure plan, EMCON consolidated sludge from the surface waste water impoundments into one existing impoundment (Pond 2). Pond 2 was closed as a landfill by taking the soil that made up the bermed walls of the six remaining impoundments and placing it on top of Pond 2 as a cover (cap) to minimize downward entry of moisture into the sludge waste. The northern waste water surface impoundment area surrounding Pond 2 was graded by EMCON to ensure positive site drainage.

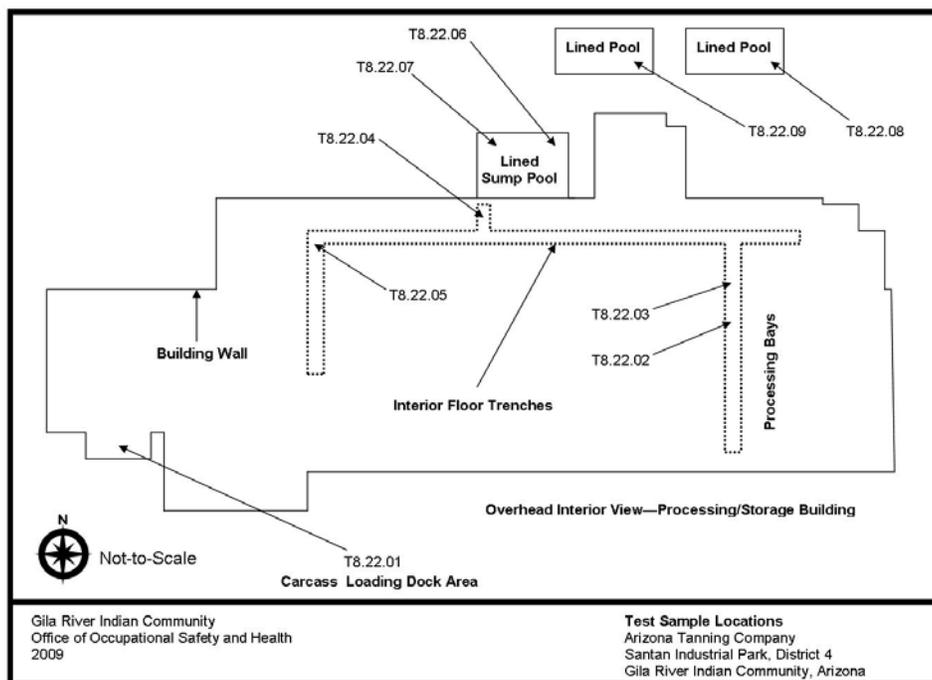
**Figure 3.**  
**Speyer and Associates**  
**Test Sample Locations for Priority Pollutant Metals**  
**Processing/Storage Building Drainage System**  
**Arizona Tanning Company, Santan Industrial Park**  
**Gila River Indian Community, Arizona**

Speyer and Associates collected nine (9) samples from the building's drainage system. Eight of the samples were directly related to waste water with the exception of one (Sample T8.22.01). Sample T8.22.01 was a soil sample taken from the carcass loading dock area (Figure 3.). From the data, it was determined that high concentrations of total chromium are present within the interior floor trenches. The highest concentration of total chromium was 88000 mg/kg (Sample #T8.22.02). Sample locations where the highest concentrations of total chromium were identified are Samples T8.22.02, T8.22.03, and T8.22.04 (Figure 3.). These samples were taken from the interior floor trenches that once received waste water from the processing bays.<sup>18</sup>

In addition, hexavalent chromium ( $\text{Cr}^{+6}$ ) was detected in Sample T8.22.04. The concentration of  $\text{Cr}^{+6}$  in Sample T8.22.04 was 15mg/kg. Moreover, Speyer and Associates also stated that the presence of  $\text{Cr}^{+6}$  and other pollutant metals found present at the site suggests that elevated concentrations of these metals could have been discharged to one or more of the surface waste water impoundments during Arizona Tanning Company’s operational period (Table 2.).<sup>19</sup>

Due to the presence of pollutant metals at the site, Speyer and Associates made recommendations concerning mitigating their potential impact. In their 2006 report Speyer and Associates state, “...metal-rich solutions and sludges may have accumulated in the process area trenches located on the interior of the building and been transmitted to holding ponds and ultimately to one (1) or more impoundment ponds located around the subject property. Such discharges over time may have impacted subsurface soils and/or groundwater.”<sup>20</sup> To monitor for groundwater contamination, Speyer and Associates recommended that three (3) monitoring wells be installed around the outside perimeter of the surface waste water impoundment area. These monitoring wells would allow the GRIC Department of Environmental Quality to identify if historic activities at the site had impacted the groundwater located in the area. Moreover, the presence of these wells would also allow for the continuous tracking of groundwater conditions at the site.<sup>21</sup>

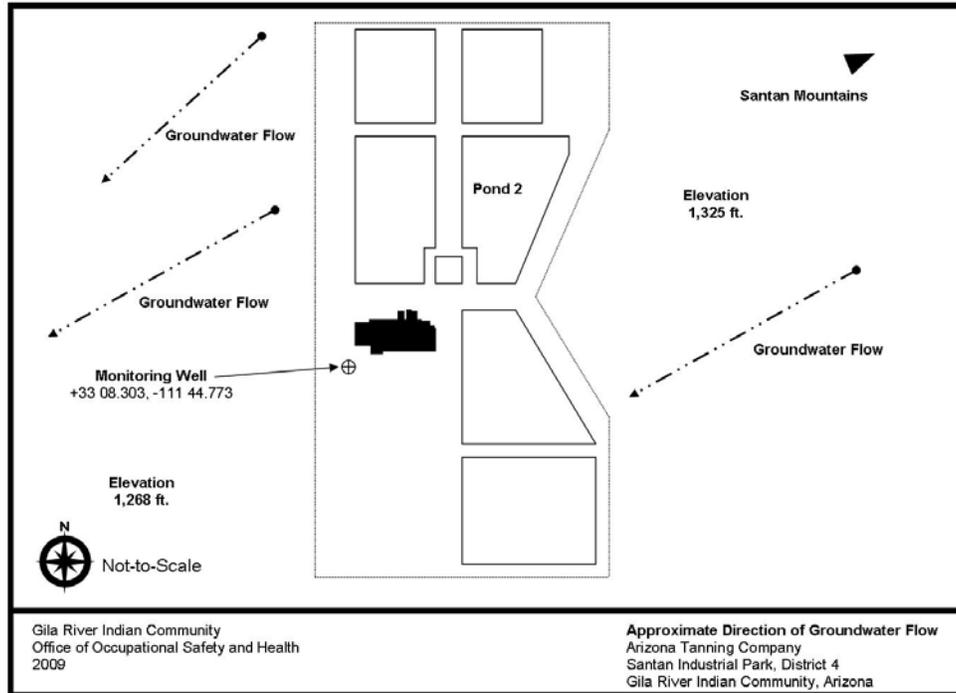
**Figure 4.**  
**Approximate Direction of Groundwater Flow**  
**Arizona Tanning Company, Santan Industrial Park**  
**Gila River Indian Community, Arizona**

In July 2008 Speyer and Associates was contracted by the Gila River Indian Community's Department of Environmental Quality to drill and install a monitoring well at the Former Arizona Tanning Company Site. Although Speyer and Associates recommended in 2006 that three (3) monitoring wells be installed; only one (1) was installed at the site in 2008. The monitoring well at the site is located approximately 728ft. southwest from Pond 2 (Figure 4.). The southwestern portion of the property was chosen by Speyer and Associates based on hydrogeologic information with respect to groundwater flow in the area.<sup>22</sup> A report produced by the U.S. Geological Survey (USGS) in 1991 supports Speyer and Associates decision to place the monitoring well at a position southwest of the surface waste water impoundment area. Based on USGS studies of the Gila River Indian Community, groundwater along the western base of the Santan Mountains maintains a southwestern flow toward the Gila River. This is due to the hydraulic head gradient beginning at the western base of the Santan Mountains leading southwest to the Gila River. In addition, the hydraulic conductivity of the groundwater located at the site is oriented southwest (Appendix F).<sup>23</sup>

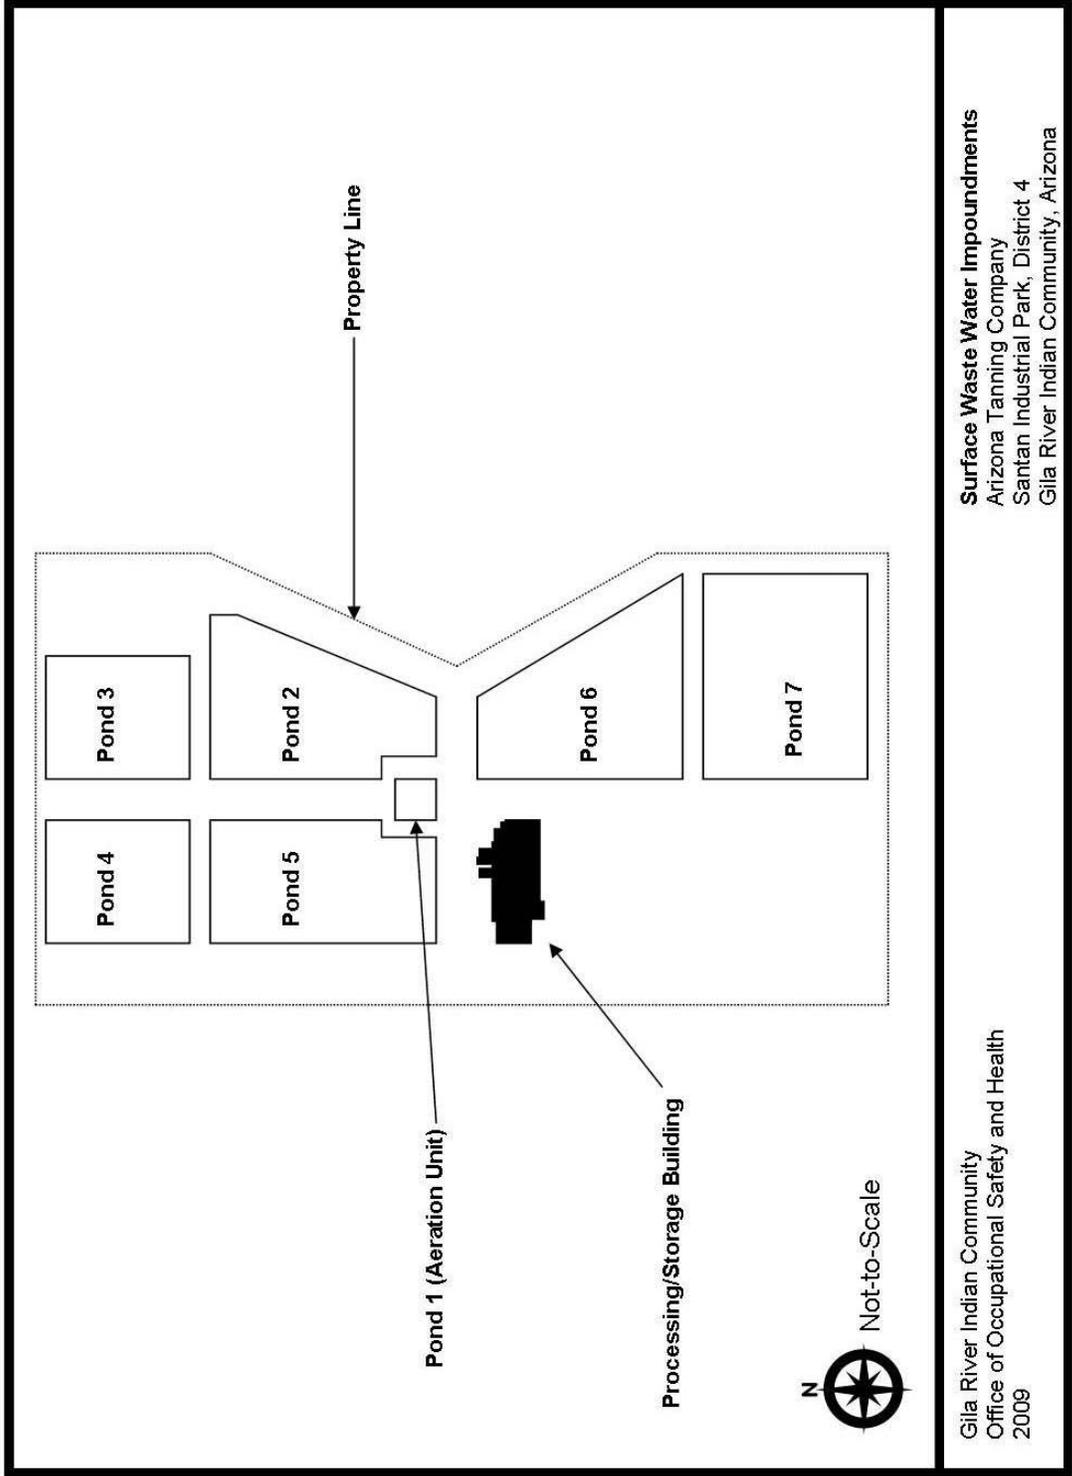
**Appendix C**  
**Arizona Tanning Company Surface Waste Water Impoundments**  
**Santan Industrial Park**  
**Gila River Indian Community, Arizona**

NWA also assessed the condition of the surface waste water impoundment area and landfill. In their report, NWA reported no noticeable alterations to the former surface waste water impoundment area or damage to the landfill (Pond 2). This was also confirmed by OSH staff who, at the time of their site inspection, observed no noticeable alterations or damage to the waste water impoundment area or landfill. OSH staff did however note that the waste water impoundment area has yielded only a minimal amount of native flora since its closure in 1992. In addition, it was also noted that livestock and all terrain vehicles (ATVs) have created paths (trails) across the northern portion of the impoundment area.

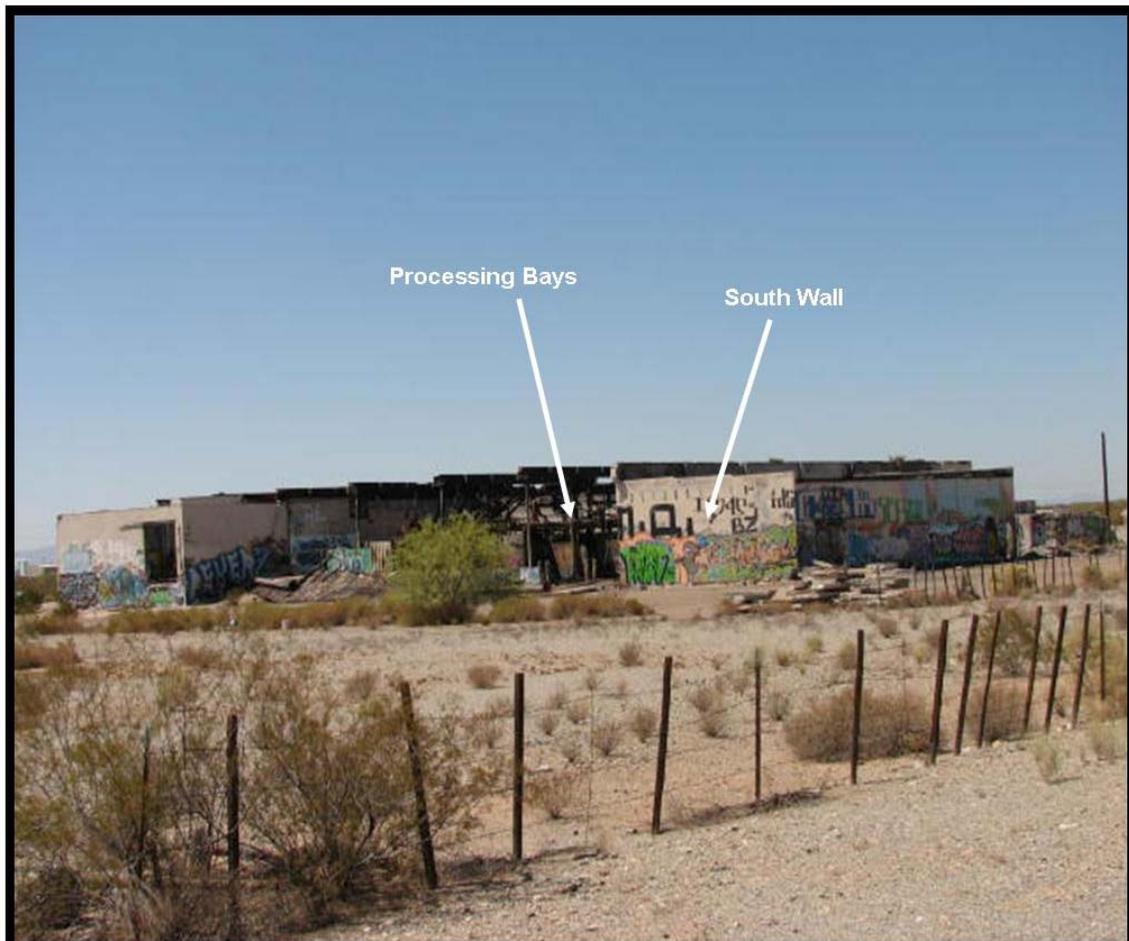
**Appendix H**  
**South Wall of Processing/Storage Building**  
**Arizona Tanning Company Site**  
**Santan Industrial Park**  
**Gila River Indian Community, Arizona**

the Gila River Indian Community in September 2006.<sup>15</sup> According to the 2006 NWA report, the tannery's processing/storage building was intact but in severe disrepair. NWA made observations regarding damage to the roof and significant structural debris within the building. These findings were consistent with observations made by OSH staff during a site inspection of the facility on 04 March 2009. However, during the OSH site inspection it was evident that the building had undergone significant degradation since 2006. This was evidenced by the proliferation of graffiti and structural damage to the building. Several large industrial components noted by NWA in 2006 (i.e., industrial grade boiler and water heater) were missing at the time OSH conducted their site inspection.<sup>16</sup> The building is accessible to trespassers due to the isolated location of the site and the lack of a security fence.

In April 2009 the Arizona Tanning Company’s Processing/Storage Building was destroyed as a result of an arson fire. Due to its age and damage caused by the fire, the structural integrity of the building was called into question by the Gila River Indian Community. As part of an effort to assess the post-fire condition of the building, the Gila River Indian Community’s Department of Environmental Quality contracted Adams and Wendt, Inc. (AWI) to conduct a comprehensive asbestos inspection.

- Abate asbestos at the site per recommendations from external consultants Adams and Wendt, Inc. – Project Number 0907202. Due to evidence of continued human activity at the site, there is an urgent need for asbestos abatement. Due to the carcinogenic nature of asbestos, immediate action is required to protect the Community.

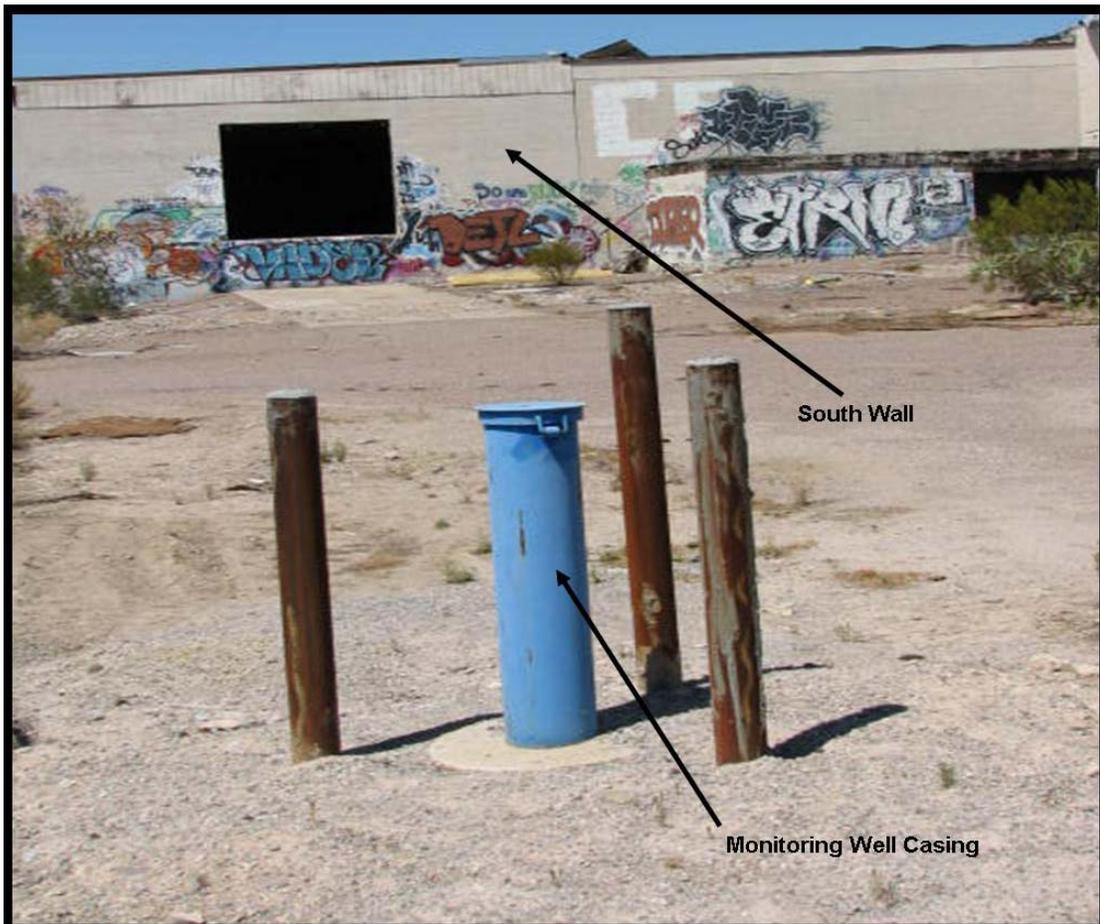
**Appendix K  
Monitoring Well  
Arizona Tanning Company Site  
Santan Industrial Park  
Gila River Indian Community, Arizona**

However, in 2008 Speyer and Associates was contracted to install one (1) monitoring well at the Former Arizona Tanning Company site. This monitoring well is located approximately 728 ft. southwest from Pond #2. Although the well is located down gradient from the surface waste water impoundment area, it is unknown if water samples taken from this well provide the best representative sample of ground water conditions at the site. Test results taken on 09 September 2008 did not shown any Priority Pollutant Metals at concentrations exceeding EPA MCLs for drinking water. Notwithstanding, Speyer and Associates concluded that groundwater beneath the site is not suitable for drinking without specific blending or treatment to reduce the concentration of metals; specifically arsenic and total chromium.

- Extract an additional water sample from the monitoring well located at the site. The condition of the groundwater should be re-evaluated. Two additional monitoring wells should be considered per recommendations made by Speyer and Associates in 2006.

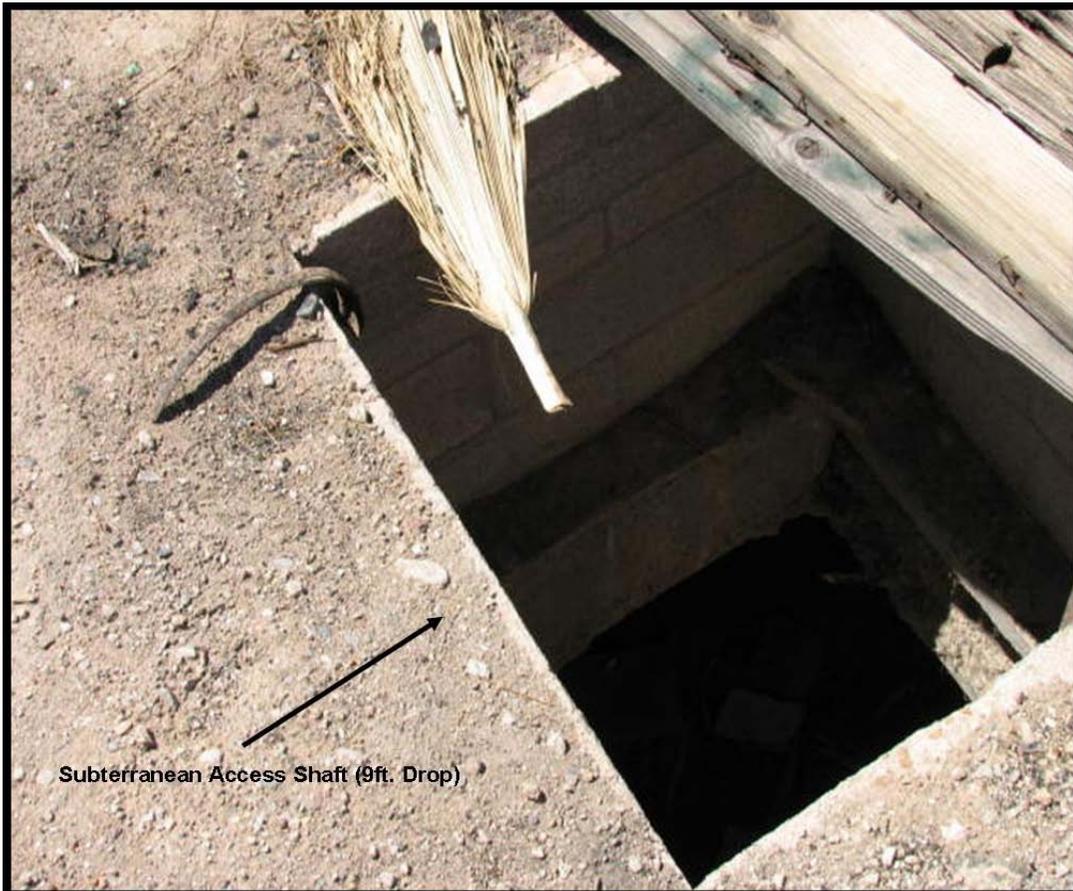
**Appendix L  
Fall Hazard  
Arizona Tanning Company Site  
Santan Industrial Park  
Gila River Indian Community, Arizona**

Numerous physical hazards are present at the site. These include sharp objects, unstable walls/iron supports, fall and drowning hazards. The 2009 site inspection conducted by OSH staff revealed one 9 ft drop into a confined space (Appendix L). In addition, the lined sump pool located on the north exterior wall of the building (approximately 8 ft. in depth) was filled to capacity with rainwater at the time of inspection (Appendix M).

The Office of Occupational Safety and Health (OSH) and ATSDR conclude that physical hazards found at the Former Arizona Tanning Company Site could result in severe bodily injury and/or death therefore it is an ***Urgent Public Health Hazard***. Located at the site are found numerous physical hazards. These include sharp objects, unstable walls/iron supports, fall and drowning hazards. The 2009 site inspection conducted by OSH staff revealed one 9 ft drop into a confined space. In addition, the lined sump pool located on the north exterior wall of the building (approximately 8 ft. in depth) was filled to capacity with rainwater at the time of inspection.

- Abate fall and drowning hazards. Due to evidence of continued human activity at the site. There is a pressing need to abate the potential for severe bodily injury and/or death due to fall and drowning hazards at the site.

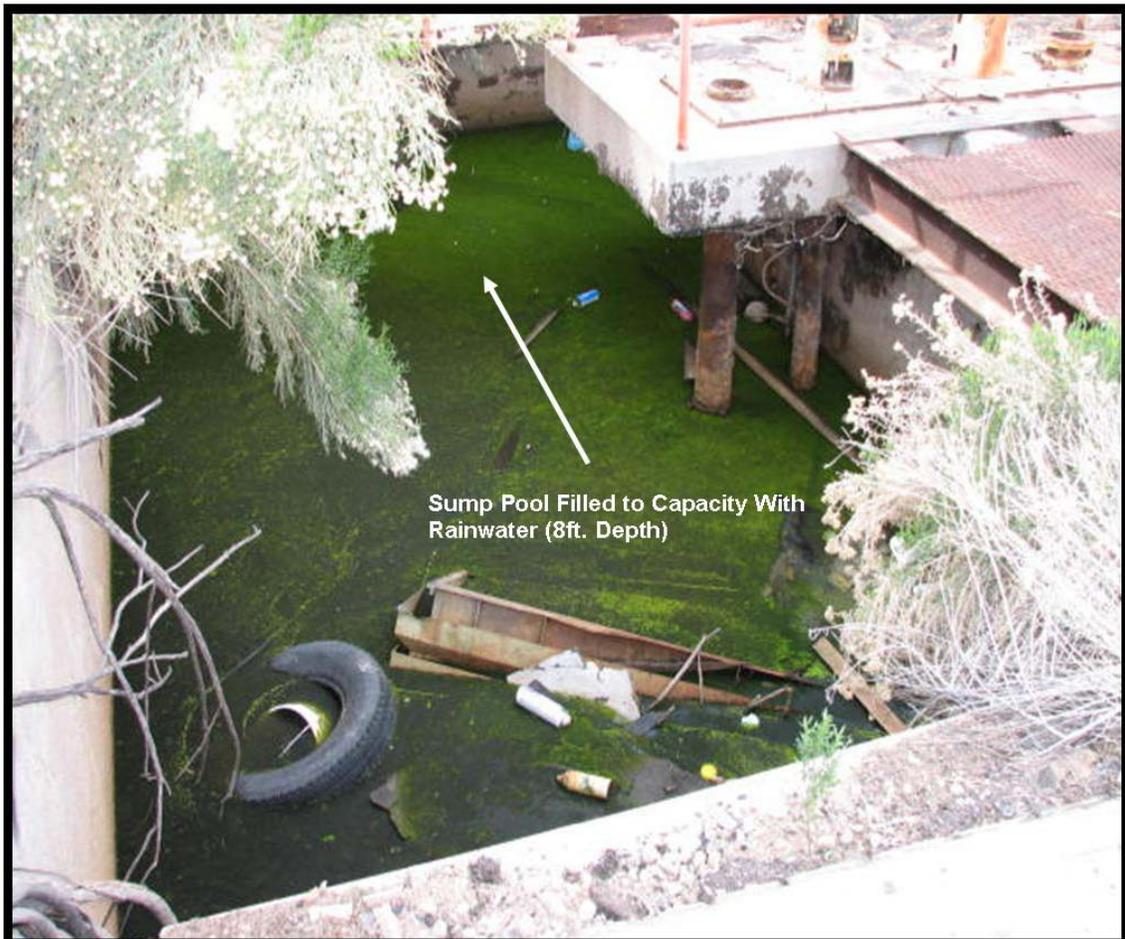
**Appendix M  
Drowning Hazard  
Arizona Tanning Company Site  
Santan Industrial Park  
Gila River Indian Community, Arizona**

Sump Pool Filled to Capacity With Rainwater (8ft. Depth)
