# Health Consultation

LEBANON ROAD LANDFILL

NASHVILLE, DAVIDSON COUNTY, TENNESSEE

JUNE 10, 2008

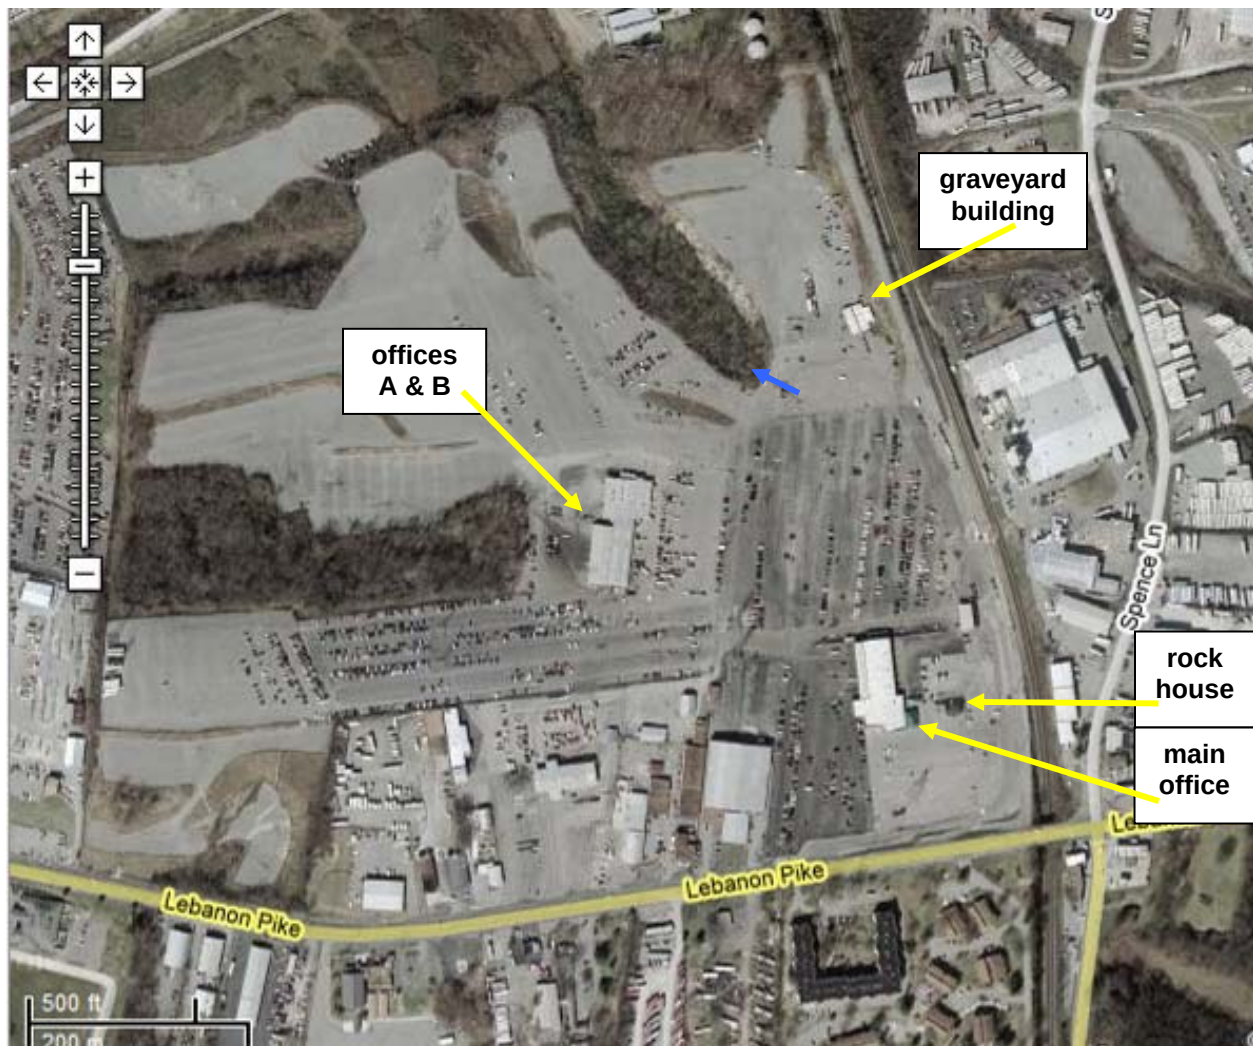
**FIGURE 1.** Aerial image showing the current Tennessee Auto Auction land use over the former Lebanon Road Landfill. The locations where methane gas levels have been measured in site reports have been noted. (Image credit: Google 2007)

There are several buildings on the site (Figure 1). The main office and sales space is located near Lebanon Road, uphill from the known landfilled areas. A small rock house, which is seldom used, is located in the southeastern corner of the site. Offices A and B, which include the maintenance garage, are on the west side of the site. Another office, called the Graveyard Building in site files, is located at a lower elevation on the far north side of the site. The site is mostly an asphalt parking lot. After years of waste decomposition, the asphalt has sunk. The parking lot has a rolling, hilly appearance (Figure 2).

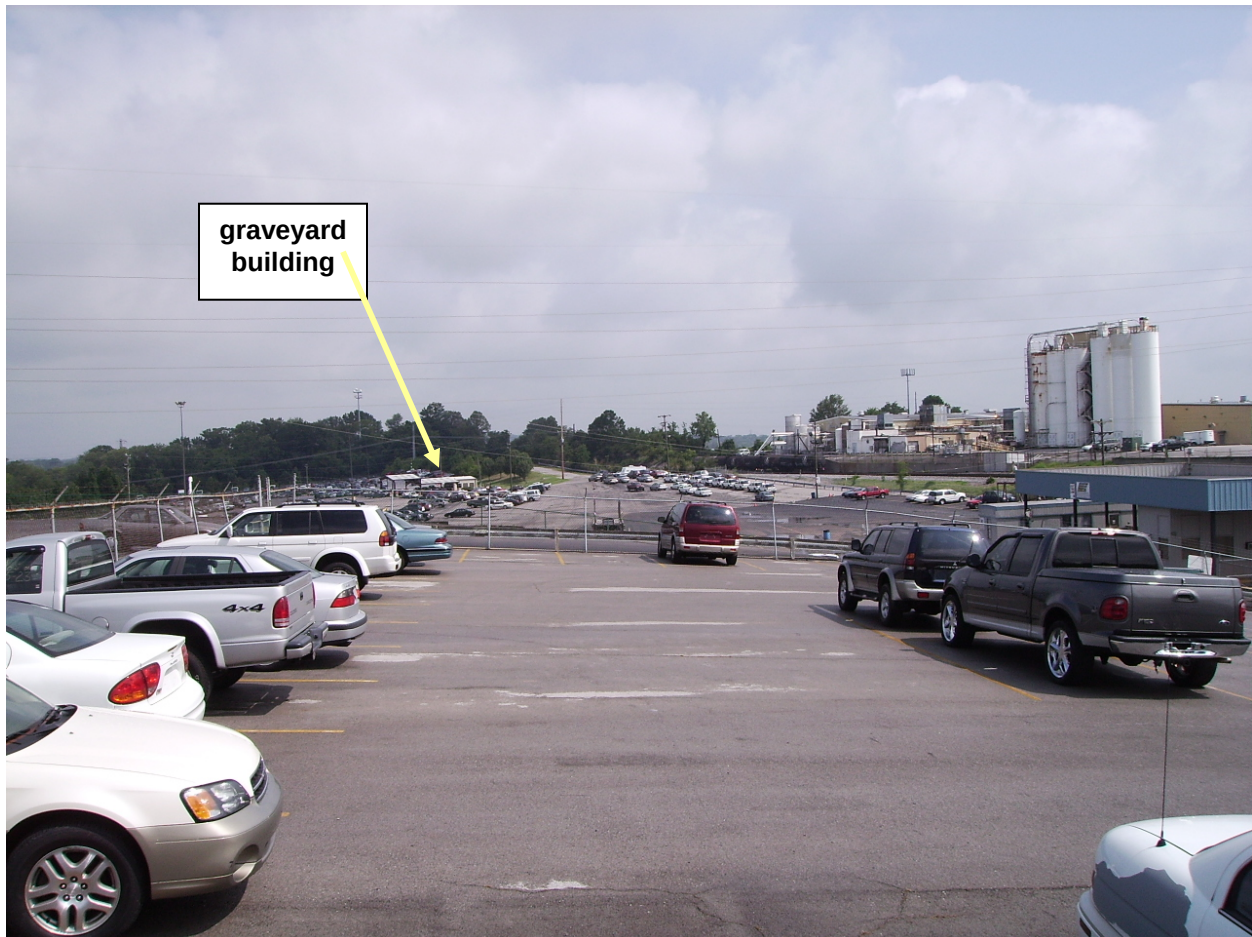
**FIGURE 2.** A photo facing northward taken from near the main office of the auto auction at the Lebanon Road Landfill. Note the approximate half mile the site extends and the “rolling hill” aspect of the pavement as it has sunken with the landfill over time. (TDH photo 07/11/07)

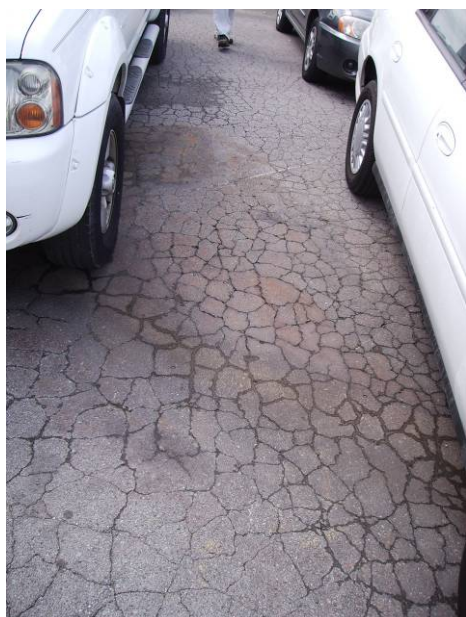
The large size of the site and unevenness of the asphalt pavement were noted. Recent rain helped to show the surface drainage pattern as well as the low areas of the asphalt parking lot. As shown in Figure 4, a portion of asphalt that was sunken and severely cracked was noted as a possible compromise in the landfill cap.

**FIGURE 4.** A portion of the large asphalt parking lot. The parking lot is used daily by the auto auction. The parking lot also acts as a cap over the old landfill to prevent water infiltration. The pavement has sunk over time, likely due to the landfill materials degrading. Areas, such as this one, with lots of cracks in the asphalt, suggest that landfill gases are being produced underneath and may be able to escape through the cracks.

Methane can readily escape from cracks in the landfill's asphalt cover. Given elevated levels of methane and an ignition source, methane flares or fires are possible. Therefore, as part of annual preventative maintenance, checking asphalt cracks for methane venting is strongly encouraged. This can be performed by sweeping the area using a field instrument such as an explosive gas detector. Any cracks or areas that show methane release can then be sealed. This type of sampling is best performed in the winter on a cool, clear morning. The methane vapor, a bit warmer underground, should more readily escape through the cold, contracted pavement and thus be more easily detected by the explosive gas detector.

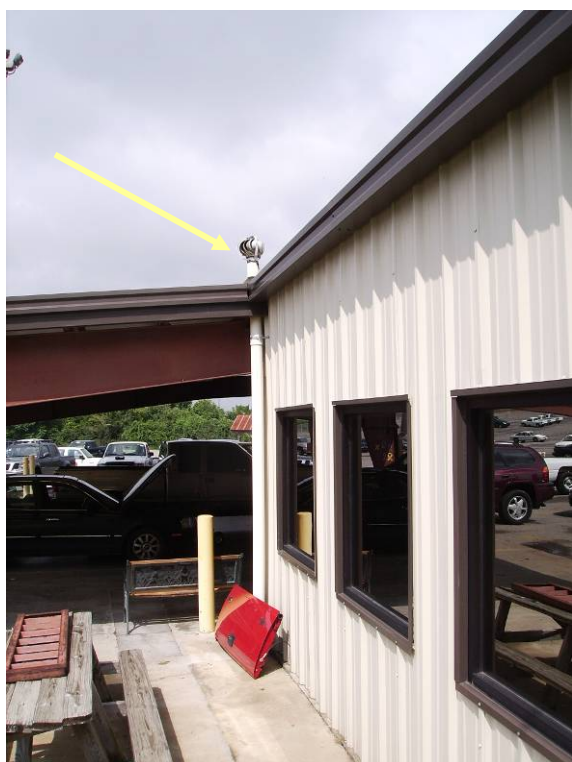
The workers knew about the methane concerns related to the site. They knew about the two vent pipes designed to keep the methane out of the Graveyard Building (Figure 5). We were shown an area of tile floor that had been repaired and was again separating (Figure 6). They said they did not know how to tell if the passive vapor removal system was working. Also, they did not think the building had a methane monitoring alarm system. They reported an early morning “methane odor.” Oftentimes when arriving to work in the morning, they would prop the door open to ventilate the Graveyard Building. This is interesting in that methane itself has no odor but other landfill products such as sulfides do have unpleasant smells. It would be safe to assume that if sulfides are present in the building, then methane would be present, too.

**FIGURE 5.** The southern side of the small graveyard building. One of two vapor vents is marked. This small building contained offices for about three employees. In the past, methane gas levels were highest within this building. A passive exhaust system was installed in December 2003 to prevent landfill gas from building up within the confined space. In December 2005, additional maintenance including caulking the floor cracks was performed to limit vapor intrusion into the building. Even with the vapor mitigation system in place, workers mentioned that unpleasant odors were often present in mornings. The building has both heating and cooling systems for indoor air climate control and ventilation.

2. Continual operation, that is twenty-four hours per day, of the passive vapor mitigation systems installed on site buildings should be required.
3. Preventive maintenance needs to be a requirement if this site is actively used. This would include inspection of passive vapor mitigation systems, sealing cracks in the Graveyard Building, and routine checks of the integrity of the entire asphalt landfill cap.
