Health Consultation

Evaluation of Potential Exposure to Releases
from Historical Military Use Areas

PORT HEIDEN
LAKE AND PENINSULA BOROUGH, ALASKA
EPA FACILITY ID: AK8570028698

JANUARY 31, 2019

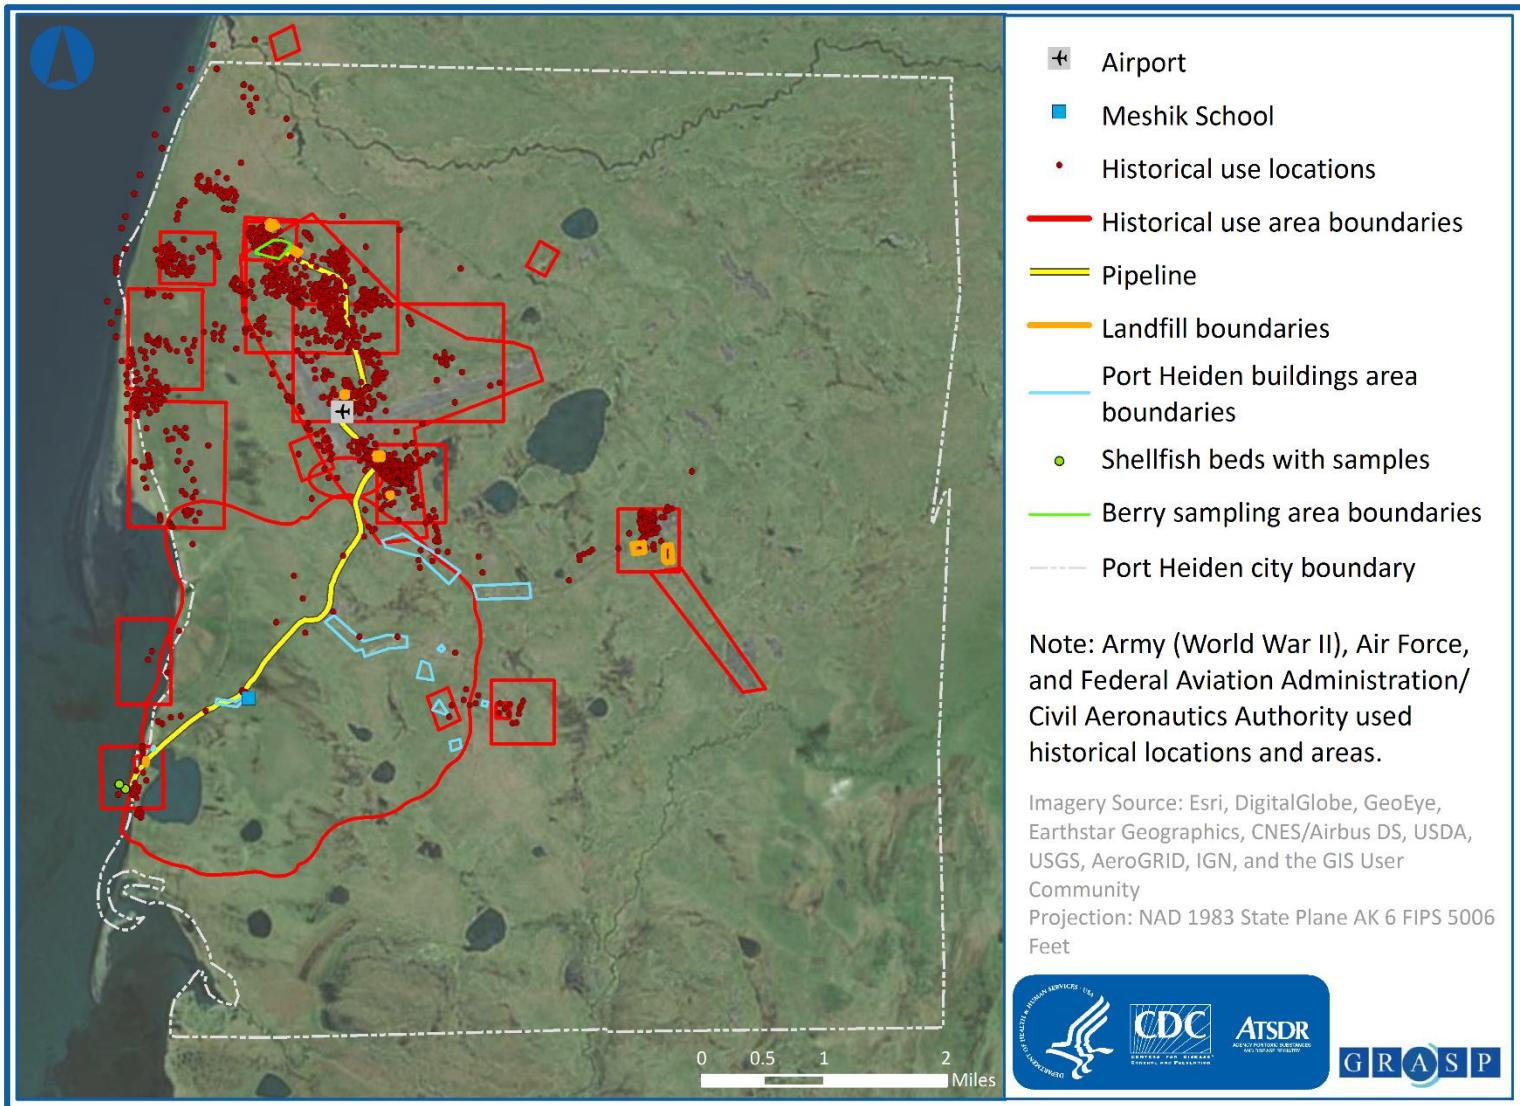
Figure 2. Port Heiden, Alaska Site Overview Map*

* An interactive and customizable version of this map (which can be used with Google Earth) will be made available to the Tribal Environmental Office. This map only includes some of the areas that may pose hazards. Many areas were not thoroughly tested, and ATSDR could not include all areas from the large volume of historical documents.

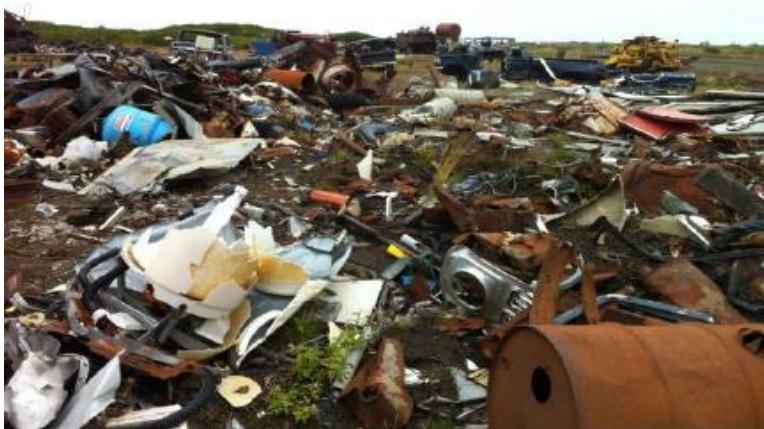
Figure 4. Prior Bone Yard Refuse that was Cleaned Up by the Village [ADEC 2012] Note: Not representative of current conditions.

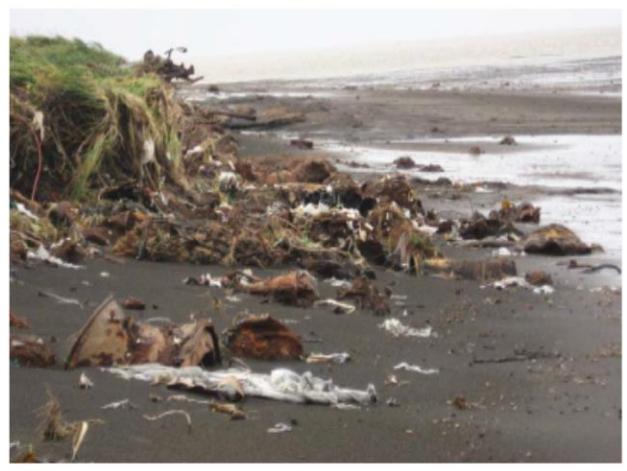
Figure 3. Previously Eroded Material from the Old Meshik Village Landfill, Port Heiden, Alaska [ADEC 2012] Note: Not representative of current conditions

The coastal area near the old village landfill, tank farm, and drum cache had a wide variety of exposed items from erosion in 2007 (Figure 3). The items included building materials, septic tanks, metal scraps, medical waste, and asbestos-containing materials and more eroding into the ocean [Iliaska 2008; [NOAA 2007](#); USAF 2006; [USACE 2007a,b](#)]. While not representative of current conditions, the figure demonstrates the types of historical waste released at the site.

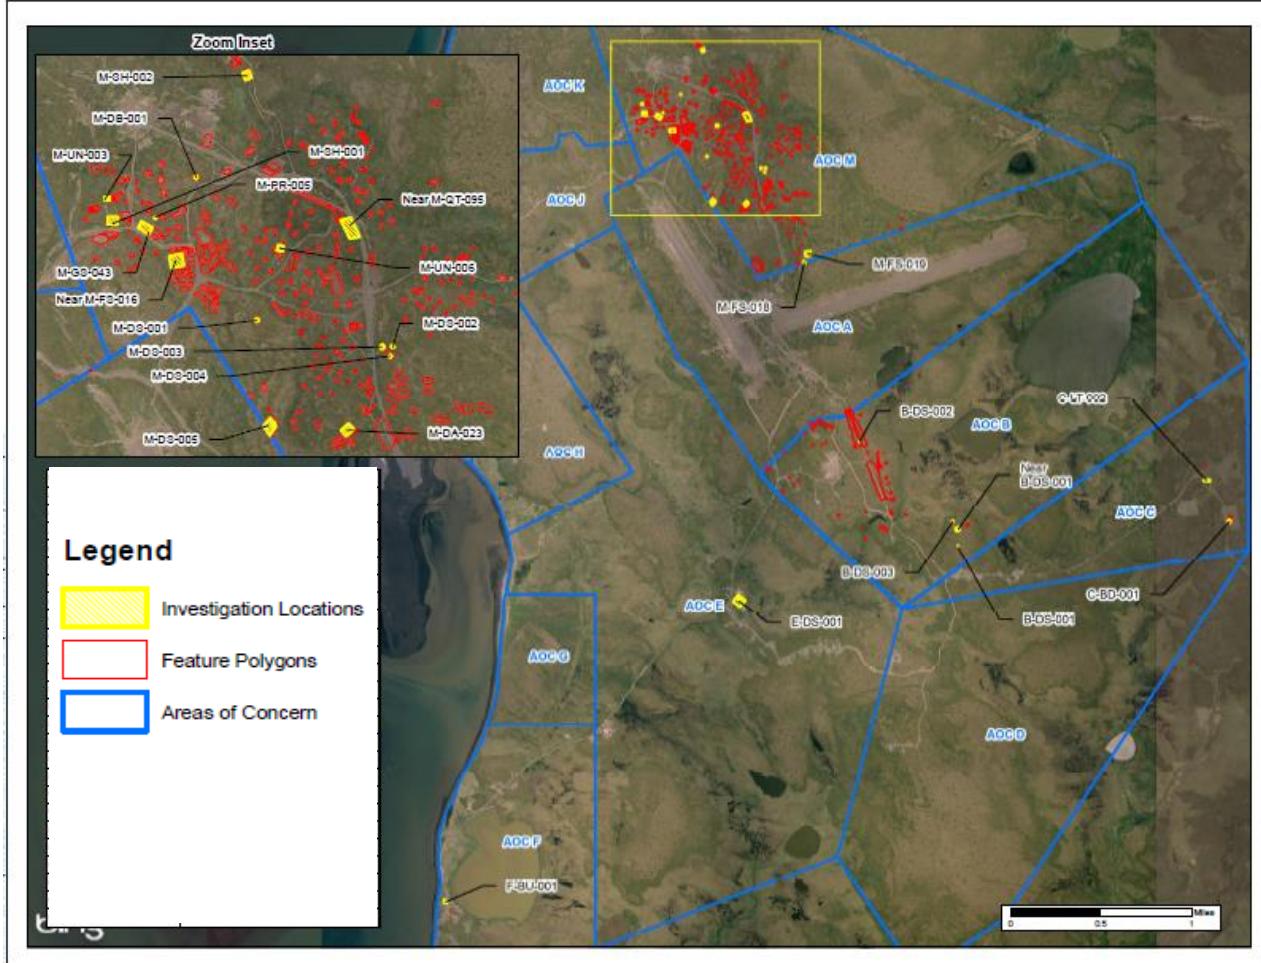
Figure 5. Site-wide Areas with Subsurface Metals or Metallic Debris [USACE 2016]

Site-wide remedial investigation by the Army evaluated potential metallic debris at former military use areas such as former administrative, housing, and military operations structures; antennae, storage, trench, transformer, dump, burn, and spill sites; and mounded material areas (Figure 5). The Army recently identified mounded material near commercial buildings of the village for further investigation due its close proximity to villagers and greater potential for exposure [USACE 2016] (Figure 6). Other areas may be addressed as physical hazards are identified.

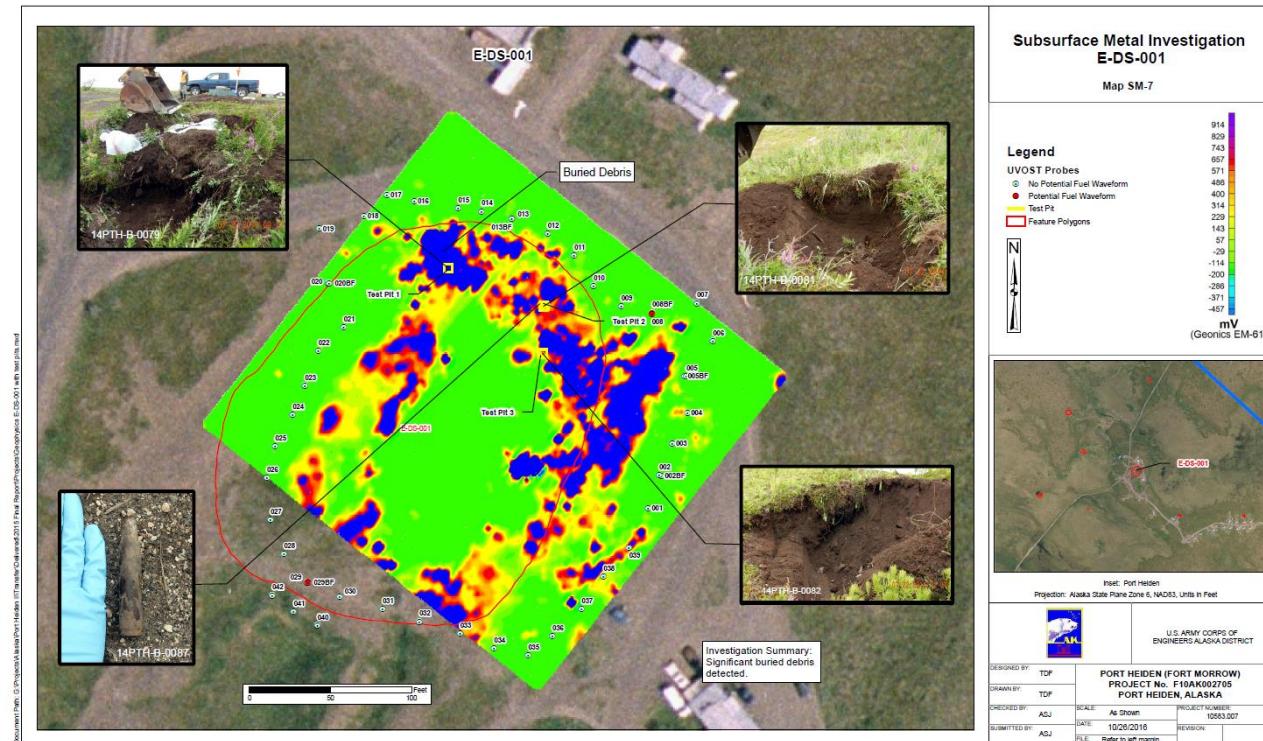
Figure 6. Subsurface Metal Investigation Near Commercial Buildings in Area of Concern E [USACE 2016]

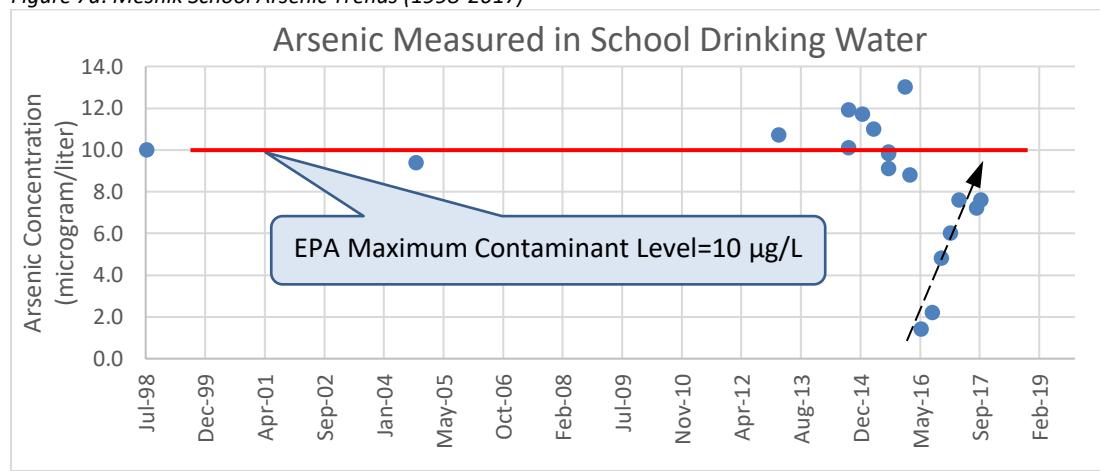
Figure 7a. Meshik School Arsenic Trends (1998-2017)

Minimizing arsenic exposure may decrease the likelihood of the most common arsenic-related cancer (lung, bladder, and skin) and non-cancer effects (skin lesions) [ATSDR 2007a]. ATSDR estimated that drinking school water may result in an average of around 7 extra cancer cases if 1,000,000 students were exposed and 2 extra cancer cases if 100,000 teachers were exposed. The average arsenic doses estimated for drinking school water (0.000027 mg/kg-day for students and 0.000034 mg/kg-day for the teacher) were less than those showing effects in the most sensitive study of ATSDR's toxicological profile (0.0012 mg/kg-day) [ATSDR 2007a]. The sensitive study found increased pre-cancerous darkening of the skin called melanosis and thickening of the skin on the palms of the hand and soles of the feet in people drinking water with naturally occurring arsenic in Bangladesh [Ahsan 2006].

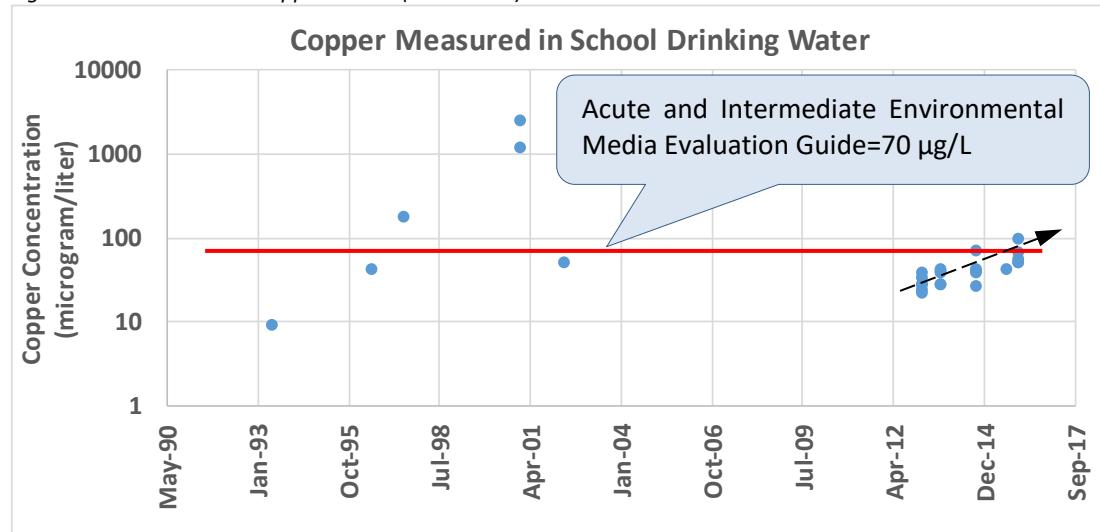
Figure 7b. Meshik School Copper Trends (1993-2016)

- **Copper** enters drinking water primarily through corrosion in plumbing and erosion of natural deposits [EPA 2017a]. Copper was detected at 176.5 µg/L in 1997 and 2,524 µg/L the next time it was measured in 2001 (Figure 7b). The EPA's maximum contaminant level is 1,300 µg/L. Five (177, 1200, 2524, 71, and 100 µg/L) out of twenty eight results were greater than ATSDR's acute and intermediate non-cancer comparison value of 70 µg/L [ATSDR 2004] between 1993 and 2016. The black arrow in Figure 7b shows the concentrations are increased from 2013 to 2016. ATSDR did not have access to copper data following the adjustment of the treatment system in 2016.

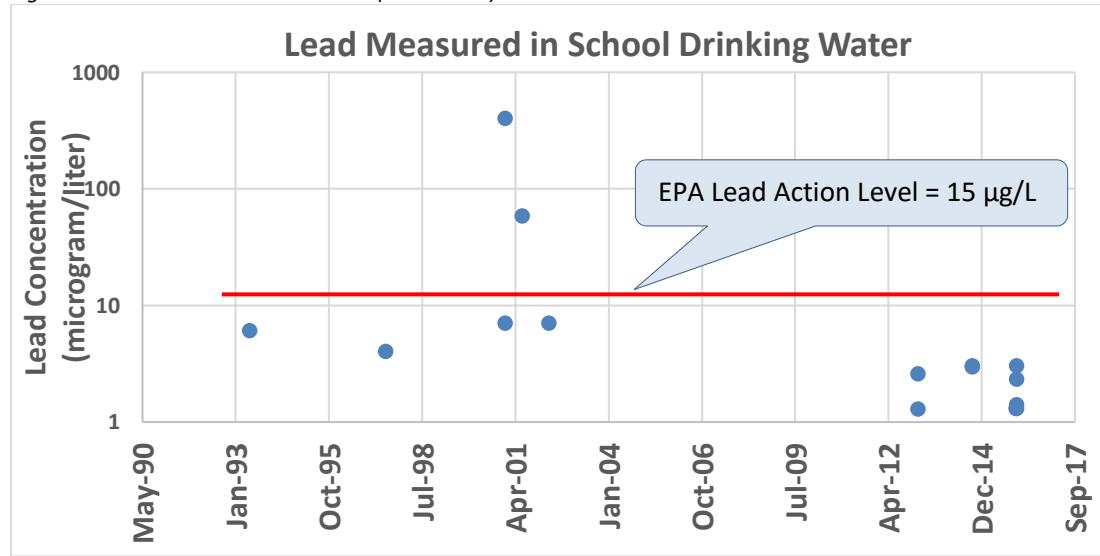
Figure 7c. Meshik School Lead Trends (1993-2016)

- **Lead** enters drinking water primarily through corrosion in plumbing and erosion of natural deposits [EPA 2017a]. Lead concentrations exceeded EPA's action level of 15 µg/L, with sample results of 398 µg/L and 7 µg/L in January 2001 and 58 µg/L in July 2001, but were otherwise less than EPA's action level when measured (Figure 7c). Data is not available from 1997 to 2001 or 2002 to 2013, nor is the location of the tap sampled within the Meshik School known. The cause of the increased concentrations is unknown. ATSDR cannot estimate the blood lead levels of people who occupied Meshik School and consumed the water from 1997 to 2001 or 2002 to 2016.

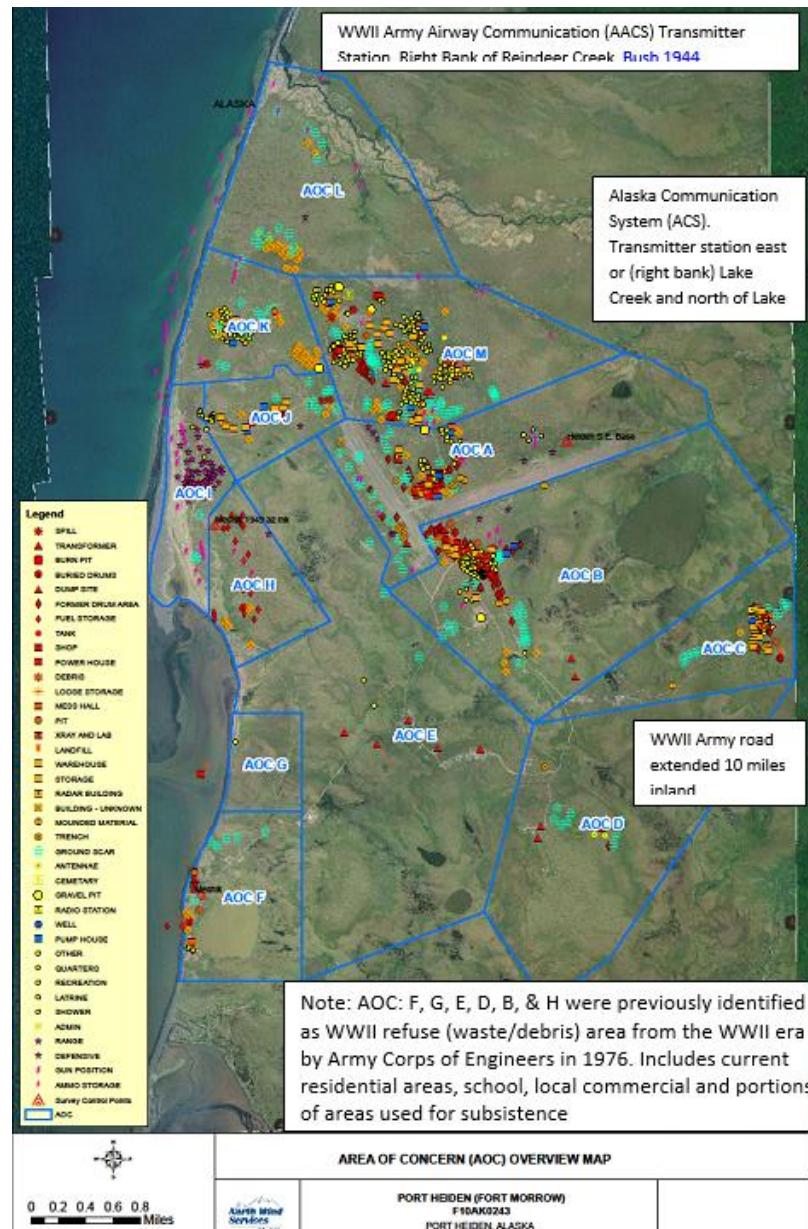
Figure 8. U.S. Army-identified Areas of Concern, Port Heiden, Alaska [USACE 2012b, 2013c, Bush 1944]

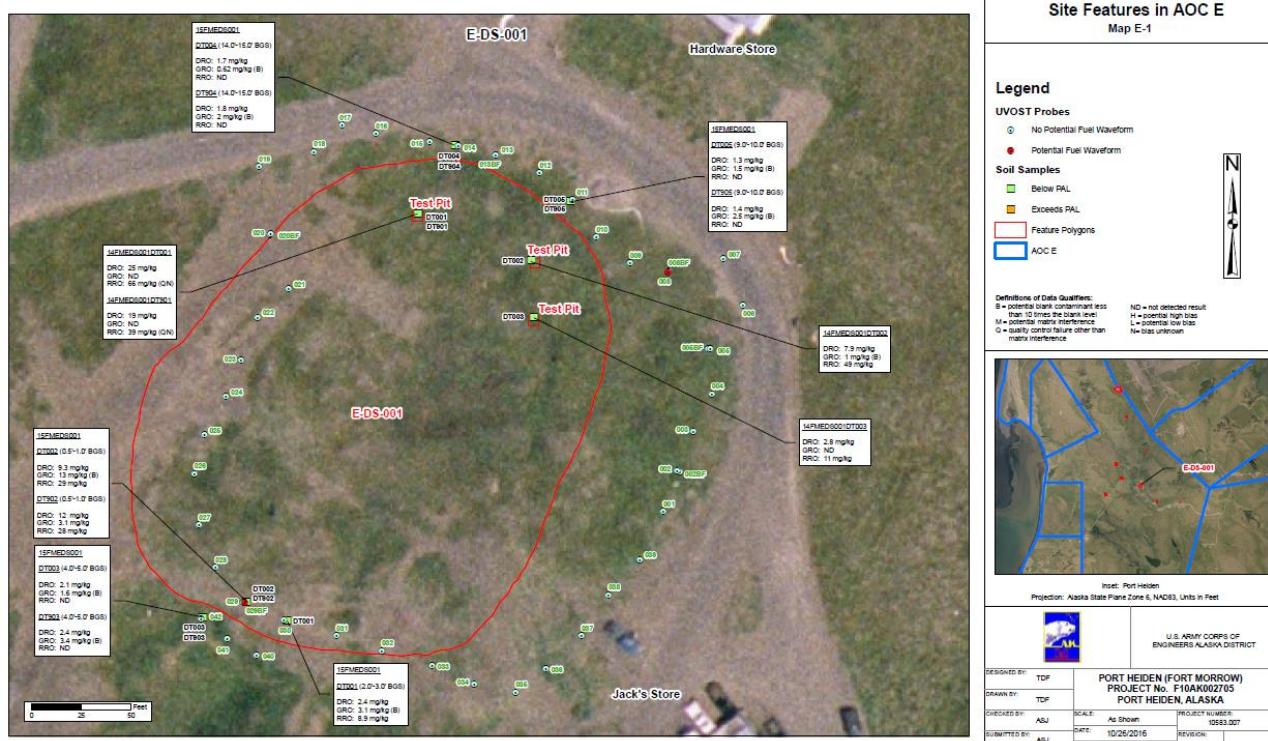
Figure 9. Sampling Locations Near Commercial Buildings in AOC E [USACE 2016]

Buried debris from test pits near commercial buildings in AOC E [Figure 9] appeared to be construction debris and could have been left by the military or others [USACE 2016]. Village elders remember seeing vehicles, batteries, scrap metal, drums, and household trash in the landfill and expressed concern about five drinking water wells nearby [ADEC [2016e](#)]. Soil screening here did not include x-ray fluorescence screening for lead [USACE 2016]. Measured soil levels of diesel range organics were 25 mg/kg, gasoline range organics were 13 mg/kg, and residual range organics were 49 mg/kg were less than ADEC's cleanup levels but greater than EPA's range of low and medium total petroleum hydrocarbon regional screening levels for migration to groundwater (0.017 – 8.8 mg/kg). One test pit near the commercial buildings in AOC E showed soil arsenic (25 mg/kg) and chromium (35 mg/kg) greater than Alaska project action levels (PALs: arsenic= 3.9 mg/kg and chromium= 25 mg/kg) and background [USACE 2016]. However, there was a data quality issue with the measurement. The arsenic was greater than ATSDR's non-cancer chronic environmental media evaluation guide of 17 mg/kg and cancer risk evaluation guide of 0.25 mg/kg. Chromium was less than ATSDR's comparison values. EPA's soil to groundwater migration regional screening levels are 0.0015 mg/kg for arsenic and 0.00067 mg/kg for chromium (VI).

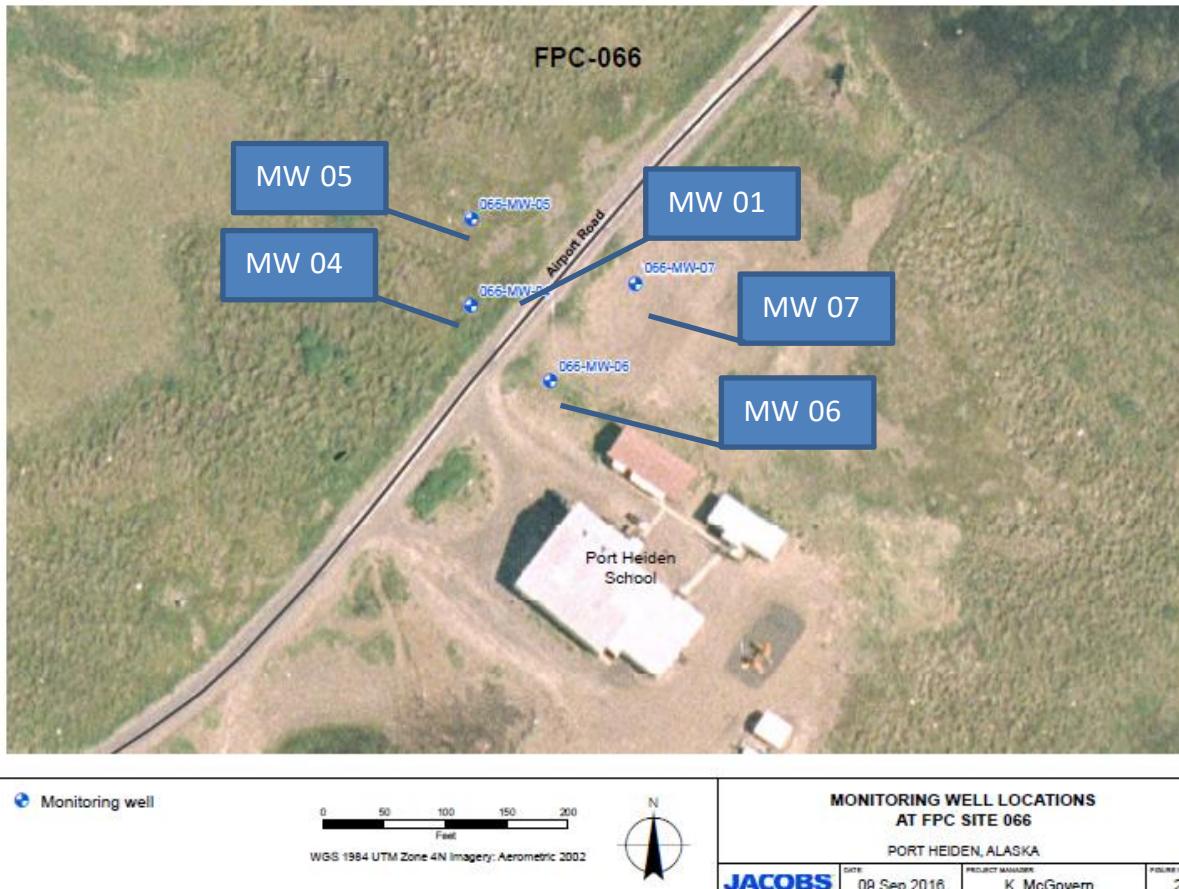
Figure 10. Pipeline Spill Monitoring Wells Near the School [USAF 2016b].

Diesel range organics were detected up to 8,100 µg/L along the pipeline (MW-01) about 200 feet from the **Meshek School** (Figure 10) and at 12,000 µg/L near the airport (Figure 11) in 2004.

Groundwater monitoring since 2009 at the pipeline spill (MW-05) about 250 feet from the Meshek school shows fluctuation in the levels of diesel range organics from 1,300 to 4,500 µg/L with a most recent sample of 3,100 µg/L [USAF 2016b]. However, sentinel wells (MW-04, MW-06, and MW-07) were located between the school and MW-05. The sentinel wells had estimated concentrations ranging from 18 to 32 µg/L in 2013-2014. These sentinel wells were not monitored after 2014 because they were less than the Alaska program's current cleanup level of 1,500 µg/L [[ADEC 2018a](#)].

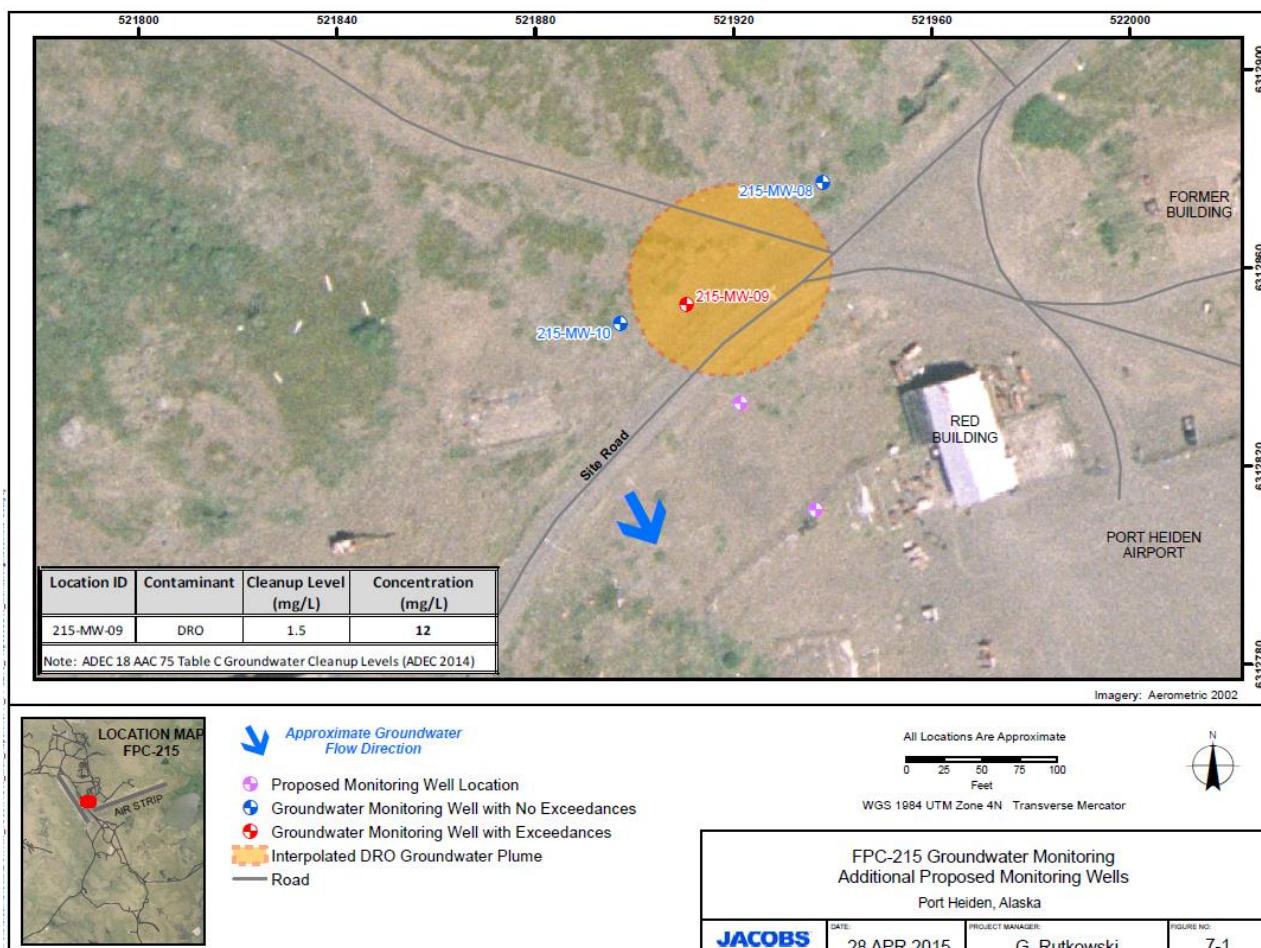
Figure 11. Diesel Range Organic Plume Near the Airport [USAF 2015].

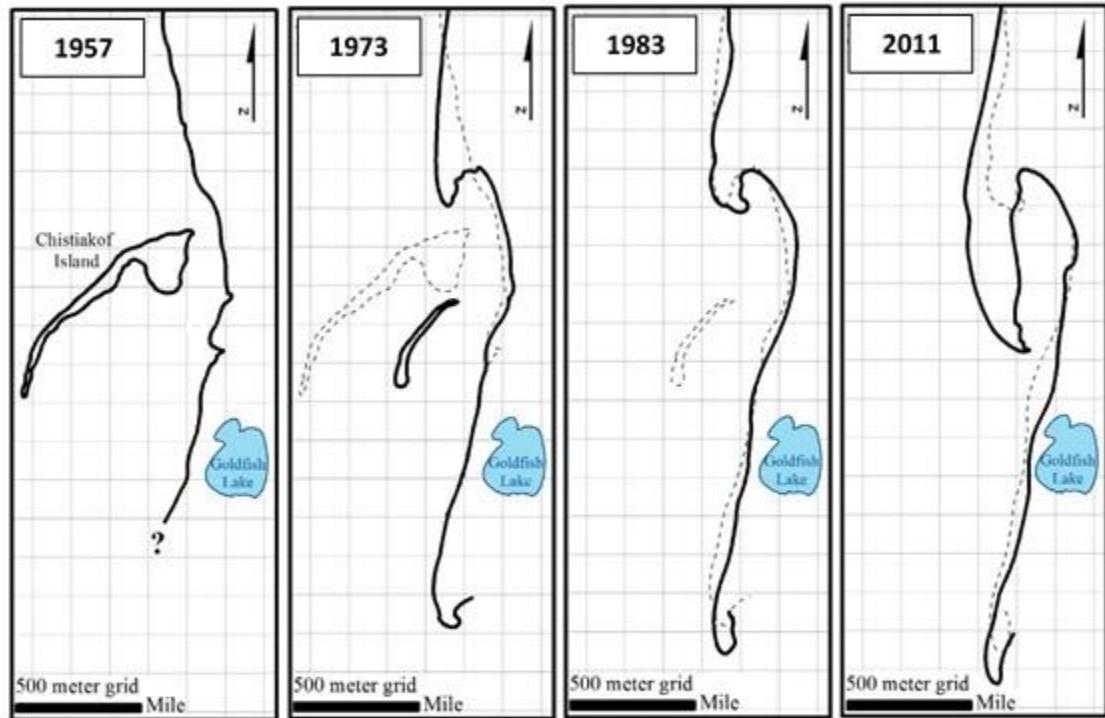
Figure A.1. Coastal Erosion of the Old Meshik Village Area, Port Heiden, Alaska [[Kinsman 2014](#)]

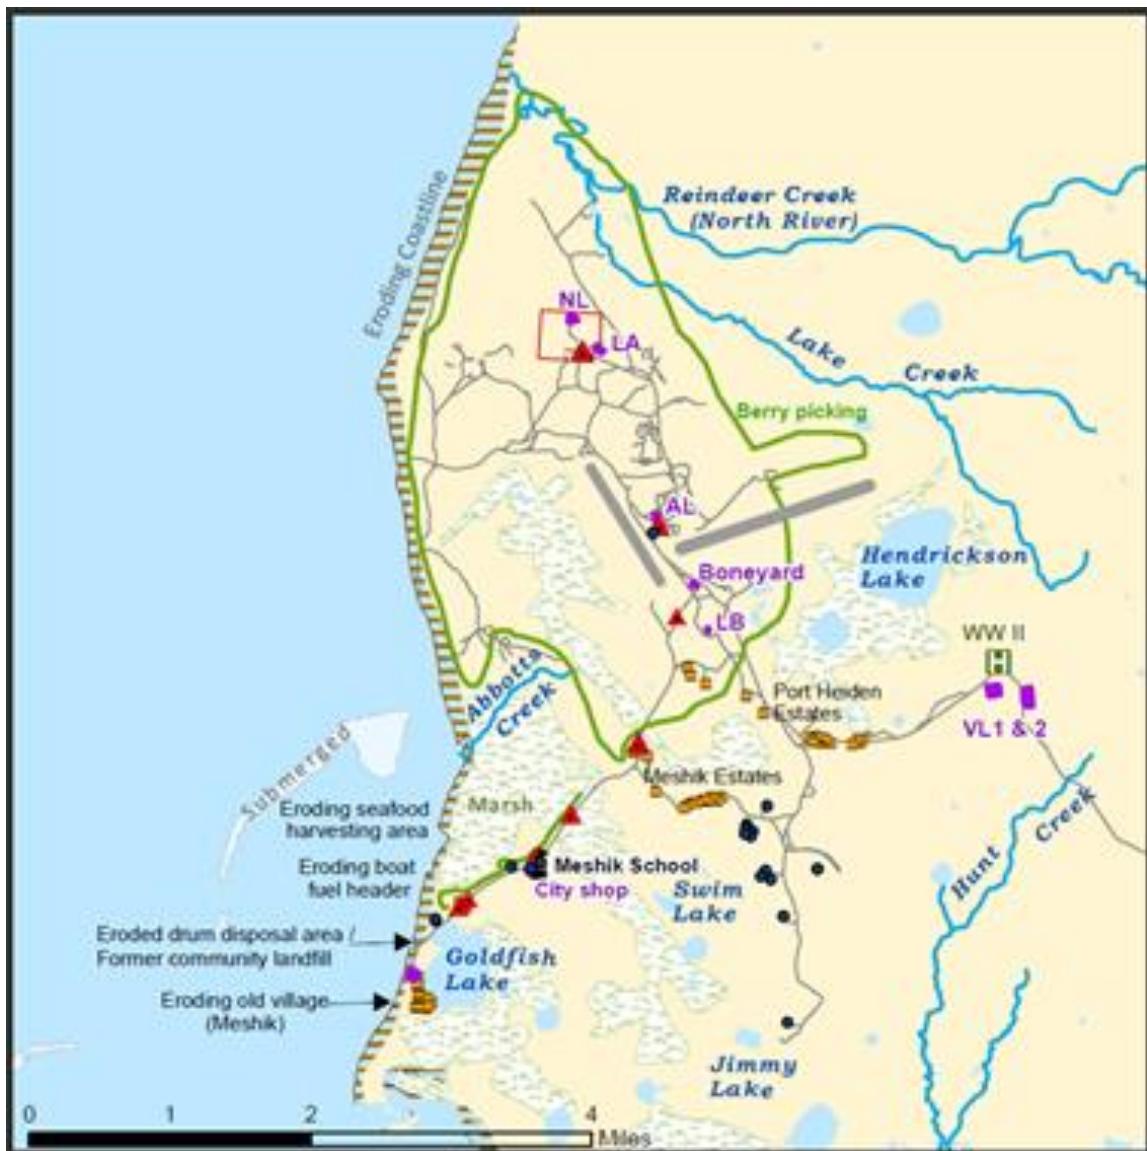
Figure A.2. Location of creeks, lakes, general berry picking areas, landfills (purple), boneyard, city maintenance shop, pipeline (red), marine terminal, and Old Meshik Village in Relation to Housing (yellow) and Meshik School, Port Heiden, Alaska. [[NOAA 2004](#), USACE 2013c, USAF 2006, USAF GIS database, Google Earth]

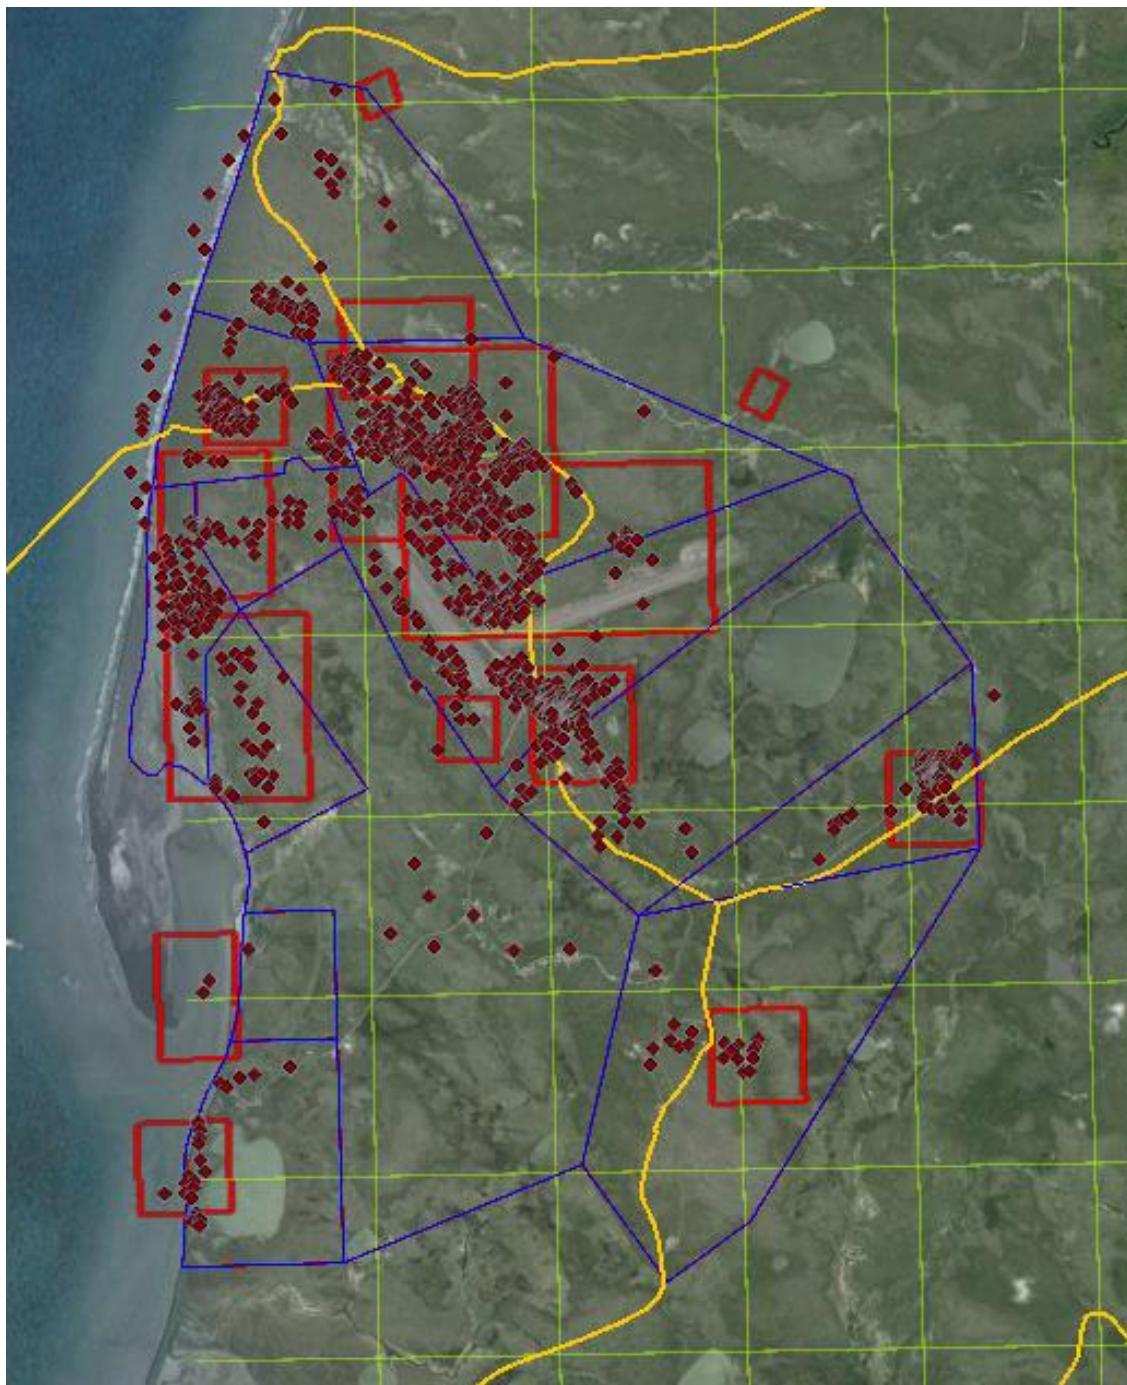
Figure A.3. Historical Site Features with Possible Contamination Identified by the Army (red square outlines), Watersheds (yellow), and landfills or waste areas (diamonds), Port Heiden, Alaska [USGS 2016, USACE 2013c, Bush 1944, Google Earth 2016]*

* The red squares mark historical features of interest and the yellow lines mark USGS watershed divides.

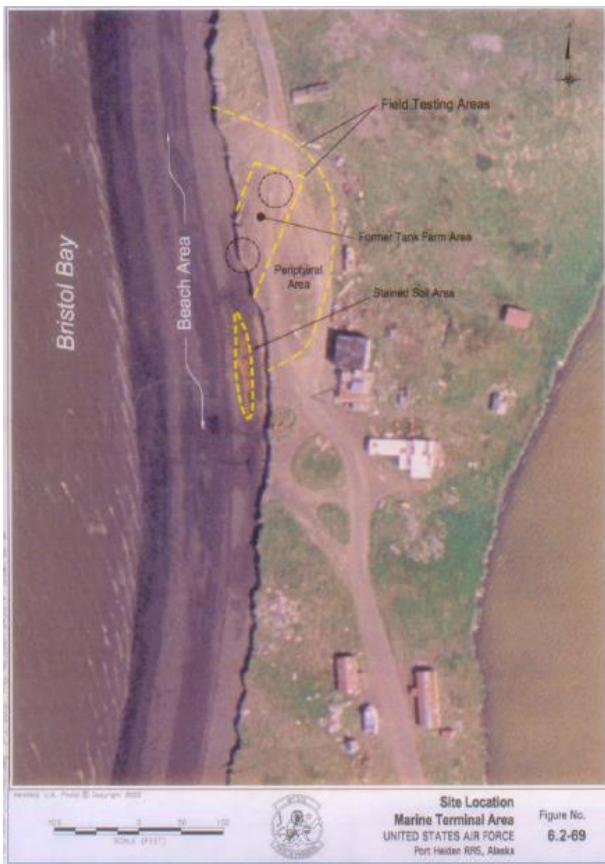
Figure A.4a. Former Marine Terminal Area Tank Farm, near Old Meshik Village. [USAF 2006]

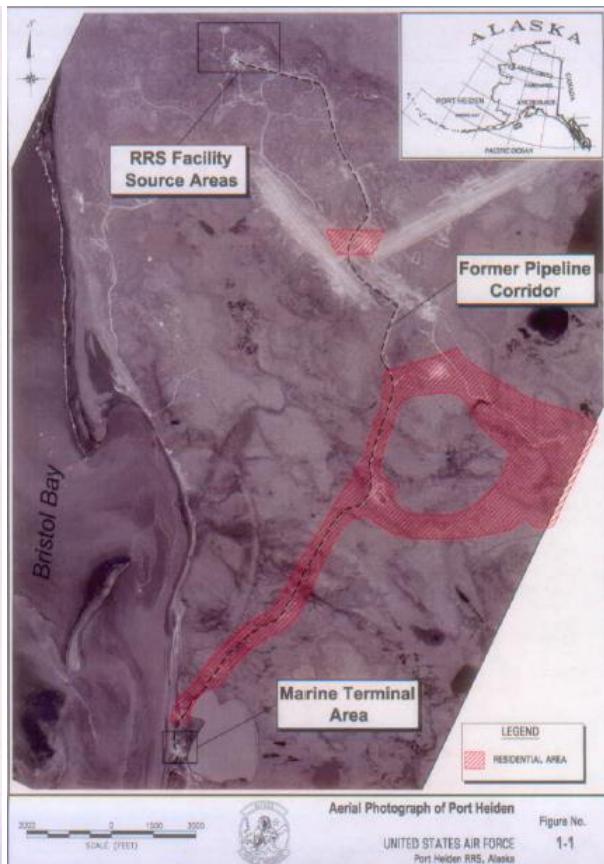
Figure A.4b. Former Marine Terminal Area in Relation to Main Historical Use Areas, Port Heiden, Alaska. [USAF 2006]

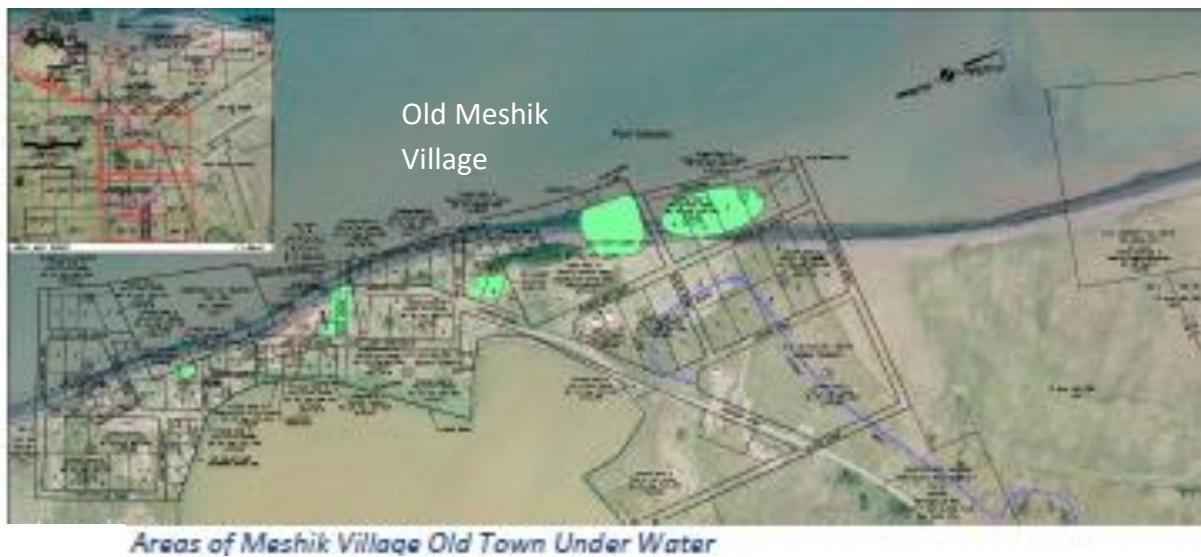
Figure A.5. Prior Drum Disposal Cache Area near Old Meshik Village, Port Heiden, Alaska. [NOAA 2007]

Area of Concern	Where contaminants may come from	How contaminants move in the environment	How people may be exposed (exposure pathway evaluation)
3. Army Drum Disposal Area	<p>The Army disposed of drums on the coastline near the former Marine Terminal Tank Farm. The community also used this area as a dump site for household waste. In October 2007, NOAA found the drum disposal area to be the source of oil sheens in the Bering Sea. Some of the drums contained over 100 gallons of petroleum from a different military dump site. Items found included old fishing gear, batteries, old vehicles, and medical waste. Coast Guard responders noted that the shoreline had eroded from 10 to 40 feet over the prior month and the sheen had dissipated.</p> <p>The Army Corps of Engineers removed approximately 2,000 drums stored at this location. Numerous rusted and open drums remain in the intertidal zone. With no evidence of ongoing release, the Coast Guard instructed local residents to monitor the beach and dump site and remove remaining debris. Although the drums were removed, waste still remains in the disposal area.</p> <p>Sampling at the Marine Tank Farm covers the Drum Disposal Area (see above). Cockles sampled near the Old Village Landfill (see below).</p> <p>References: NOAA 2007</p>	<ul style="list-style-type: none"> • Disposal area is entirely underwater • Contaminants in the drums previously on the beach may have leaked and contaminated the soil (now sediment) of the area. It may be impacting seafood 	<p>Completed exposure pathway</p> <ul style="list-style-type: none"> • Physical hazard <p>Potential exposure pathway</p> <ul style="list-style-type: none"> • Subsistence harvest of clams, crabs and resident fish may be exposed to sediment with other contaminants such as PAHs (no data) • Direct contact with sediment (no data)

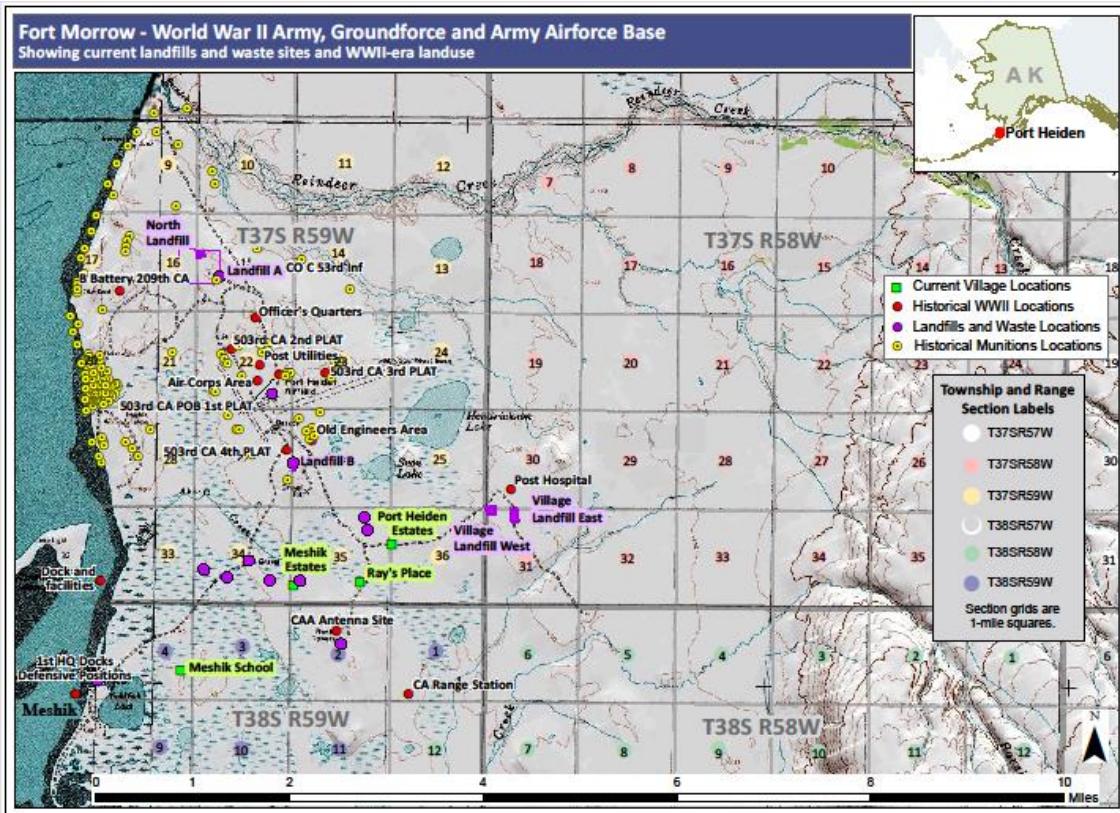
Figure A.6. Former possible World War II Munitions Storage Areas and other sites of interest relative to land use, Port Heiden, Alaska. [USGS 1963; References in Appendix C]

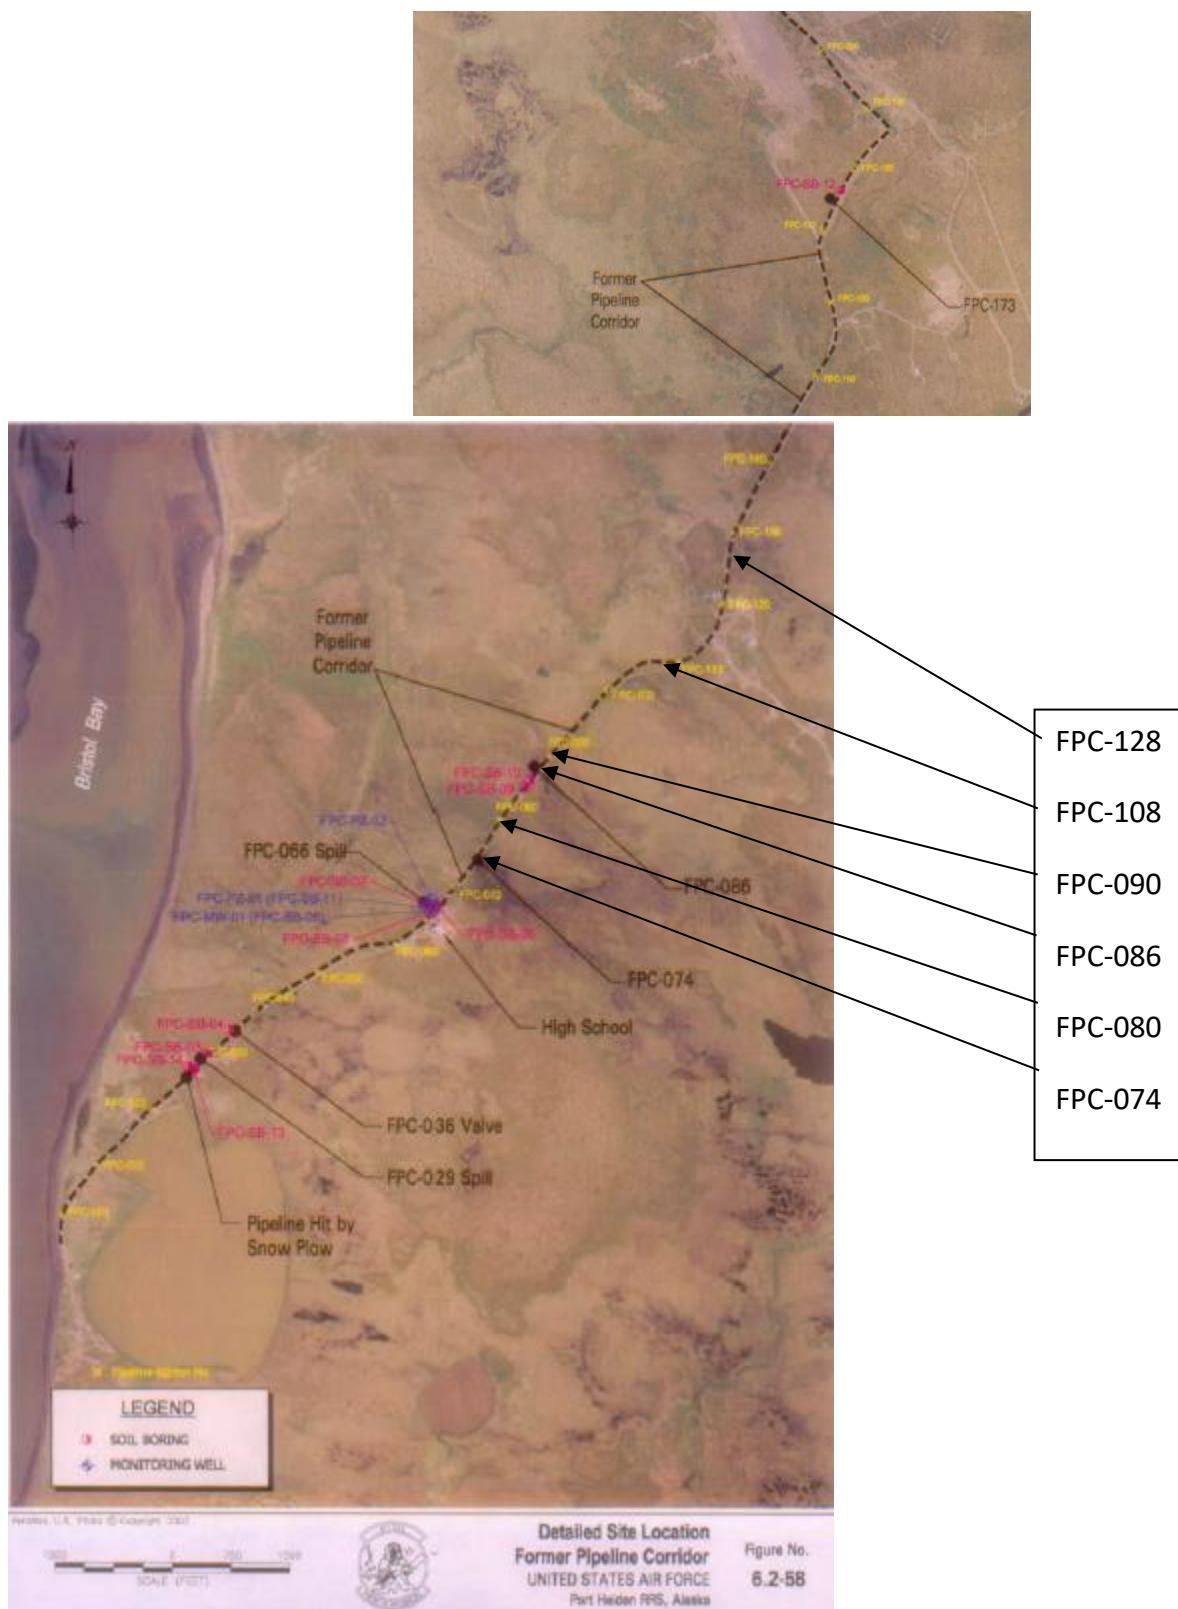
Figure A.7. Former Pipeline Corridor (FPC) Surface Water and Groundwater Sampling Locations that Exceeded Screening Values (Table D.4) [USAF 2006]

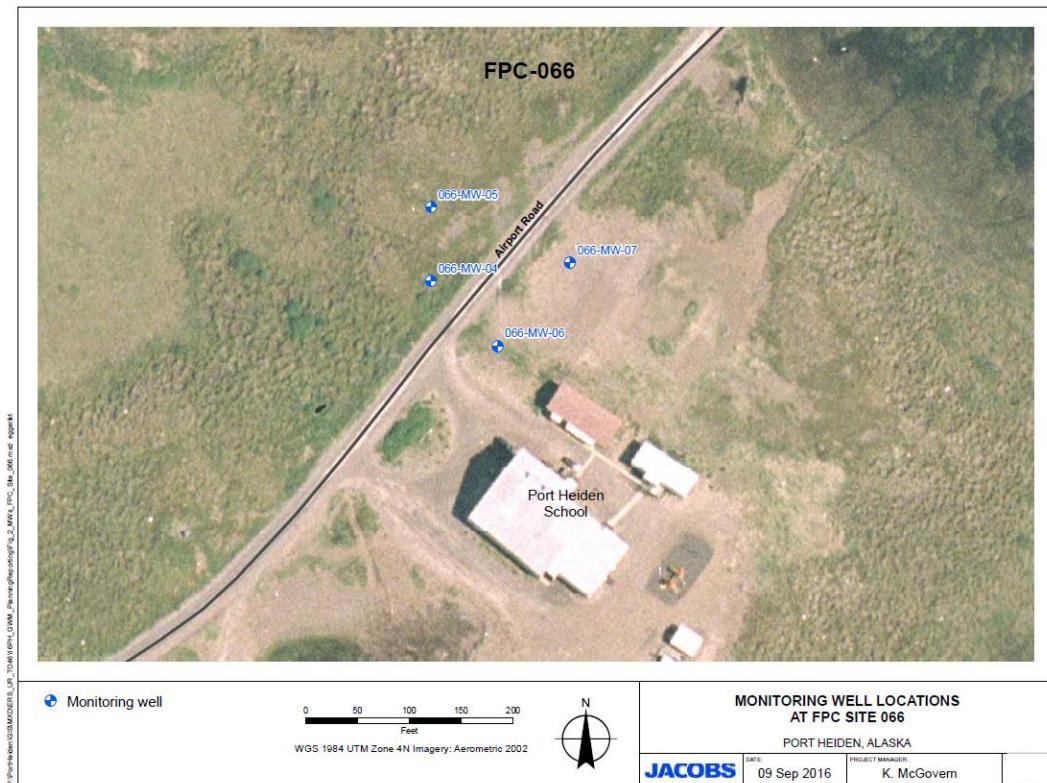
Figure A.8. U.S. Air Force Monitoring Well Locations Near Meshik School, Port Heiden, Alaska. [USAF 2016b]

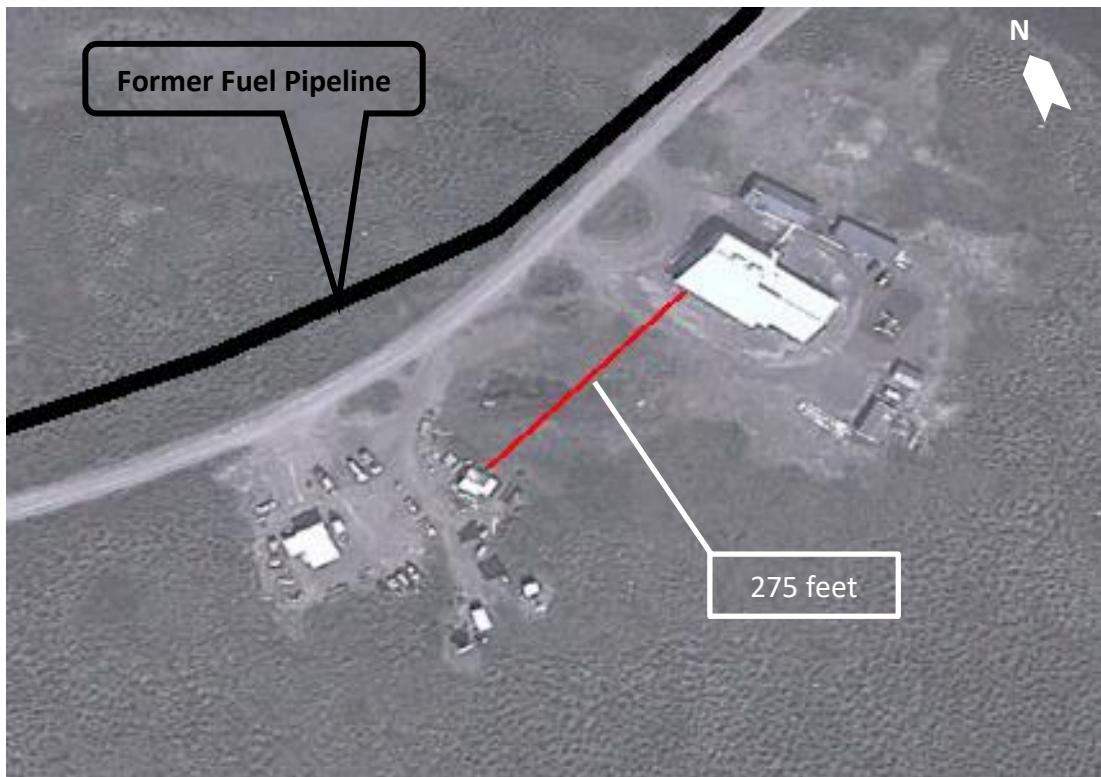
Figure A.9. Proximity to City Maintenance Shop to Meshik School, Port Heiden, Alaska. [Jacobs 2014, Google Earth]
