Health Consultation

Evaluation of Potential Exposure to Releases
from Historical Military Use Areas

PORT HEIDEN
LAKE AND PENINSULA BOROUGH, ALASKA
EPA FACILITY ID: AK8570028698

JANUARY 31, 2019

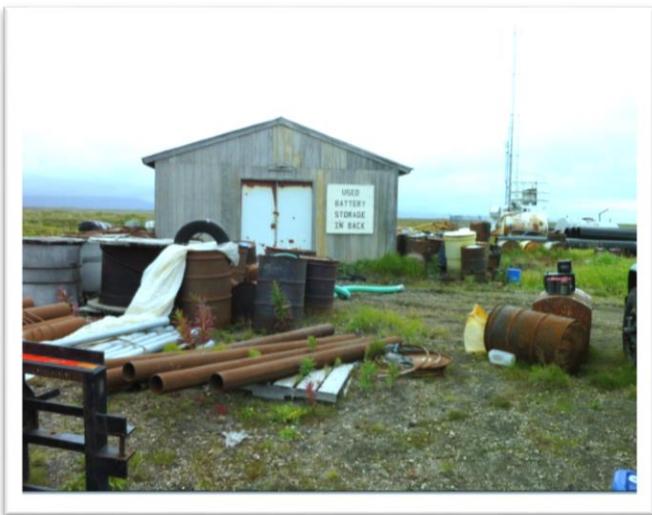
Figure A.10. Historical photo of city maintenance building with battery storage area near Meshik School, Port Heiden, Alaska. [ADEC 2012]
