Letter Health Consultation

MACMILLAN RING FREE OIL SITE

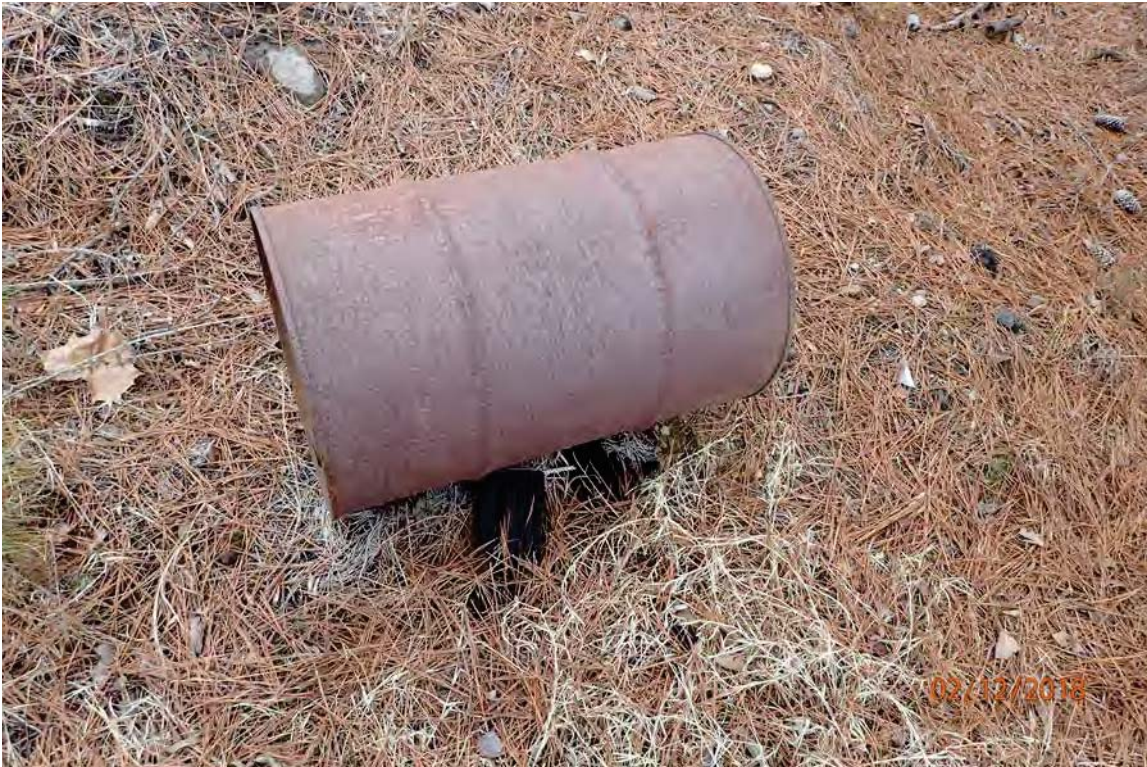
Photo 15: Unidentified rusty drum near Industrial Area. 2018

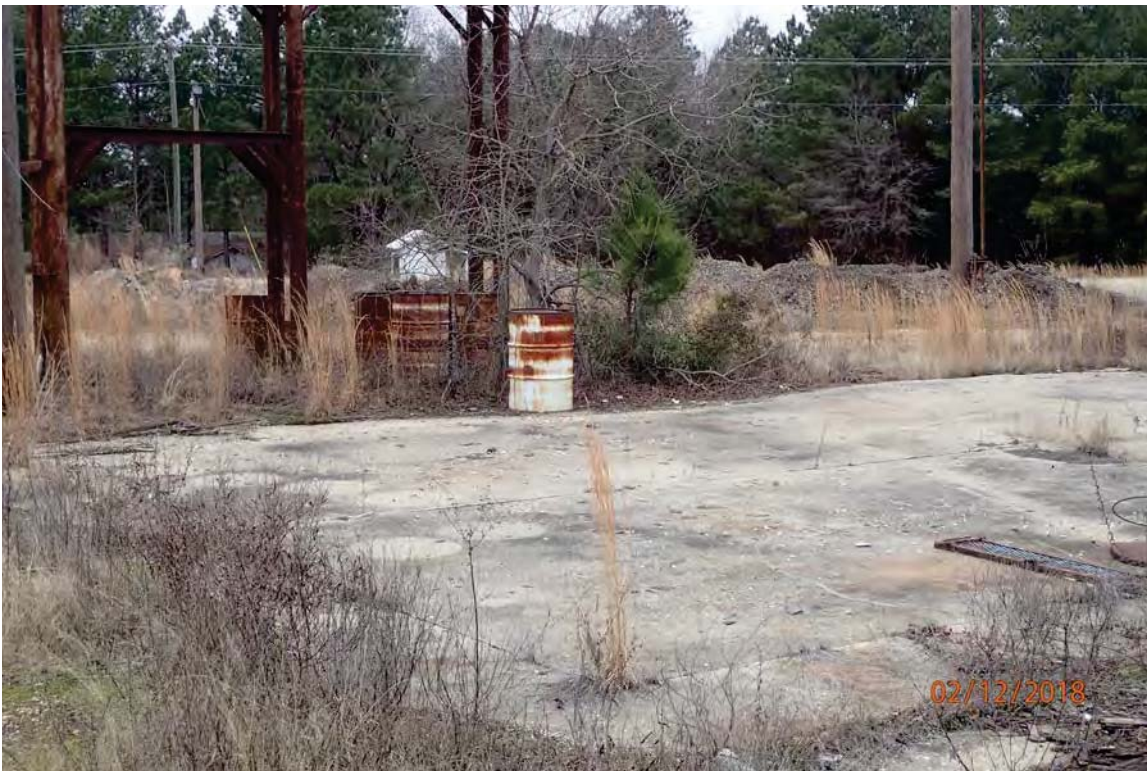
Photo 16: Unidentified drums near Industrial Area. 2018
