Subject: Indoor Air Evaluation  
Naval Air Station Cecil Field  
Jacksonville, Florida

Potential Indoor Air  
Evaluation Locations  
due to underlying  
contaminated groundwater  
at NAS Cecil Field  
(February 2001)

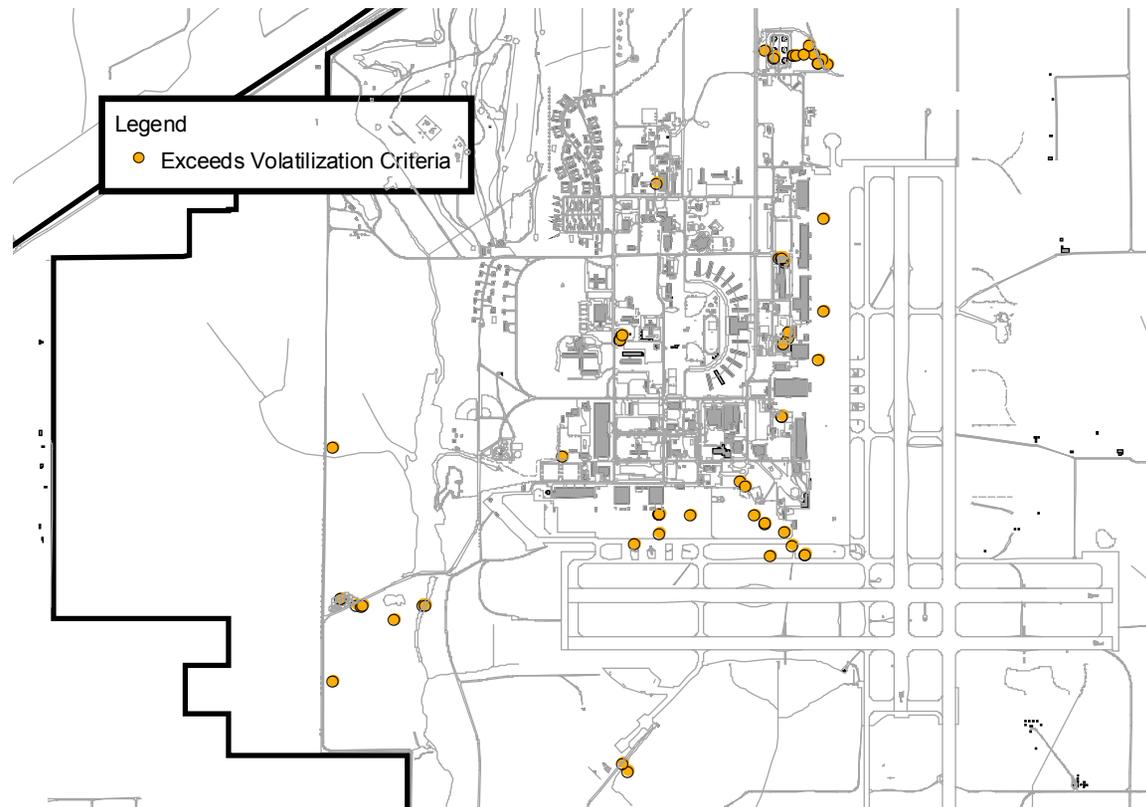
The results of Step Two were displayed in ArcView.

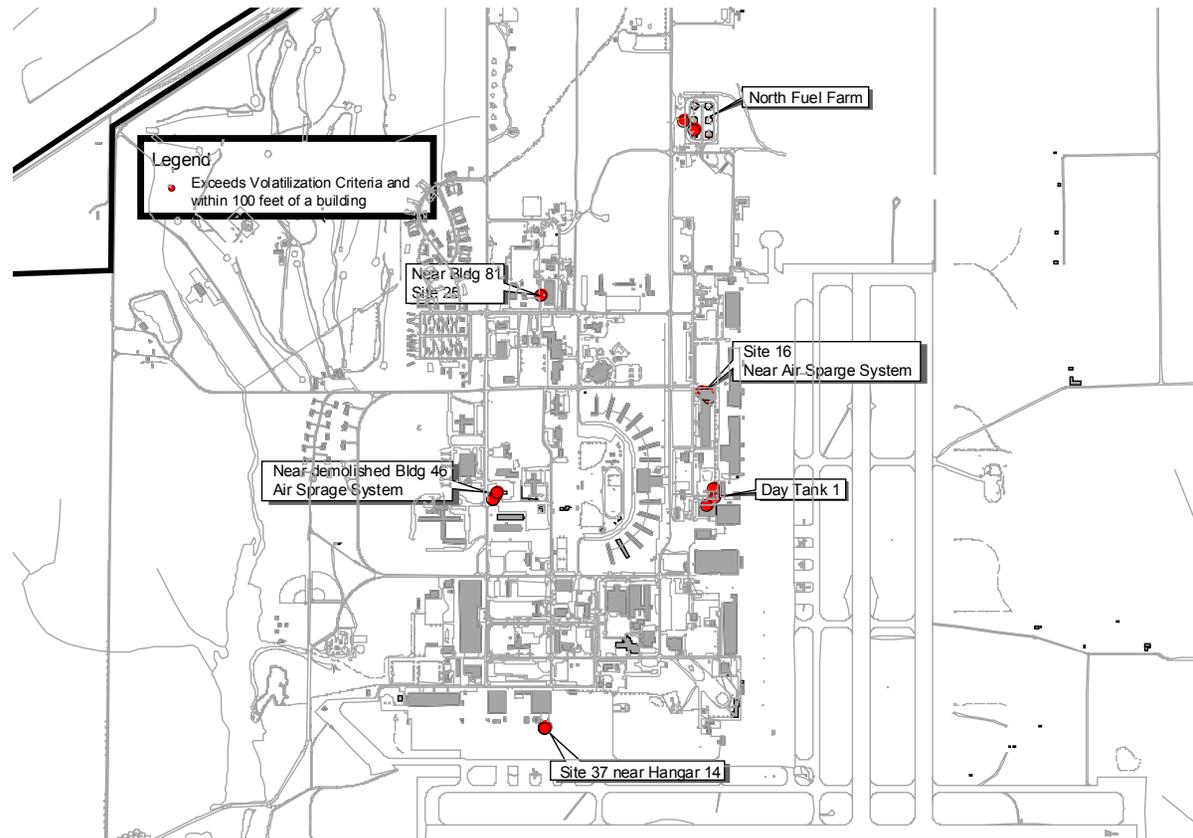
Select all locations within 100 feet of any building displayed in ArcView.

Corresponds to 18 locations across the facility.

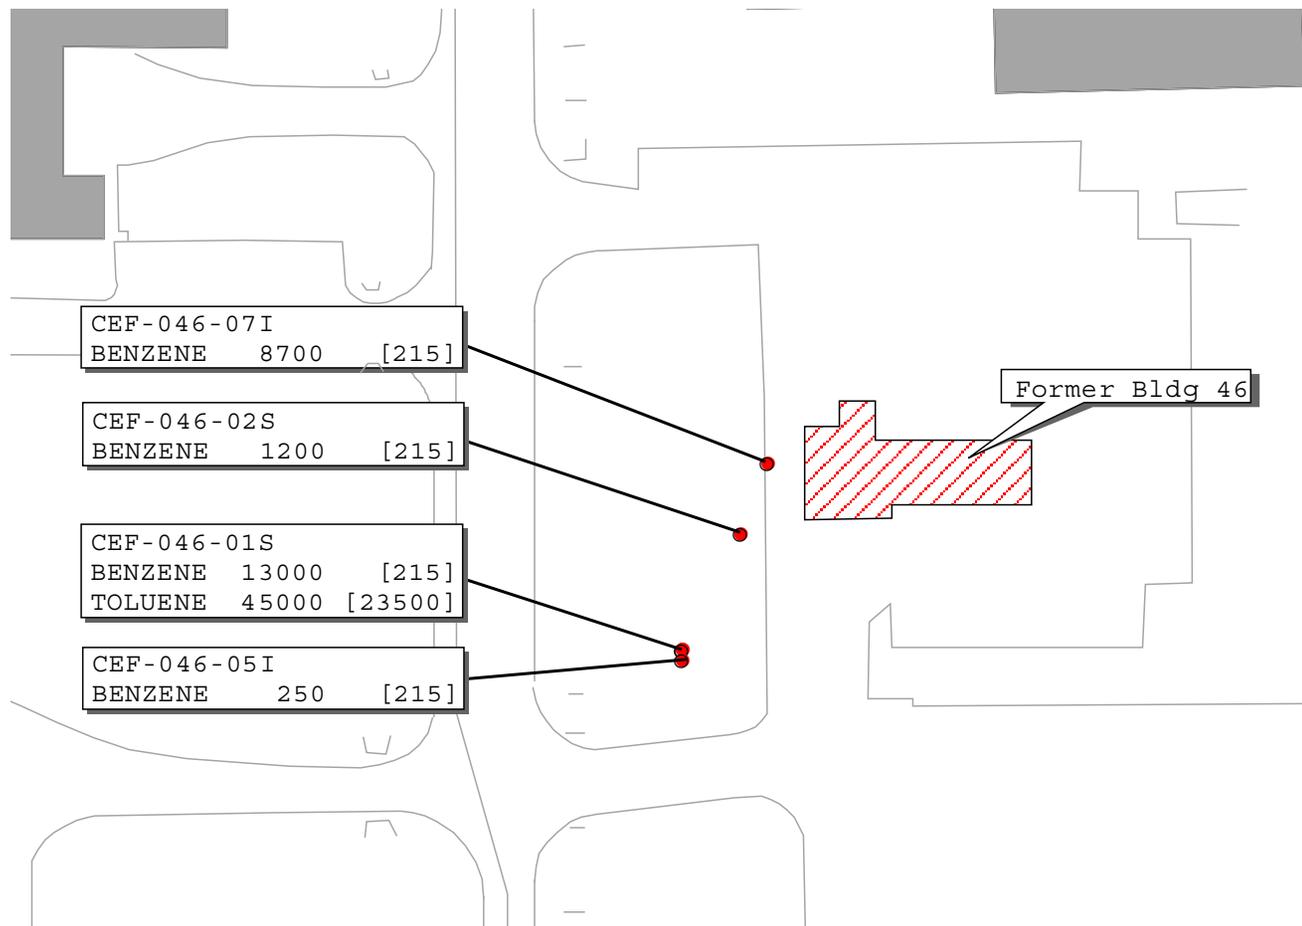
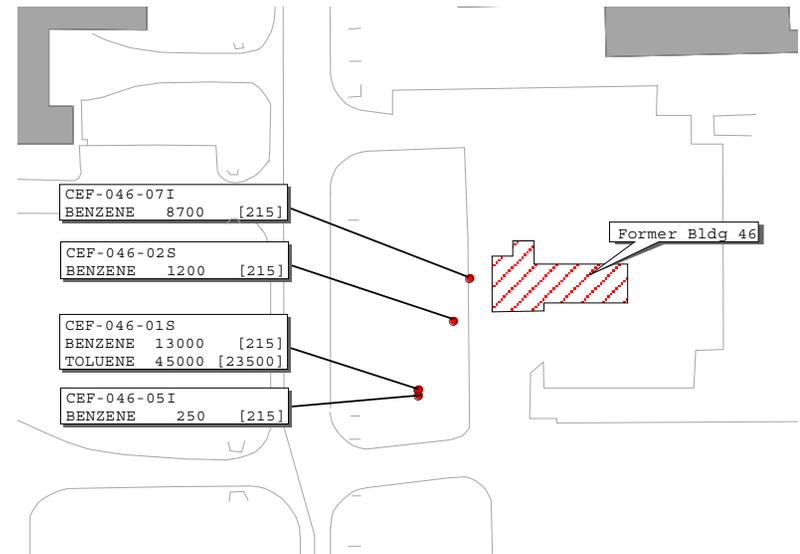
# Building 46 - Evaluation

- Building 46 not longer exists
- Plume has an air sparging (AS) system in-place
- Future building construction is not anticipated due to road expansion.
- Institutional controls for groundwater will be implemented.
- Clean up goals should be reached by 2002.
- Indoor Air issues do not apply

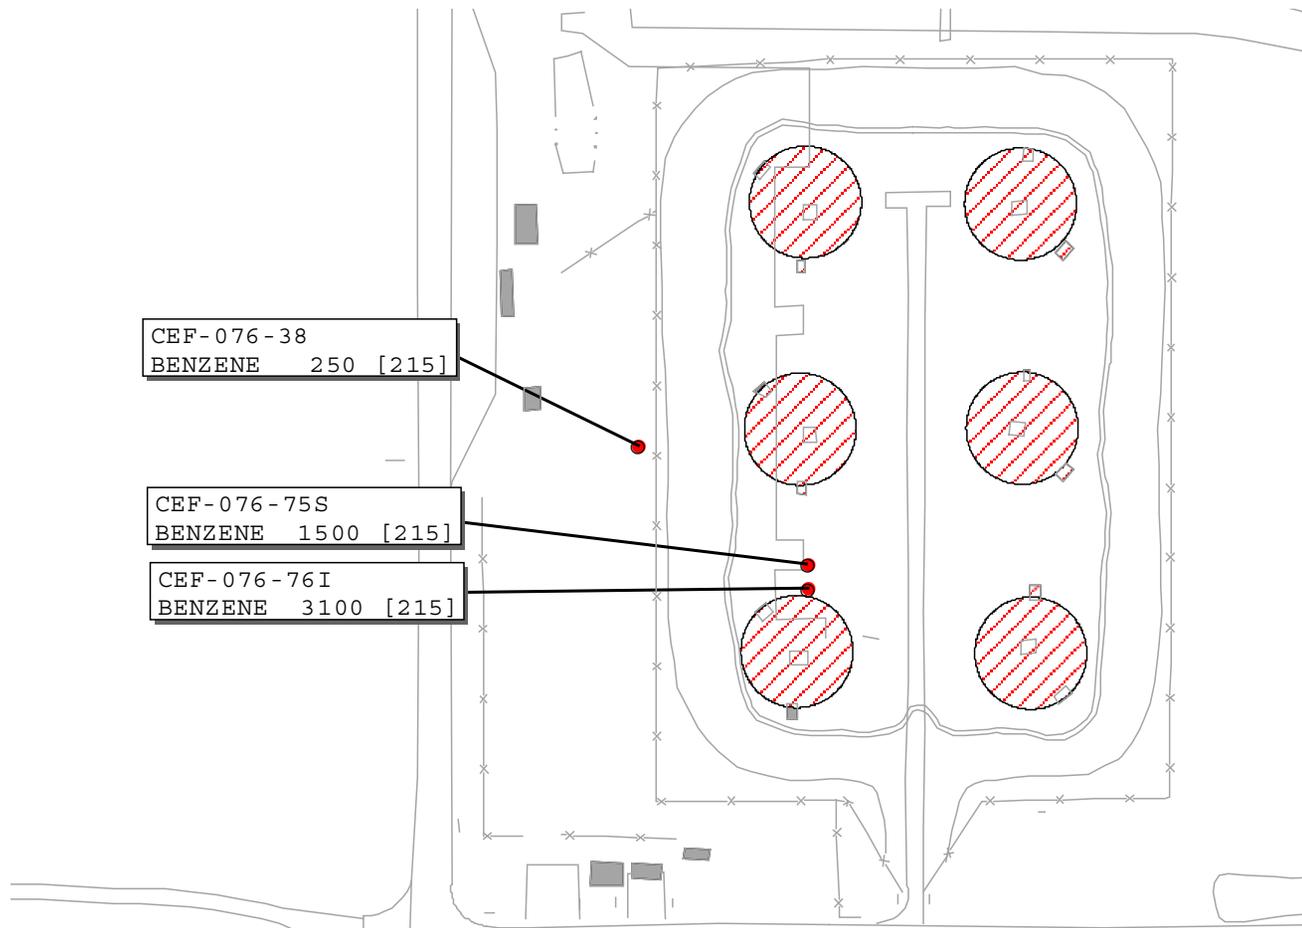
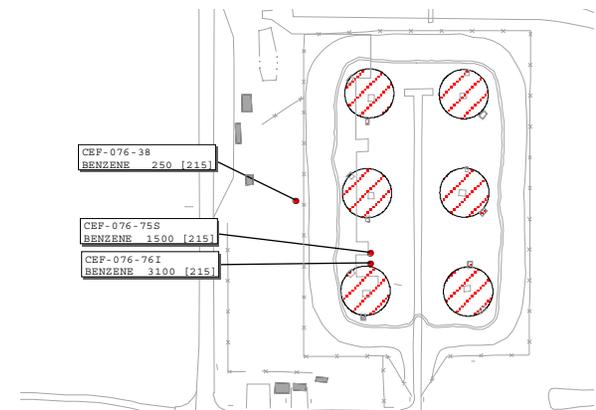
# North Fuel Farm - Evaluation

- Contaminated soils have been removed.
- Former Fuel Tanks have been removed.
- All buildings were demolished during removal
- Institutional Controls will be implemented for groundwater.
  - Any future development will have to evaluate underlying contamination
  - Reuse is to develop an Aviation Commercial/Business Park
- Remedial actions for groundwater are under evaluation.
- Indoor Air issues do not apply

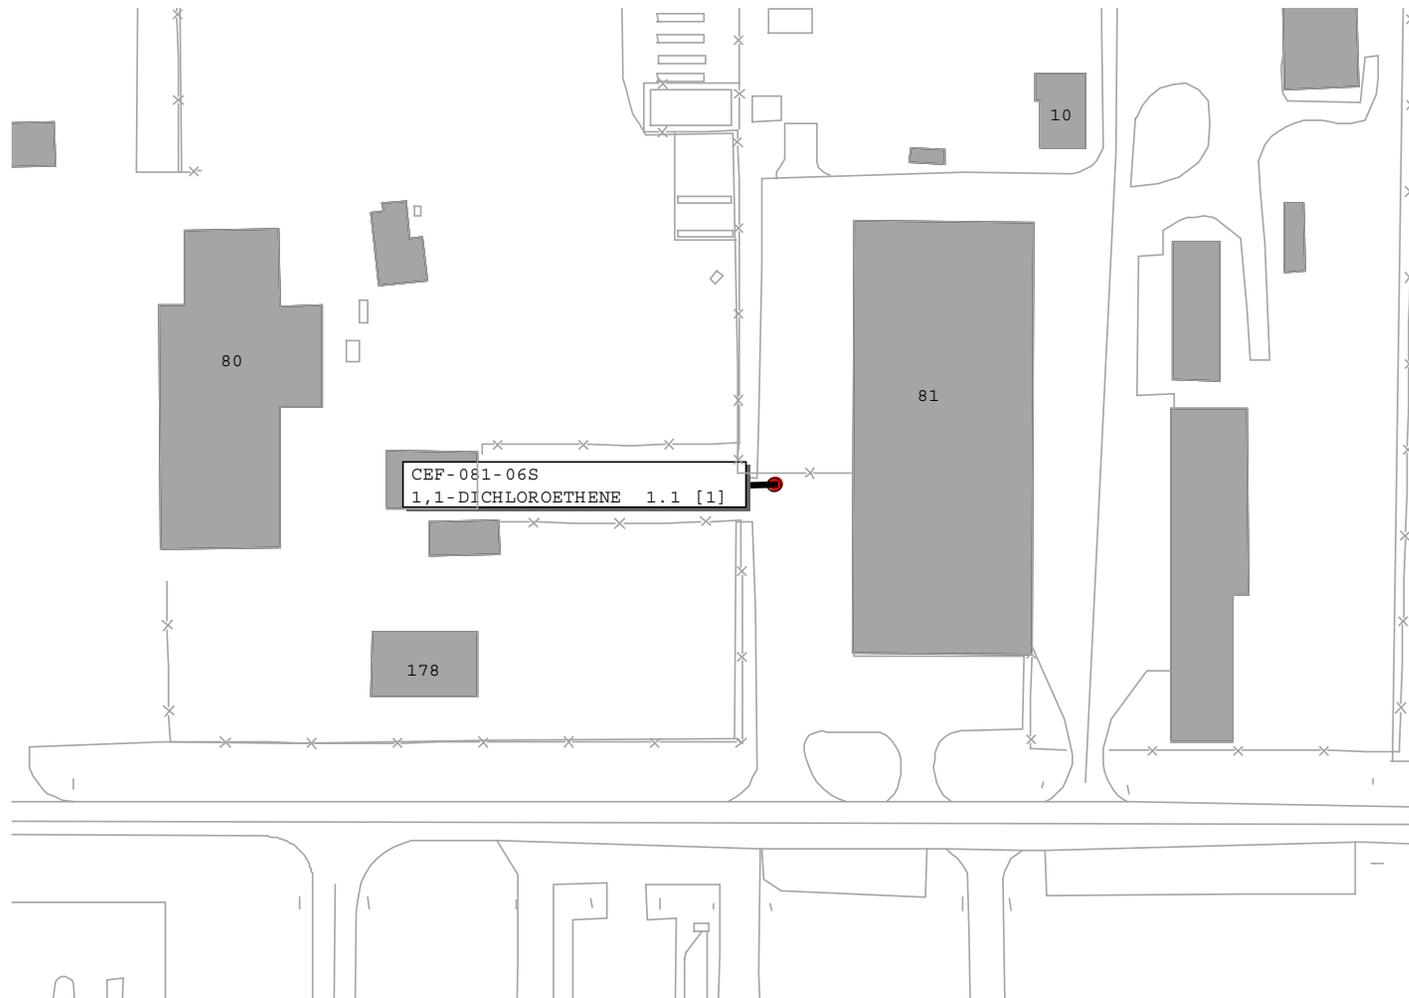
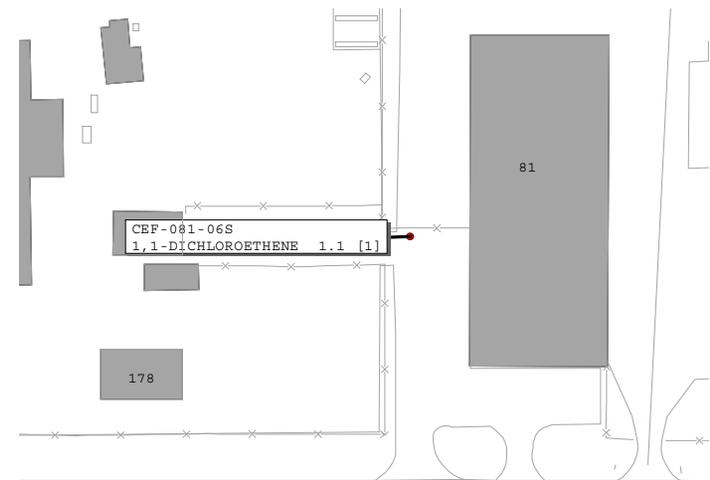
# Building 81 - Evaluation

- 1,1-DICHLOROETHENE @ 1.1 criteria of 1.0
- Sample approximately 45 feet west of building
- No plume identified
- Building 81 is planned to be demolished
- Indoor Air issues do not apply

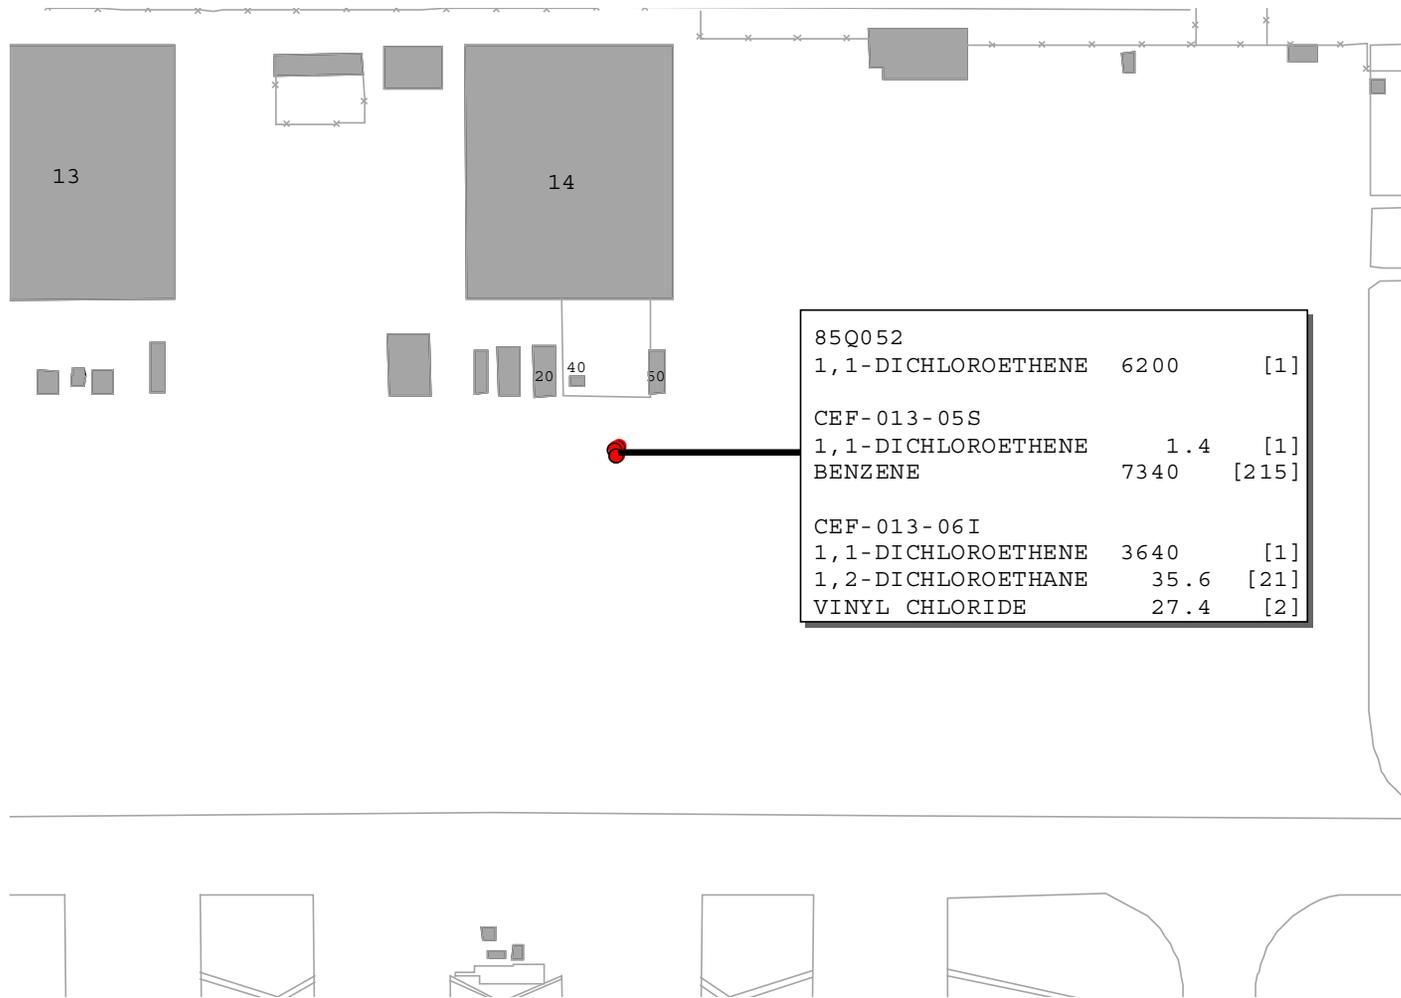
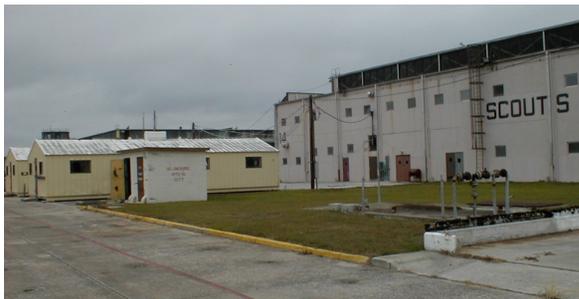
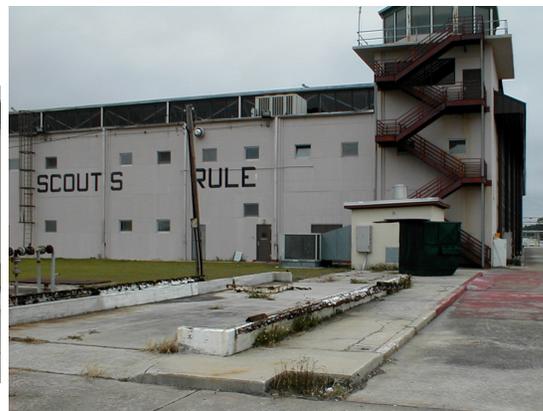
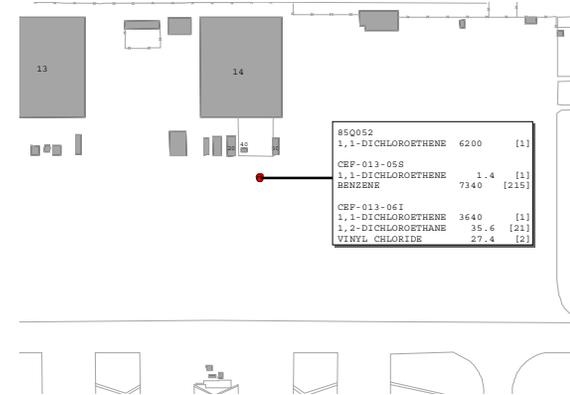
# Site 37 - Evaluation

- Activities include: Air plane service and parking
- Closest buildings are 14,20, 40, and 50
  - Building 14 is a Aircraft Maintenance Hangar with open bay doors on the east and west sides
  - Building 20 is a skid mounted storage building - No direct pathway is present
  - Building 40 is to be removed during Site 36 soil excavation
  - Building 50 has been removed
- AS system to be put in-place
  - Institutional Controls will be implemented for groundwater exposure
- No utilities are present within the foot print of the groundwater plume
- Indoor Air contamination not expected due to groundwater contamination

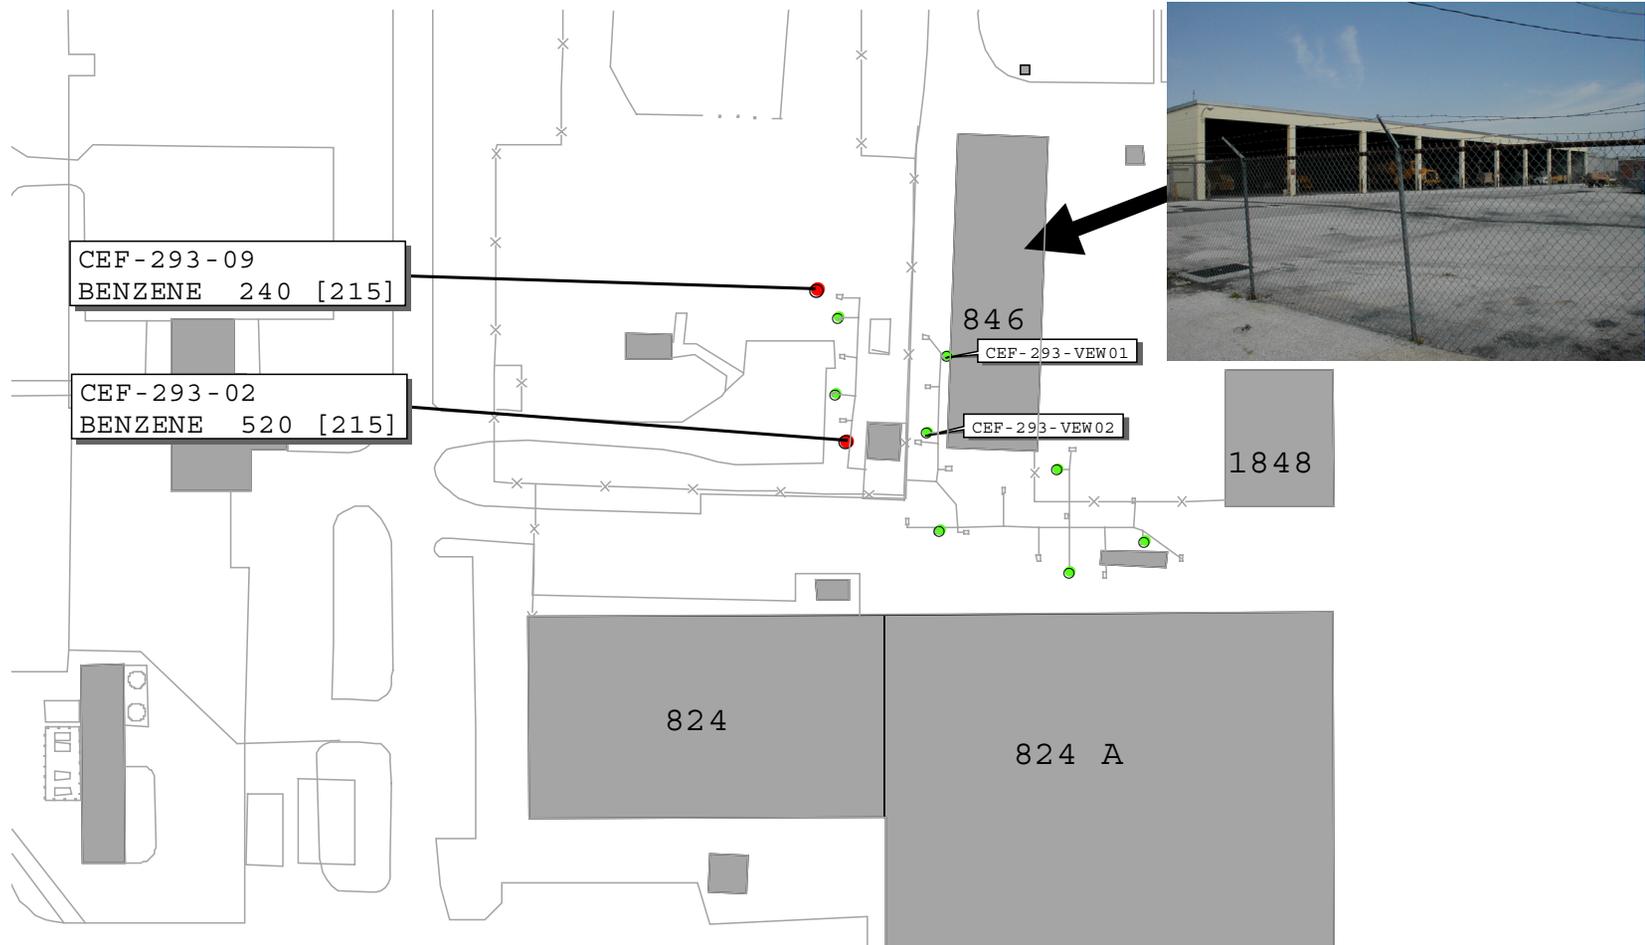
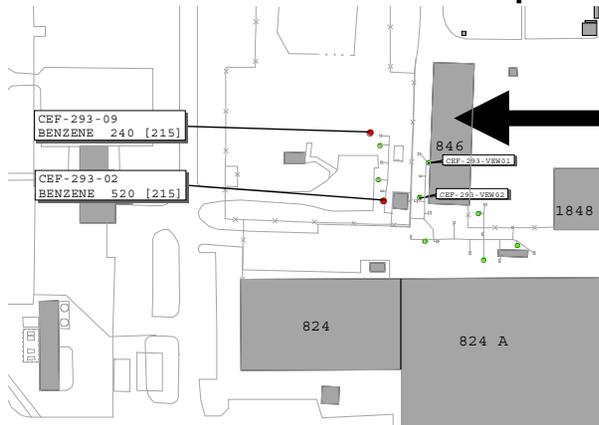
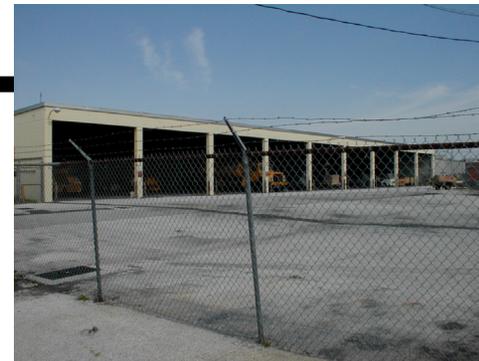
# Day Tank One

- Closest building is 846
  - 846 is a garage with the eastern side of the building constantly open. This building may have indoor air concerns due to the nature of the garage activities; but not expected from groundwater contamination plume.
- A Biosparge Vapor Collection system in-place
- Surrounding vapor extraction wells have been non detect
  - Vapor Extraction wells 1 & 2 have had free product
- Indoor Air is not anticipated to be an issue.

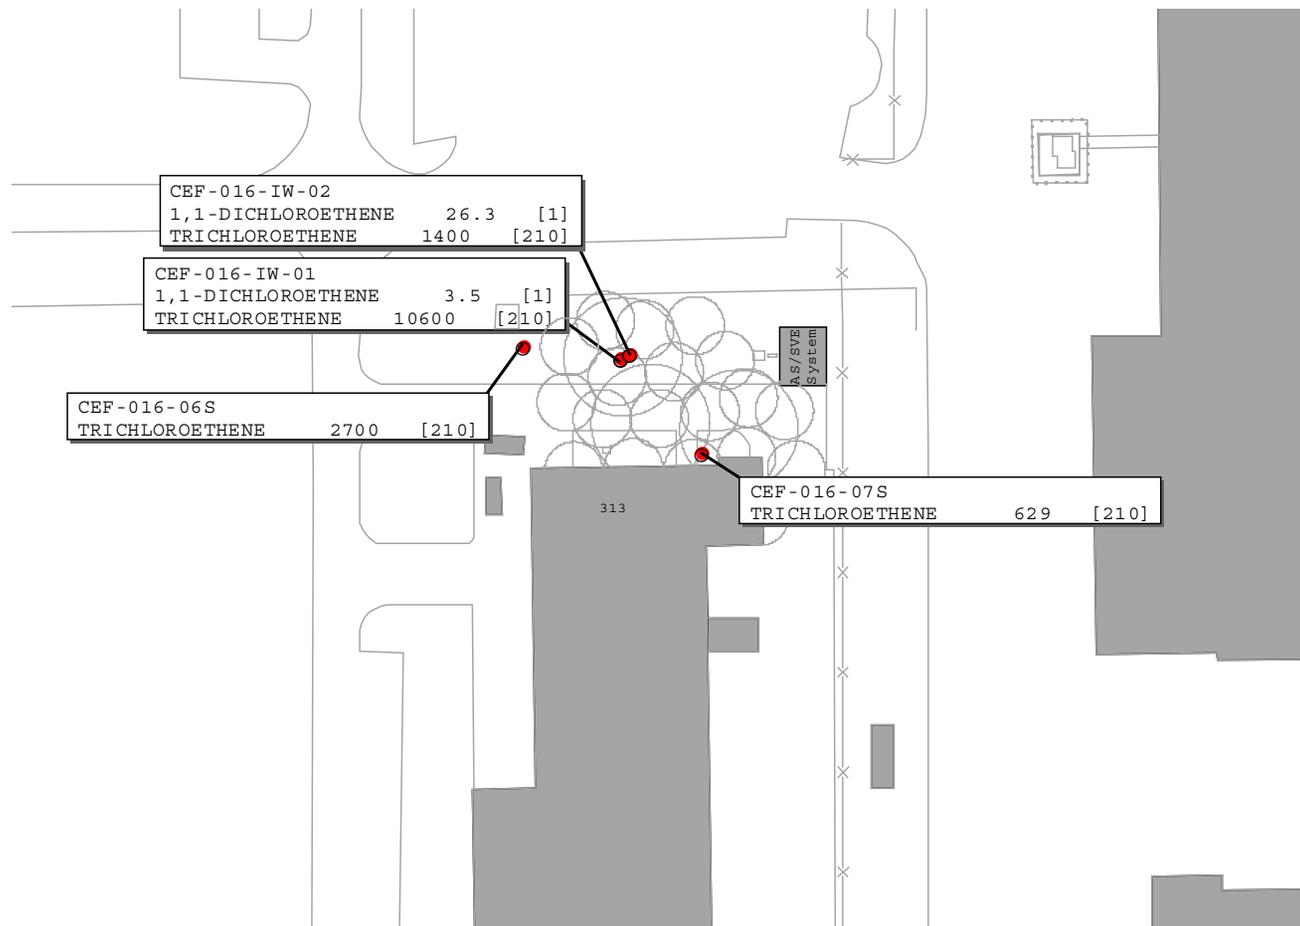
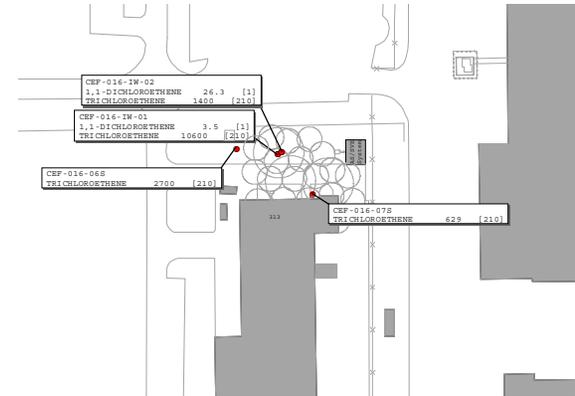
# Site 16 - Evaluation

- Closest building 313
- 313 activities similar to prior occupants
  - storage and repairs to marine and power plant turbine engines
- AS/VS system in-place

- System operation
    - continuously from 06/99 To 05/00
    - operation has been in pulse mode since
- Dated sample results due to AS/VE system operations

- IW-01 & 02 were last sampled on 08/98
  - 6S last sampled 11/99, has been abandoned
- 7S last sampled 01/01
- Piezometers located around Building 313
  - Air data collected 12/99 was evaluated with SCREEN3 (USEPA approved air model) indicated that concentrations in the piezometers were below published criteria for worker exposure

- Utilities are present within the foot print of the groundwater plume
  - These underground pathways may present a pathway to the building
- May have Indoor air contamination due to nature of building activities, but not expected due to contaminated groundwater
