Health Consultation

FORMER IMAGE OF WICKER SITE
1000 CHIN ROAD (FORMERLY VAVAGES ROAD)
BLACKWATER INDUSTRIAL PARK, DISTRICT 1
GILA RIVER INDIAN COMMUNITY
PINAL COUNTY, ARIZONA

EPA FACILITY ID: AZD982408809

MAY 14, 2009

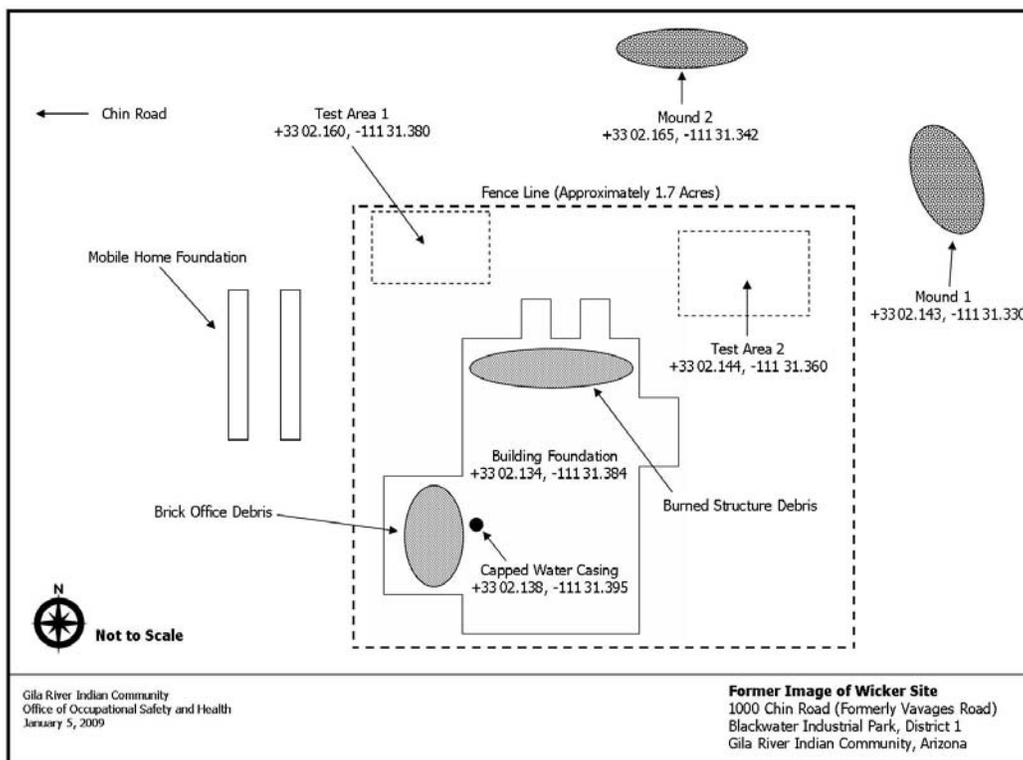
Figure 1.
Location of Soil Sample Test Areas Conducted by
HAZTECH Enviro-Systems, Inc. – 24 March 1994

Soil tests for both Areas 1 and 2 were limited to contaminants of concern (target analytes). The target analytes chosen by HAZTECH Enviro-Systems, Inc. were Acetone, 2-Butanone (Methyl Ethyl Ketone (MEK)), Methylene Chloride, Toluene and 1-1-1 Trichloroethane (TCA). Of the five target analytes tested using EPA Methods 8240 and 8010/8020, only MEK was detected at 0.16 mg/kg in Test Area 2. However, EPA rejected the sampling methods chosen by HAZTECH as a basis for determining the extent of contamination at the site.^{19, 20}

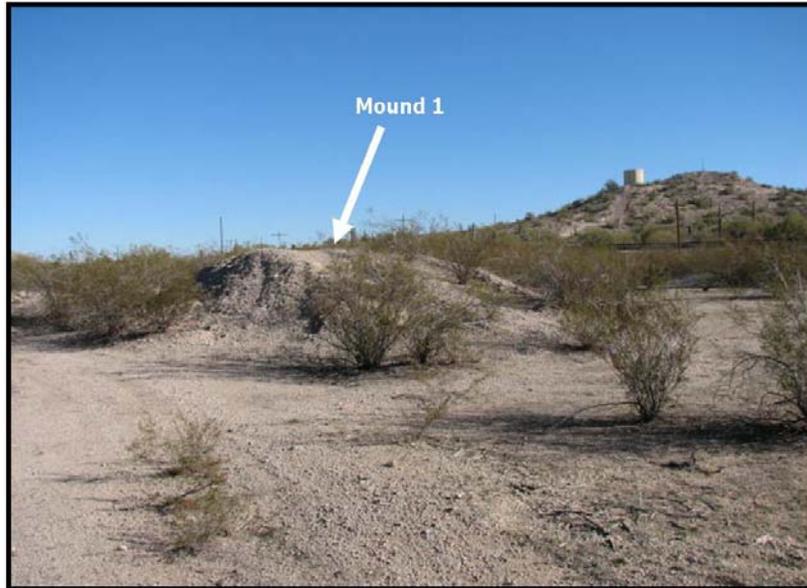
Appendix C Mound 1 and 2

2. The area north and east of the 1.7 acres utilized by Image of Wicker, Inc. has two large mounds containing rusted drum rings, pallet remnants and related debris. The two large mounds are within the 4.04 acre property defined as the Former Image of Wicker Site. An onsite evaluation of the site by OSH staff in October 2008 verified observations made by N. Weiss Associates, Inc. in 2005 regarding the description and location of the two mounds. In addition, OSH staff observed a significant number of metal fragments, which appear to be awning debris, protruding from the soil located north of the 1.7 acre area. Moreover, N. Weiss Associates, Inc. stated in their 2005 report that the “mounded earth is suspect as a possible land disposal area” related to hazardous waste once produced at the Former Image of Wicker Site. To this date, these mounds have not been examined as recommended by N. Weiss Associates, Inc.

Former Image of Wicker Site
Mound 1
1000 Chin Road (Formerly Vavages Road)
Blackwater Industrial Park, District 1
Gila River Indian Community
Pinal County, Arizona

1. A limited Phase II environmental site assessment, as recommended by N. Weiss Associates, Inc. should be carried out to address unknown issues defined in the Conclusions section of this report.
2. Public access to the Former Image of Wicker Site should be limited due to the number of physical hazards found at the site.

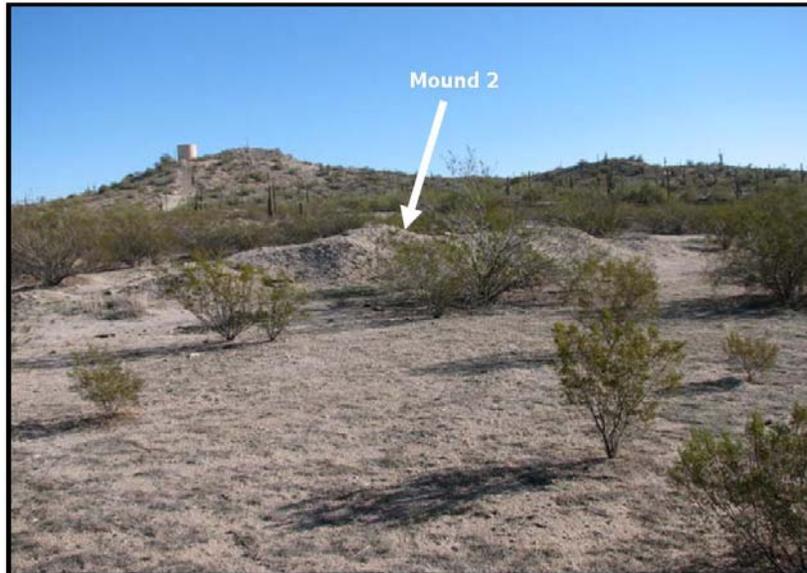
Former Image of Wicker Site
Mound 2
1000 Chin Road (Formerly Vavages Road)
Blackwater Industrial Park, District 1
Gila River Indian Community
Pinal County, Arizona

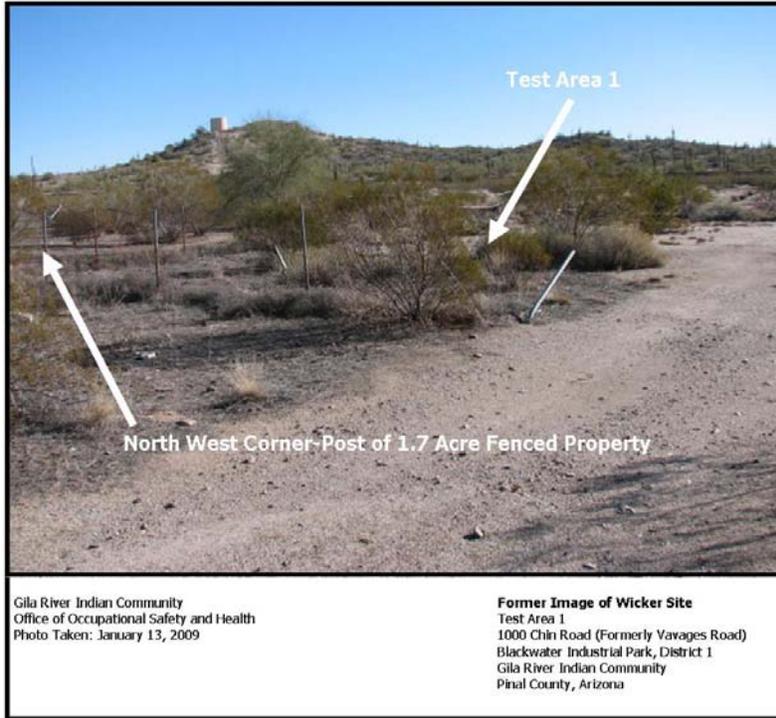
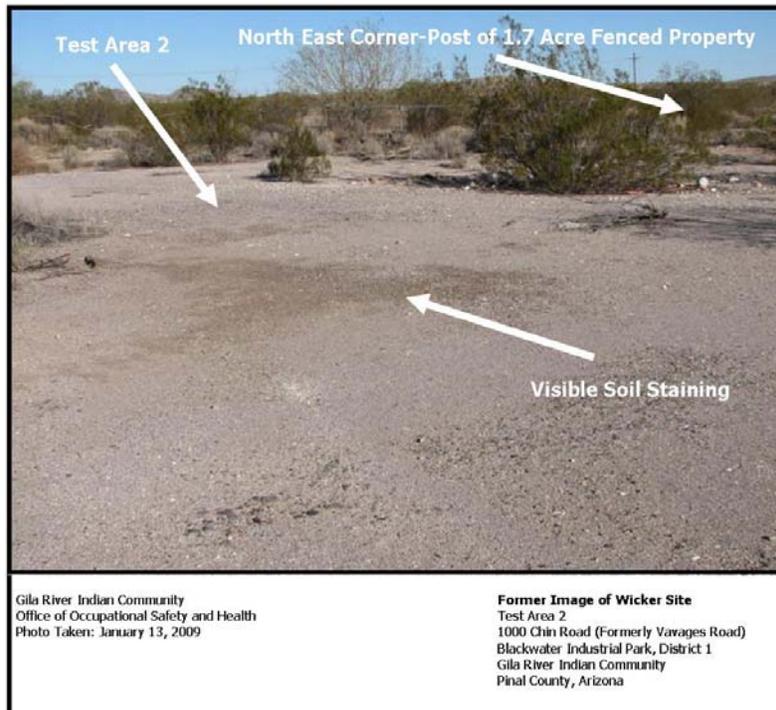
Appendix D Test Area 1 and 2

1. The vertical extent of contamination in Test Areas 1 and 2 has not been fully characterized. The levels of VOCs reported by RECON Engineering, Inc. (although well below Arizona SRLs in 1998) were taken at 3 inches below the soil level and were assumed to represent the worst case scenario. N. Weiss Associates, Inc. states that this assumption was never validated and that the vertical extent of contamination in Test Areas 1 and 2 should be further defined. To date, the vertical extent of possible contamination at the site has not been evaluated.
