# Public Health Assessment for

**ELMENDORF AIR FORCE BASE  
ANCHORAGE, ALASKA  
EPA FACILITY ID: AK8570028649  
DECEMBER 21, 2006**

Agency for Toxic Substances and Disease Registry

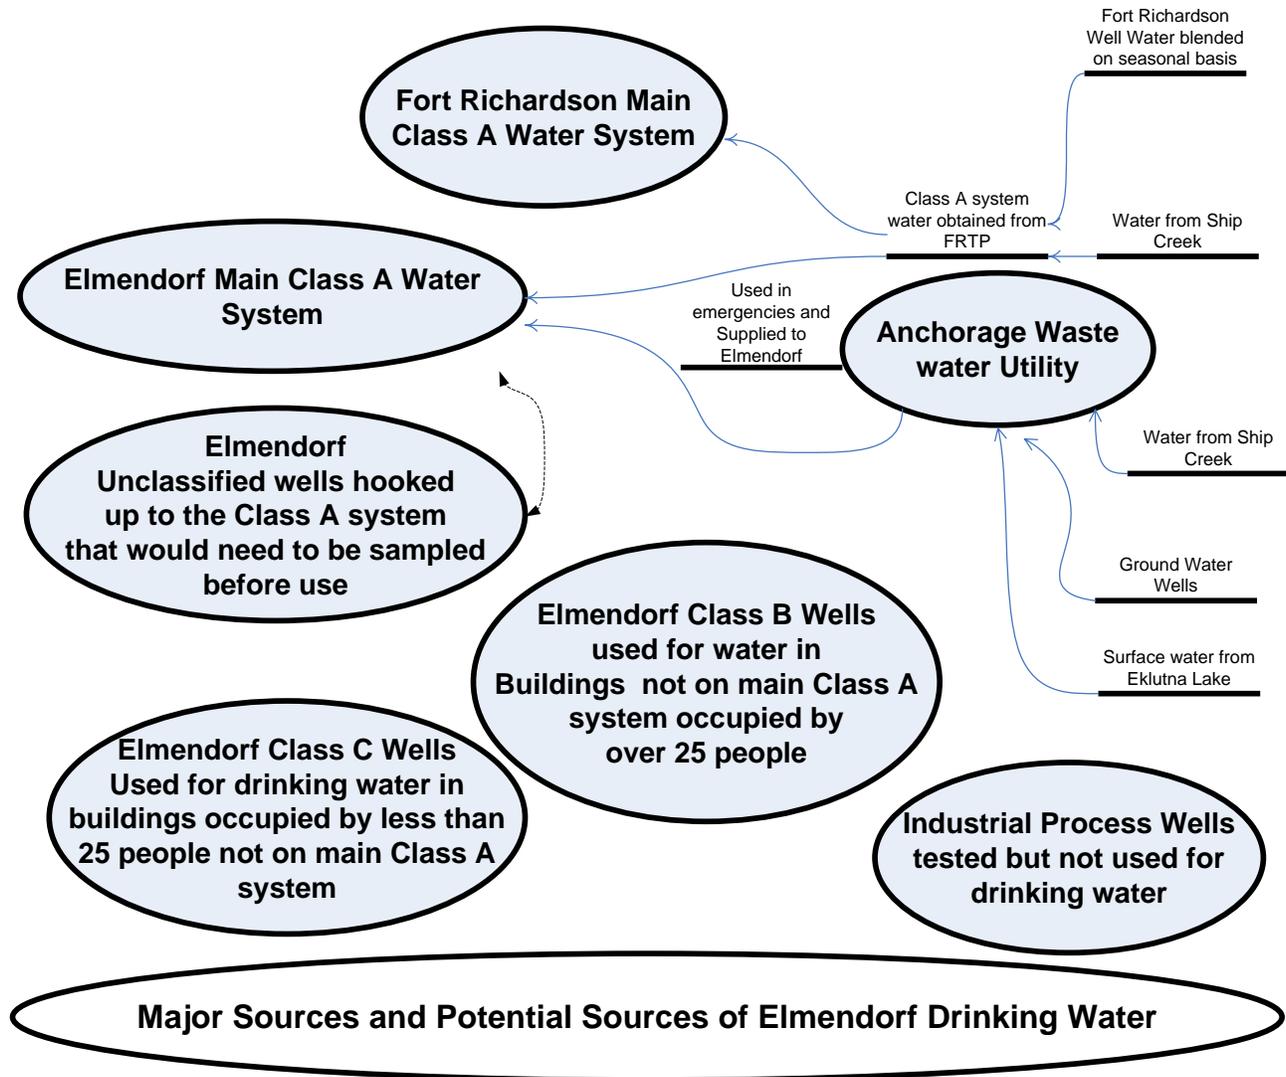
As diagramed below, water is piped through metered mains connected to, owned, and operated by the Fort Richardson Army Base Water Treatment Plant (FRWTP) distribution system to the Elmendorf main Class A distribution system. Water is treated at Fort Richardson and then distributed to 13,000 people at Elmendorf. Water from Fort Richardson drinking water wells is blended by FRWTP with Ship Creek water on an as needed basis usually in the winter when there is lower flow in Ship Creek and supplied to both Elmendorf and Fort Richardson main water distribution systems. Elmendorf like Fort Richardson conducts water sampling in accordance with SDWA, DOD and ADEC requirements.

The Anchorage Water and Waste Water Utility (AWWU) supply system is hooked up as a back up system to supply a second source of water. AWWU water is drawn primarily from Eklutna Lake in the Chugach Mountains, located southwest of Anchorage. Water is also obtained from Ship Creek and 21 groundwater wells (active and standby) in the municipalities of Anchorage, Eagle River, and Girdwood. AWWU has two water treatment plants; the closest is near Fort Richardson on Ship Creek. Elmendorf is also served by two metered back up water lines from AWWU. In the past, six buildings were hooked directly to AWWU water and sewer lines. Currently, the six buildings are provided water by the main Elmendorf Class A water system. AWWU water is always available, but not routinely used by the Elmendorf system, but is used only in emergency situations i.e., natural disasters or major system or supplier disruptions. Unclassified wells are hooked up to the A system, but will not be used unless tested in accordance with SDWA requirements. One well located on the southwest portion of the base provides cooling water to the power plant and has a chlorination system in place in the event it is required for drinking water backup supply in an emergency. Three unclassified wells near the new hospital provide cooling water to the hospital power plant and have a
