Health Consultation

MICHIGAN INDUSTRIAL FINISHES CORPORATION
HAMTRAMCK, WAYNE COUNTY, MICHIGAN

EPA FACILITY ID: MIN000509131

MARCH 21, 2005

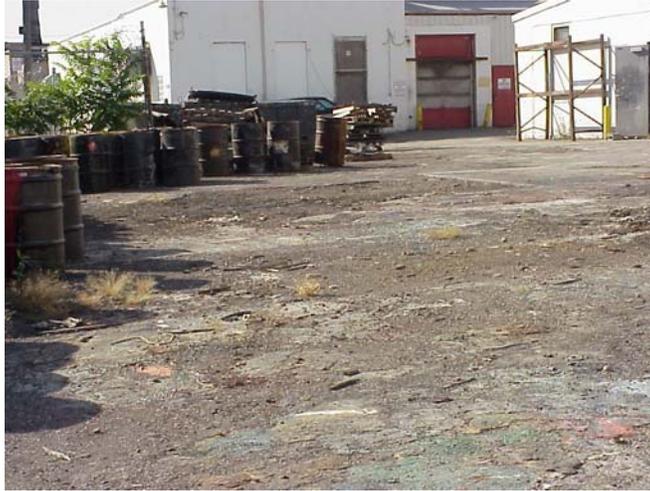
Figure 3. Barrels and Stained Soils Near Northeast Perimeter

On October 7, 2004, DCH staff visited the MIF property, walking around the exterior of the site fence along Vincent Street on the east and the railroad tracks on the west without entering the property. DCH observed numerous drums stored outside without protection from weather or fire and staining of the soil in the storage area on the east side of the manufacturing building (Figure 3.).

- The MIF site be immediately secured to prevent trespass, and that
- Waste materials present on the site be characterized and removed for appropriate disposal.

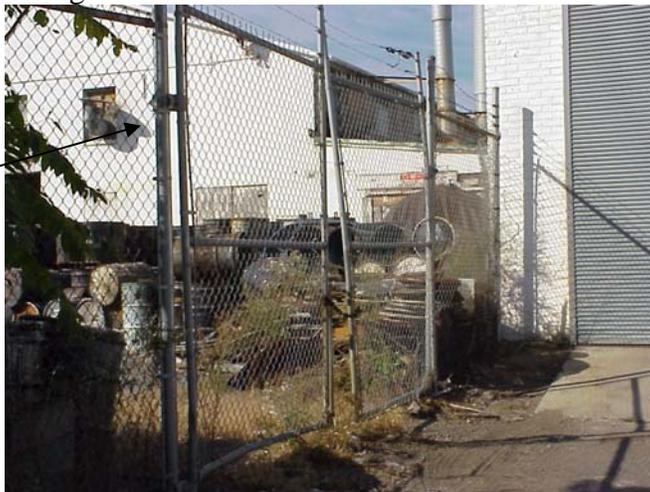
Figure 4. Fence Gate on Northeast Perimeter

The fence gate on the northeast perimeter near the area shown in Figure 3 was secured with a chain, but was bent and would easily have allowed trespasser access to the site (Figure 4.). EPA staff has observed smashed door locks and other evidence of attempts to break into the MIF buildings. There has been a fire on the site that the owner of MIF claims was intentionally set, although the Detroit Fire Department was not able to confirm arson (EPA 2005).

Vent Pipe
in Window

A vent pipe can also be seen in Figure 4 protruding from a high window in the manufacturing building. According to the EPA Action Memorandum for the MIF site,

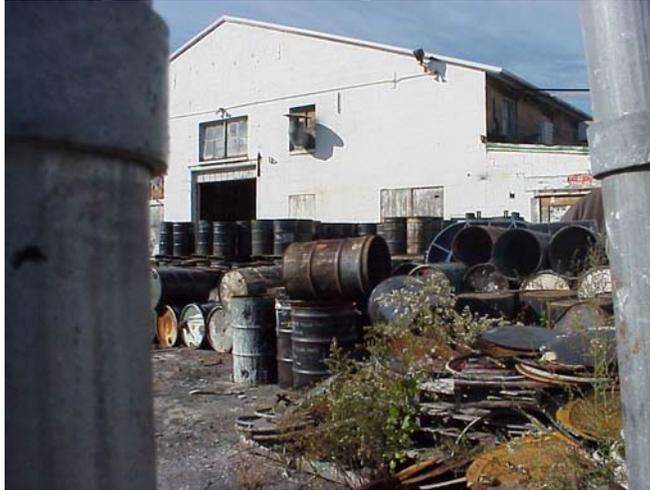
Figure 5. View Through Northeast Gate

several mix tanks occupy this area of the building (EPA 2004) (Figure 2). Figure 5 presents another view of this area. Residential homes are located across Vincent Street approximately 150 yards from the area shown in Figures 4 and 5.

Air sampling has not been conducted on or around the MIF site. However, during the October 7, 2004 site visit, DCH staff detected solvent odors in the front yards of residential property located approximately 150 to 200 yards from stored drums and a vent pipe shown in Figures 4 and 5. The inhalation pathway of exposure was therefore potentially complete in the past. Production has ceased at the MIF site and is not expected to resume in the future; therefore inhalation of VOCs is no longer occurring.

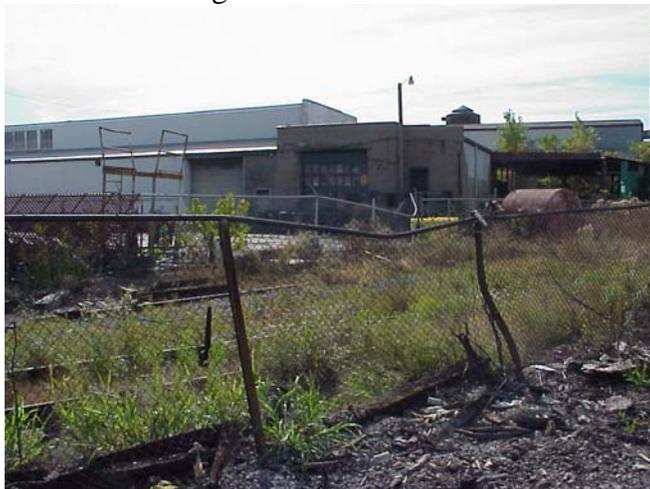
Figure 6. West Fences

DCH staff was granted access to the railroad yard bordering the west side of the MIF site. There are two fences between the railroad tracks and the MIF property, presumably one owned and maintained by the railroad and the other by MIF. Figure 6 shows the condition of these fences. The barbed wire at the top of both has been bent over, possibly to allow a person to climb over without injury. In addition, several railroad ties were stacked against the fence in the foreground, which would allow a person to easily climb this fence (Figure 7.)

The MIF site was not adequately access restricted. The condition of both the northeast gate and the west fence suggested that trespassers were entering the site. Trespassers, particularly children, could have vandalized the barrels or caused a fire or explosion.

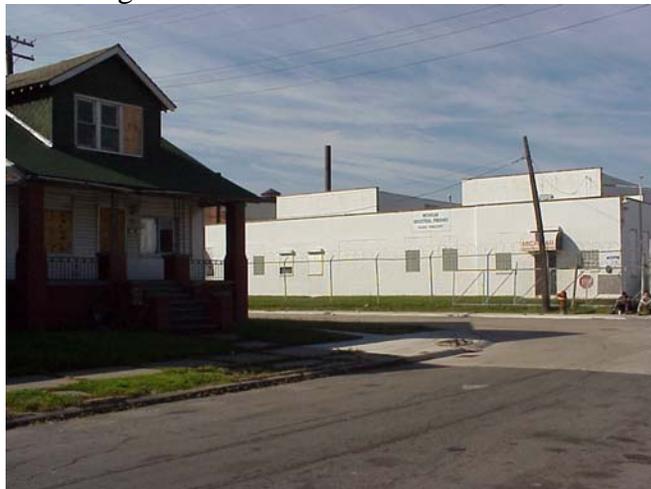
Figure 8. Home Nearest the MIF Site

Figure 8 shows the proximity of the MIF site to the homes to the east across Vincent Street. While the home shown in this picture is unoccupied, the homes immediately to the east and across Marcus Street are occupied with families including small children. During the October 7, 2004, site visit DCH staff could detect solvent odors in the front yards of these homes approximately 150 to 200 yards from the storage area shown in Figures 3 and 4.
