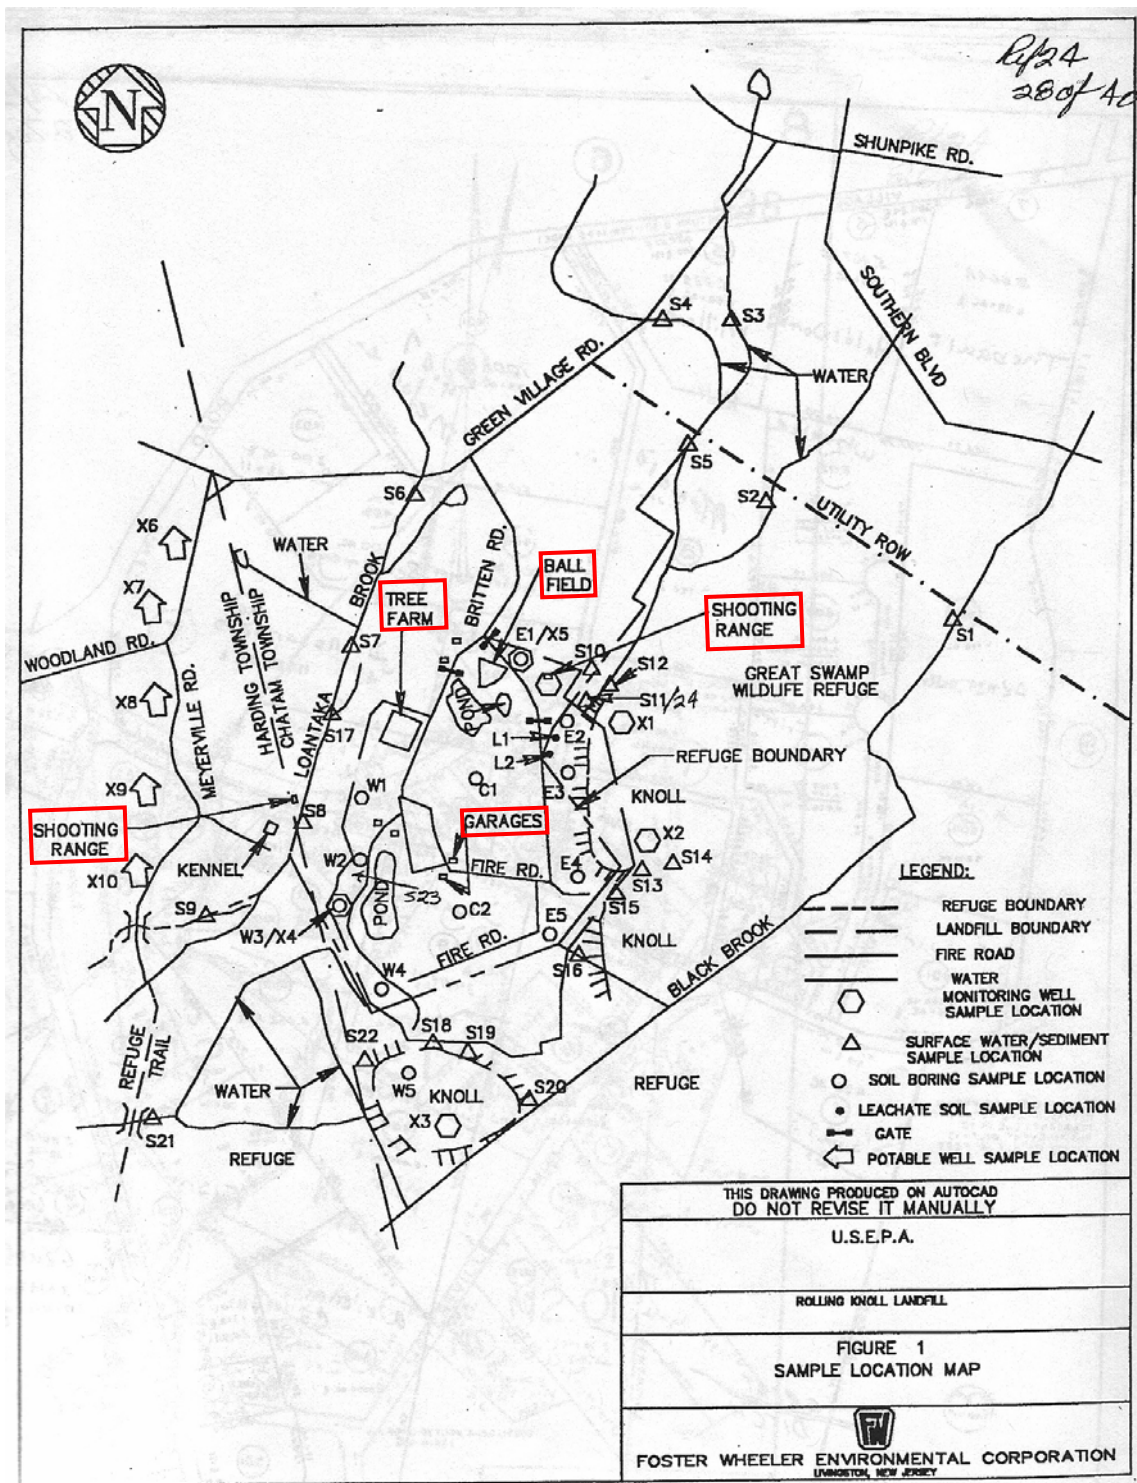
**Figure 7: Sample location Map (Foster Wheeler 2000)**

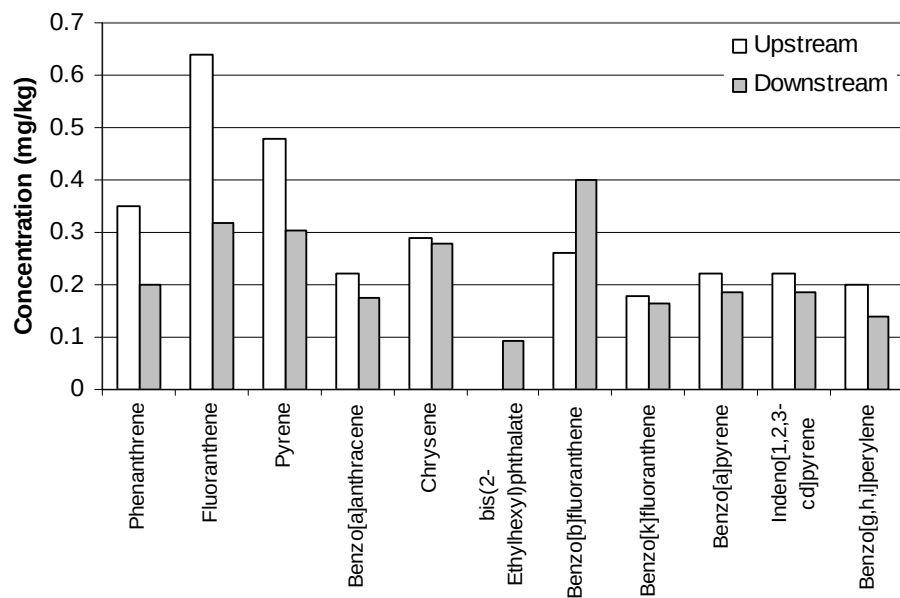
**Figure 8: Upstream and mean downstream SVOC concentration detected in the sediment of Loantaka Brook (Foster and Wheeler 2000)**

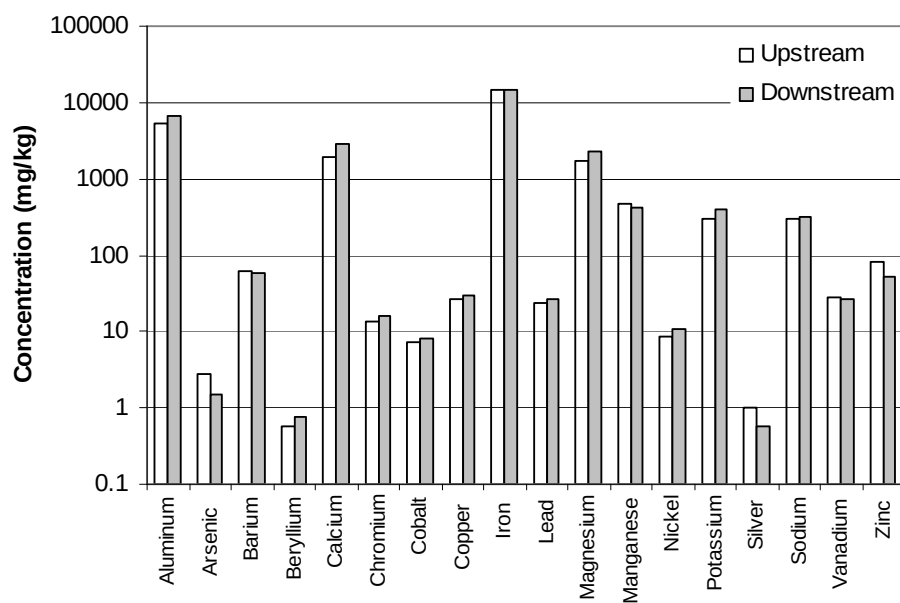
**Figure 9: Upstream and mean downstream metal concentration detected in the sediment of Loantaka Brook (Foster and Wheeler 2000)**
