Health Consultation

WISCONSIN DEPARTMENT OF COMMERCE BUILDING

LA CROSSE, LA CROSSE COUNTY, WISCONSIN

MAY 19, 2005

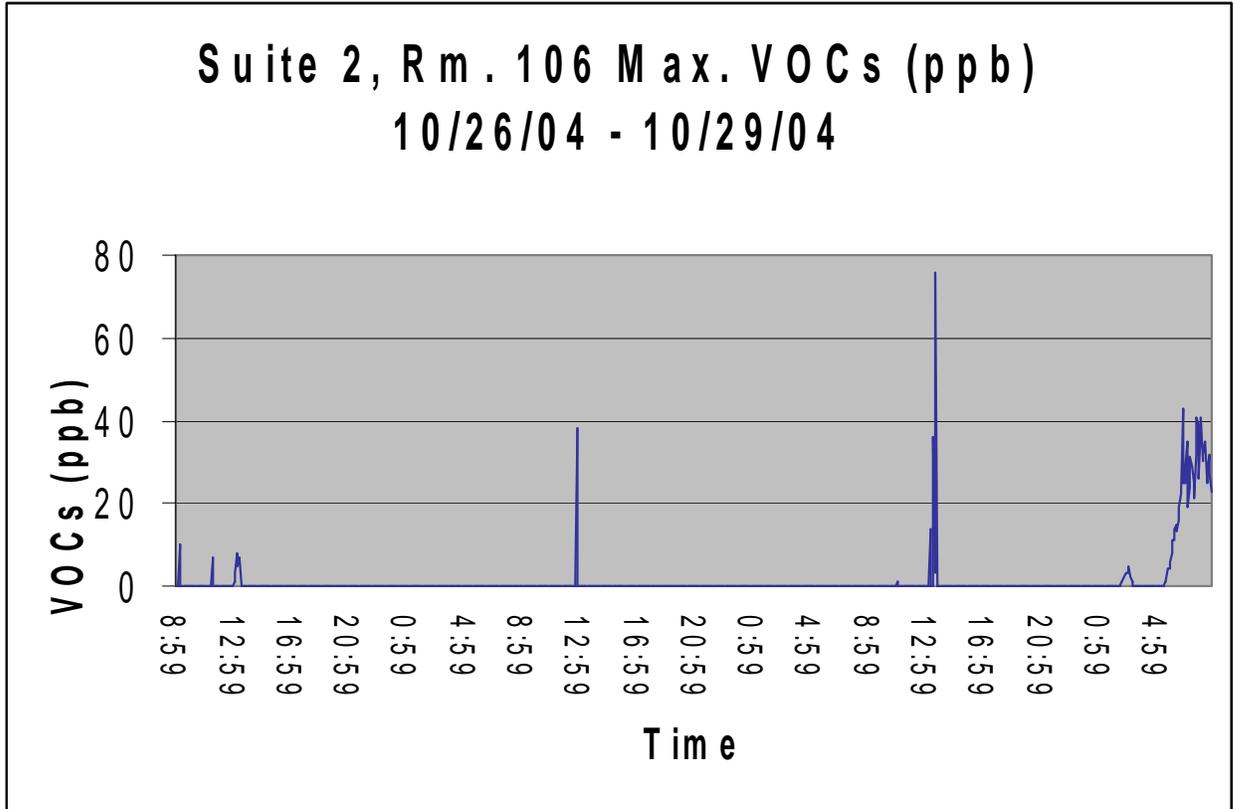
Appendix C

Volatile Organic Compounds Collected with ppb Rae Photoionization Detector (ppb)
Suite 2, Rm. 106 (Closest to Petroleum Lab)
WI DOC Building, La Crosse, WI
October 26, 2004 to October 29, 2004

Air samples from the DOC building were collected for laboratory analysis on 13 occasions between August 9, 2004 and February 17, 2005. The results for samples collected for VOC analysis on October 26, 2004, are not included in Appendix B because the samples were not analyzed, due to improper sample media. Sample periods ranged from instantaneous (grab) to 8 hours. A number of these samples were collected either during or shortly after a strong odor event.
