Letter Health Consultation

Evaluation of Lead and Polychlorinated Biphenyl Concentrations Detected at the

POWELL LEAD SITE

BIG STONE GAP, WISE COUNTY, VIRGINIA

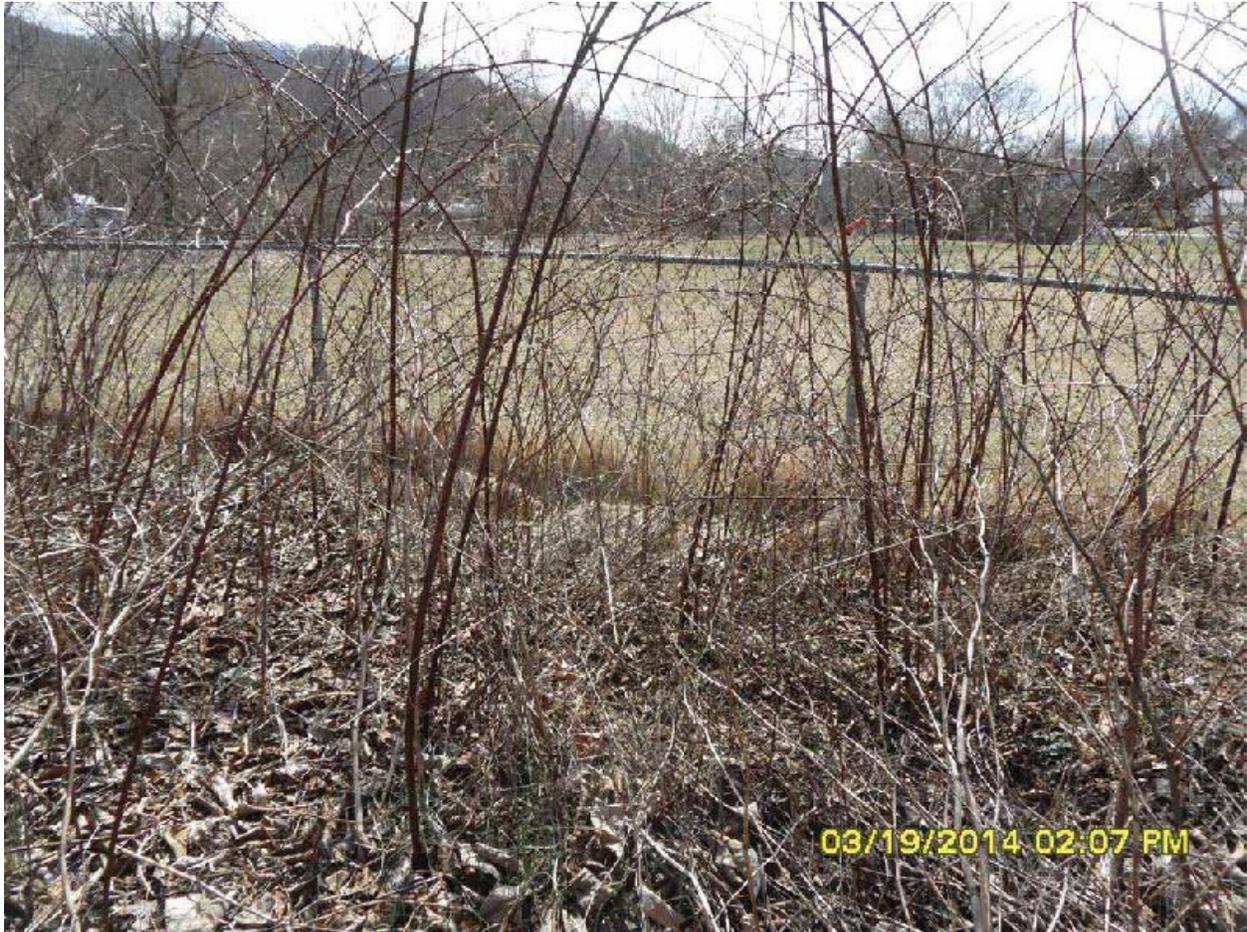
Figure 2. Picture of the mound and fence separating it from the playground. The mound is the area in the foreground covered in tall, brown vegetation in the winter

VDH contacted VDEM and the local health department in Wise County for assistance with identifying potential receptors at the site who may be exposed to contaminants in the soil in and around the mound and playground. The local health department, in agreement with VDEM, told VDH that exposure to soil in the mound would be difficult given the amount of dead vegetation covering it in the winter and the dense vegetation growing on the mound during the rest of the year (see Figure 2 in the Attachment).

Present and future exposure to soil contaminants at the mound is an *eliminated* exposure pathway because the mound is covered with heavy vegetation preventing direct contact with the soil and the mound is now enclosed by a fence restricting future access.

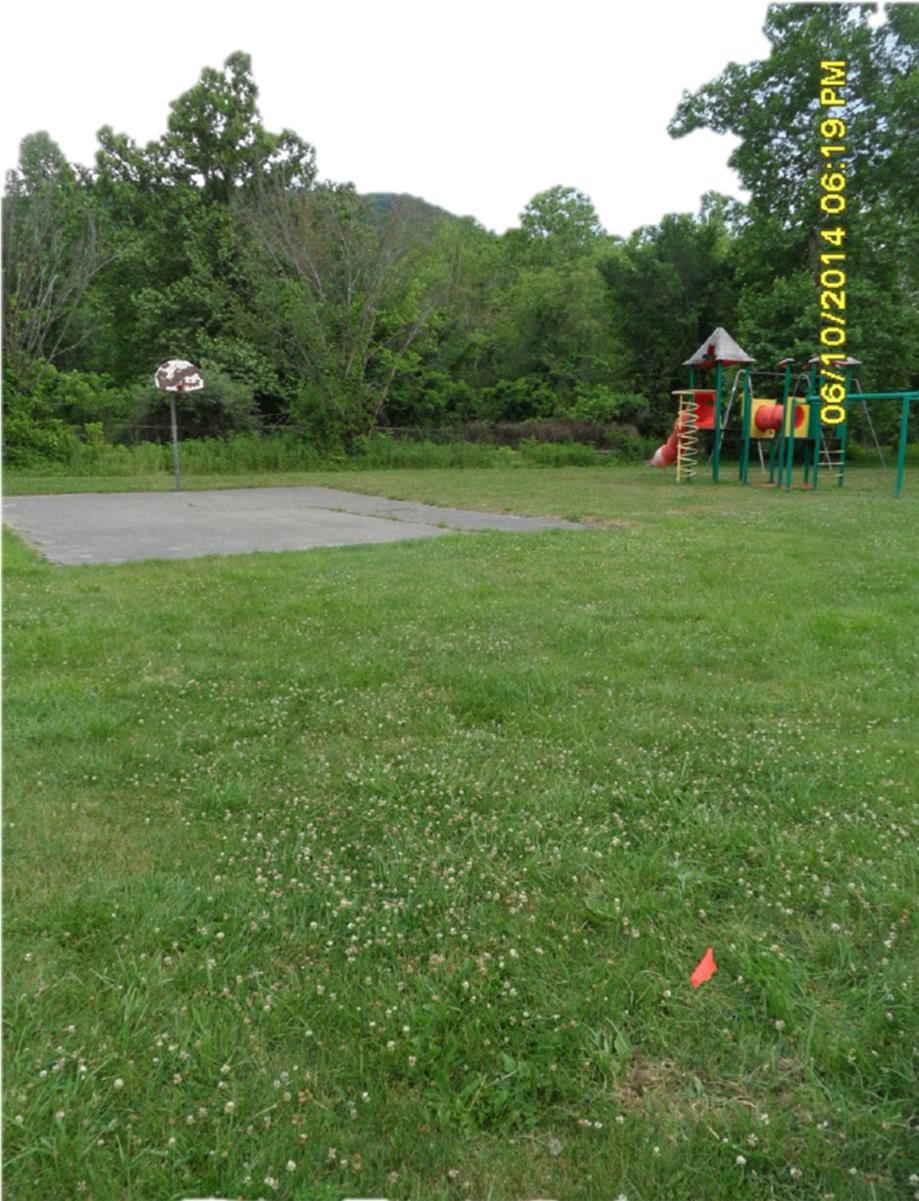
Figure 3. Photograph of Playground Area

The local health department reported that the playground adjacent to the mound was used for youth organized sports. The field is used from March to May for softball practice (girls, ages 10-13) five days a week for two hours each practice. From mid-July to Labor Day, the field is used for football practice (boys, ages 8-10) four days a week for three hours each practice. In addition, the playground includes jungle gym equipment and a small basketball court that may be used by children six years and younger while siblings practice sports. The playground is well covered with grass throughout the playing field and jungle gym area, and the small basketball court is covered with asphalt (see Figure 3).

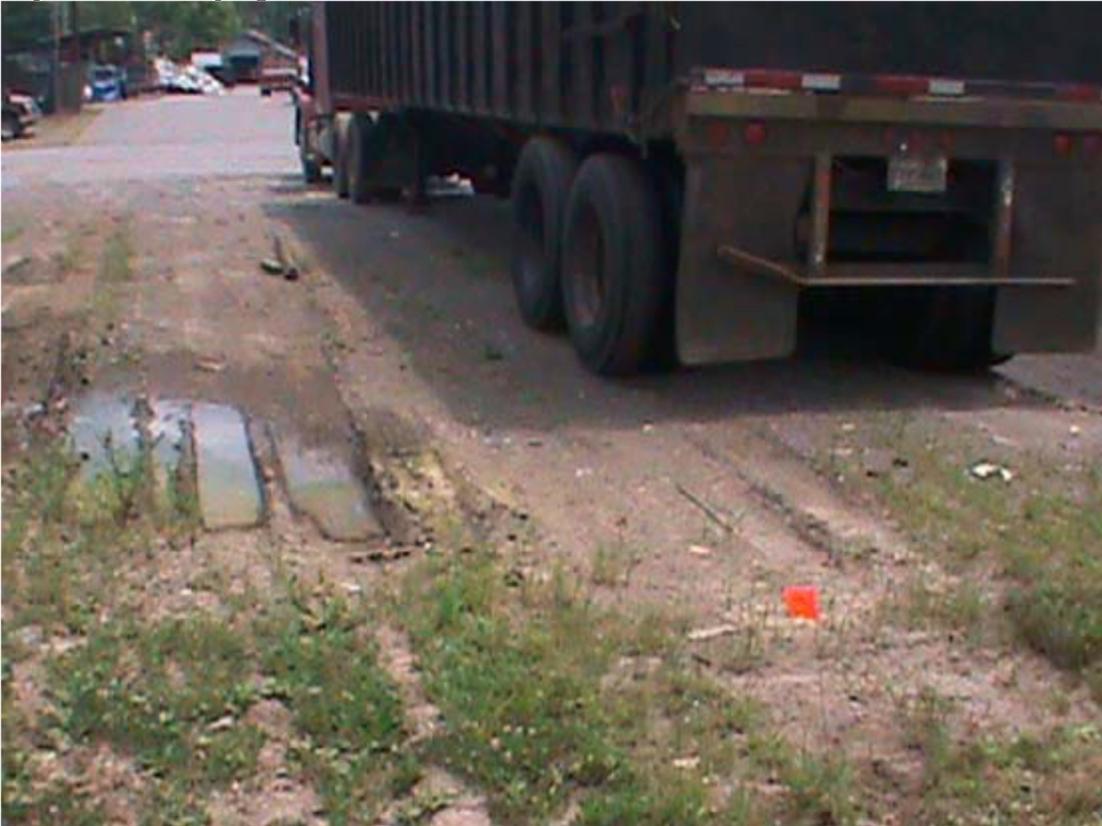
Figure 4. Photograph of roll-off area east of the mound

The area east of the mound is an active gravel/dirt parking spot for tractor trailers and roll-offs (see Figure 4). The rest of the area to the east is covered with grass, limiting contact with the soil. There is no indication that the area east of the mound is frequented by any members of the

community or trespassers, and worker exposure is limited to boot contact with bare spots infrequently when loading or unloading trailers and roll-offs.²
