Letter Health Consultation

C&R BATTERY COMPANY SITE

RICHMOND, VIRGINIA

**Prepared by
Virginia Department of Health**

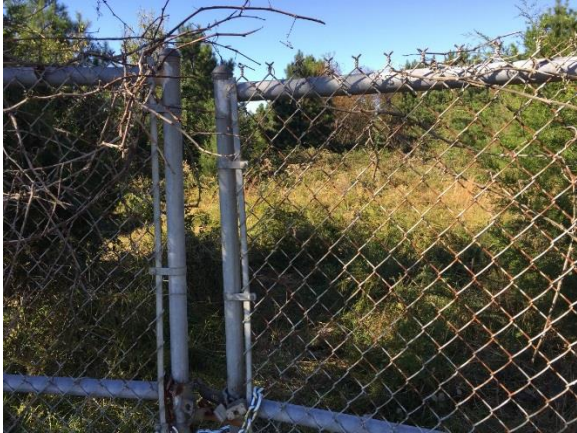
Front gate

- The gate at the entrance to the parcel located at 1320 Bellwood Road was secured with a new chain and padlock (see [Attachment C. Site Photos, October 18, 2018](#));
- The 1320 Bellwood Road parcel was heavily overgrown with grass, shrubs, and small trees.
- The 1320 Bellwood Road parcel appeared enclosed in a chain link fence, but tree cover limited most visibility from neighboring businesses (Capitol Oil Services Propane and C.D. Hall Construction).
- A faint trail at the gate and litter inside the gate of the 1320 Bellwood Road parcel appeared to indicate that trespassers had access at some time, but the gate shows no signs of being opened recently and the lock is secure.

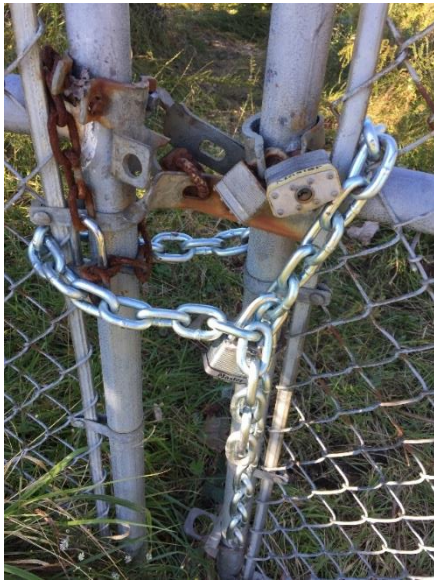
Chain on front gate

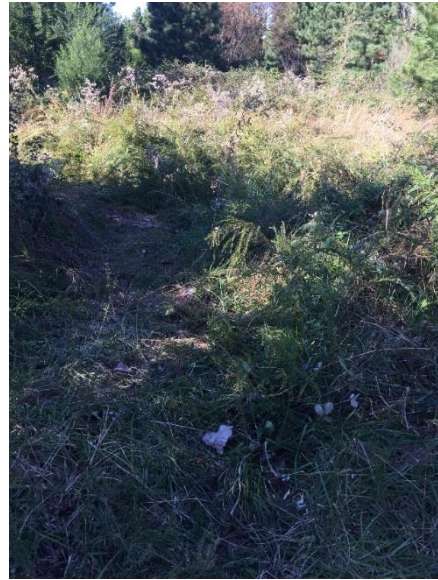
Inside front gate
