Health Consultation

**HURRICANE RESPONSE SAMPLING ASSESSMENT FOR
D. L. MUD, INC.**

VERMILION PARISH, LOUISIANA

AUGUST 30, 2006

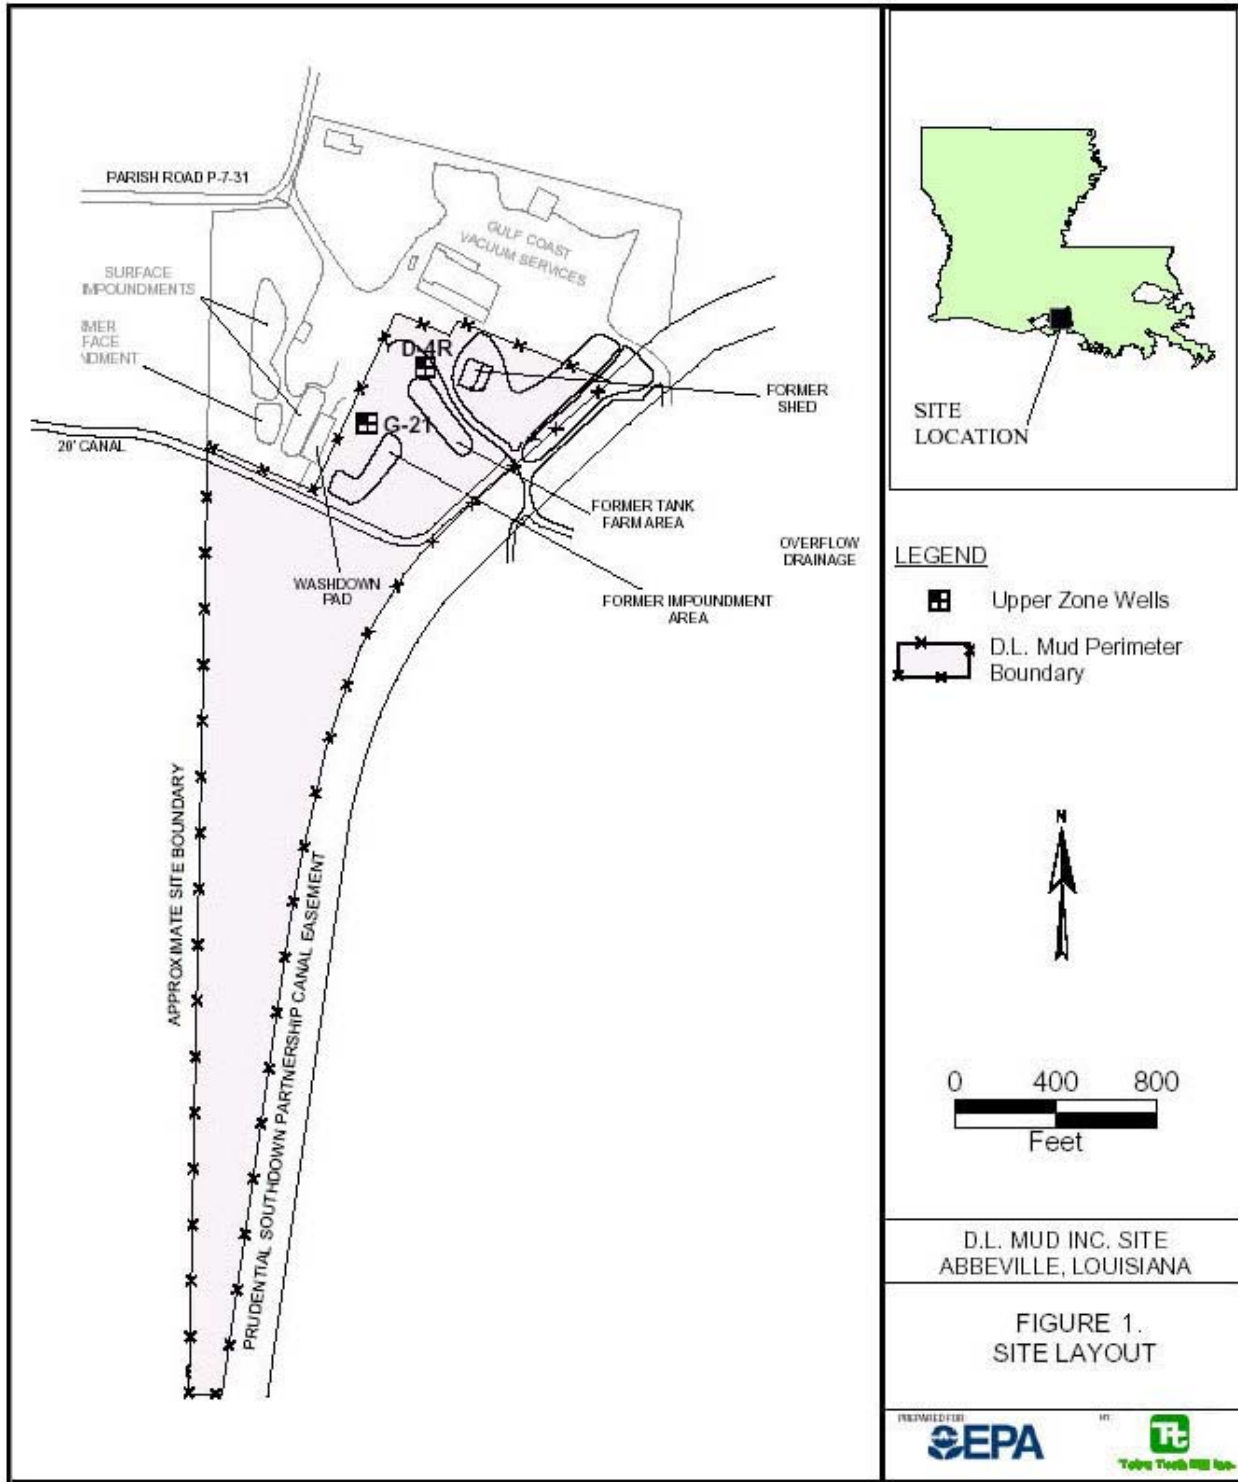
D.L. Mud, Inc. Post-Hurricane Assessment

Along with the site visit, two shallow groundwater samples were collected from monitoring wells. These samples were analyzed to determine whether any contaminants from residual soils left after excavation had migrated into the groundwater following the hurricane. Figure 1 shows the location of the two wells sampled at the site. The results were compared to EPA's September 2003 Five-Year Review for D.L. Mud. Contaminant levels were comparable to those recorded in the Five-Year Review, from which it was concluded that the contaminants detected were not present as a result of hurricane-related flooding. The remedial actions in place at the site were not compromised by the hurricane [5, 6].

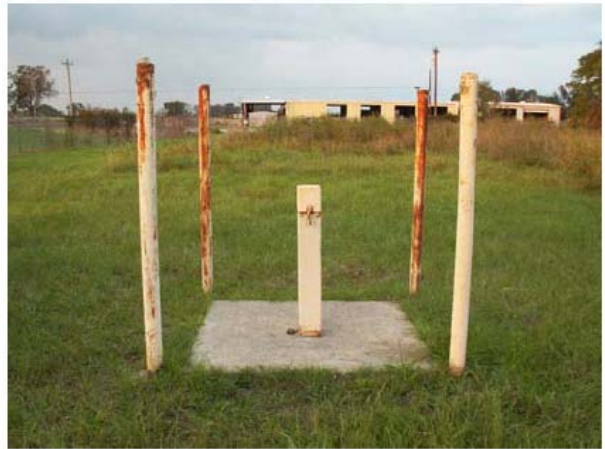
File Name: D.L.Mud_photo2.JPG
Date/Time Taken: 01 Oct 2005 1835
Description: Well G-21, view to northeast.
N29°57'27.2"; W92°11'10.2"

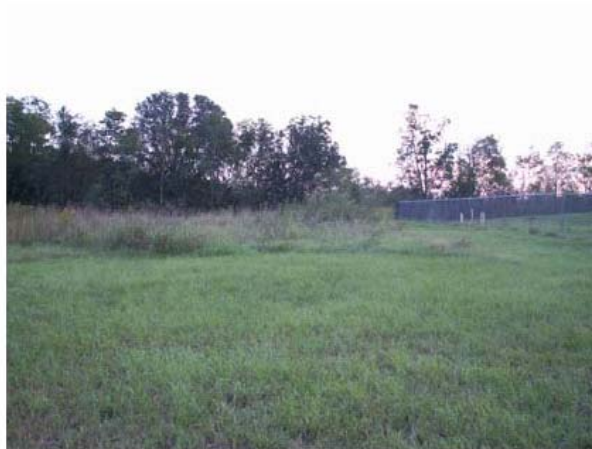
File Name: D.L.Mud_photo3.JPG
Date/Time Taken: 01 Oct 2005 1836
Description: Southern boundary of site showing no apparent storm impact, view to south.
N29°57'27.2"; W92°11'10.5"

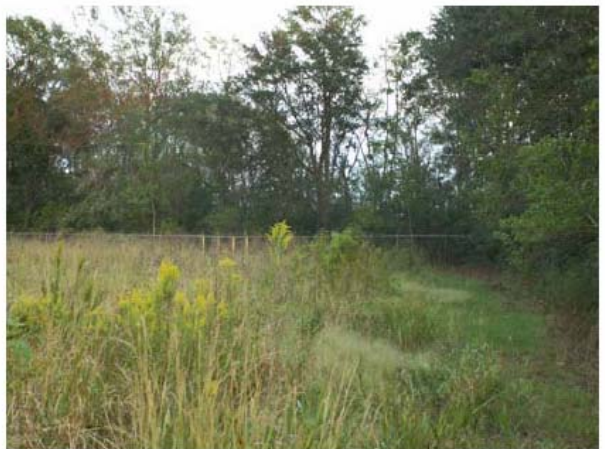
File Name: D.L.Mud_photo4.JPG
Date/Time Taken: 01 Oct 2005 1838
Description: View to east along southern boundary of site, showing no apparent storm impact.
N29°57'25.9"; W92°11'11.9"

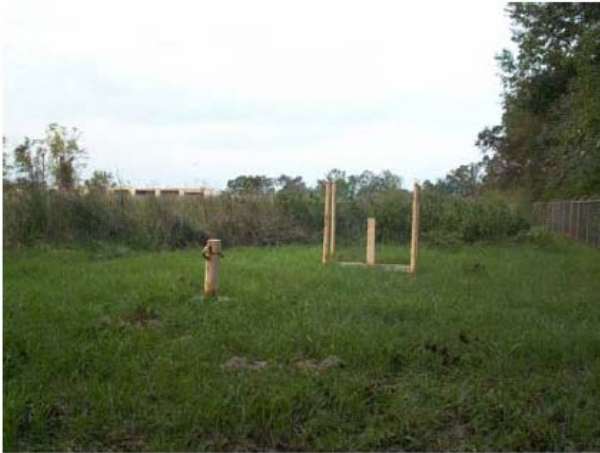
File Name: D.L.Mud_photo5.JPG
Date/Time Taken: 01 Oct 2005 1840
Description: View to north along eastern boundary of site, showing no apparent storm impact.
N29°57'24.7"; W92°11'9.4"

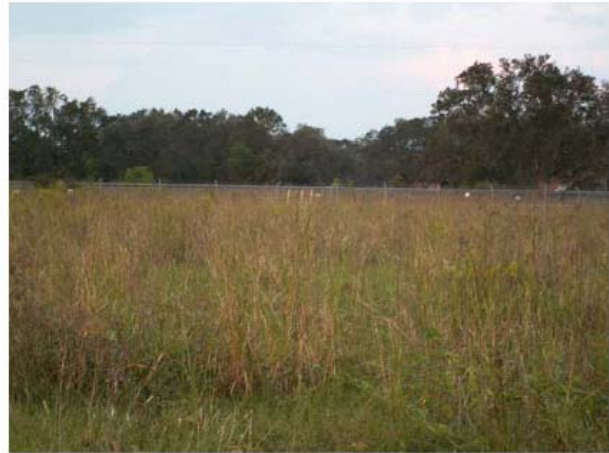
File Name: D.L.Mud_photo6.JPG
Date/Time Taken: 01 Oct 2005 1843
Description: View to northeast along northern site boundary, showing no apparent storm impact.
N29°57'27.2"; W92°11'10.4"

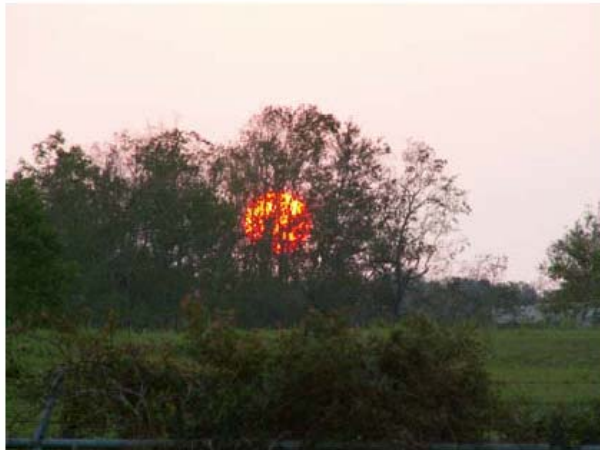
File Name: D.L.Mud_photo7.JPG
Date/Time Taken: 01 Oct 2005 1847
Description: Western boundary of site, view to west.
N29°57'28.8"; W92°11'9.2"

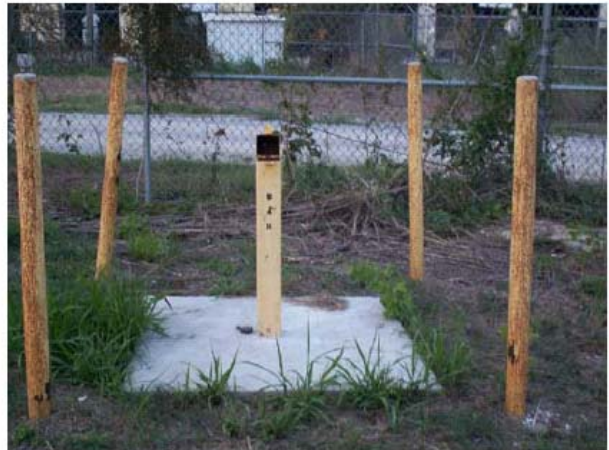
File Name: D.L.Mud_photo8.JPG
Date/Time Taken: 01 Oct 2005 1848
Description: Well D-4R, view to north.
N29°57'28.8"; W92°11'8.8"

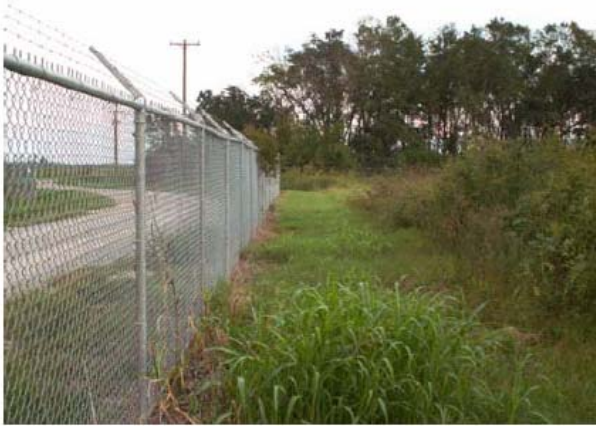
File Name: D.L.Mud_photo9.JPG

Description: View to east along northern boundary of site, showing no apparent storm impact.
N29°57'28.8"; W92°11'8.8"

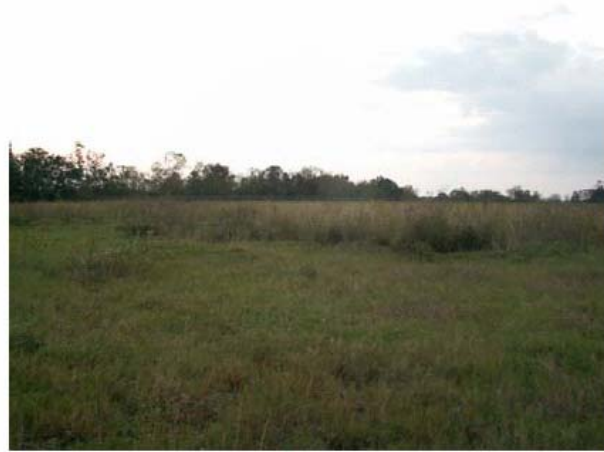
File Name: D.L.Mud_photo10.JPG

Description: Grassy area in interior of site, showing no apparent storm impact, view to southwest.
N29°57'27.3"; W92°11'7.8"
