Health Consultation

MALLARD BAY LANDING BULK PLANT
POST HURRICANE SOIL SAMPLING EVALUATION
CAMERON PARISH, LOUISIANA
EPA FACILITY ID: LAD0000187518

OCTOBER 26, 2006

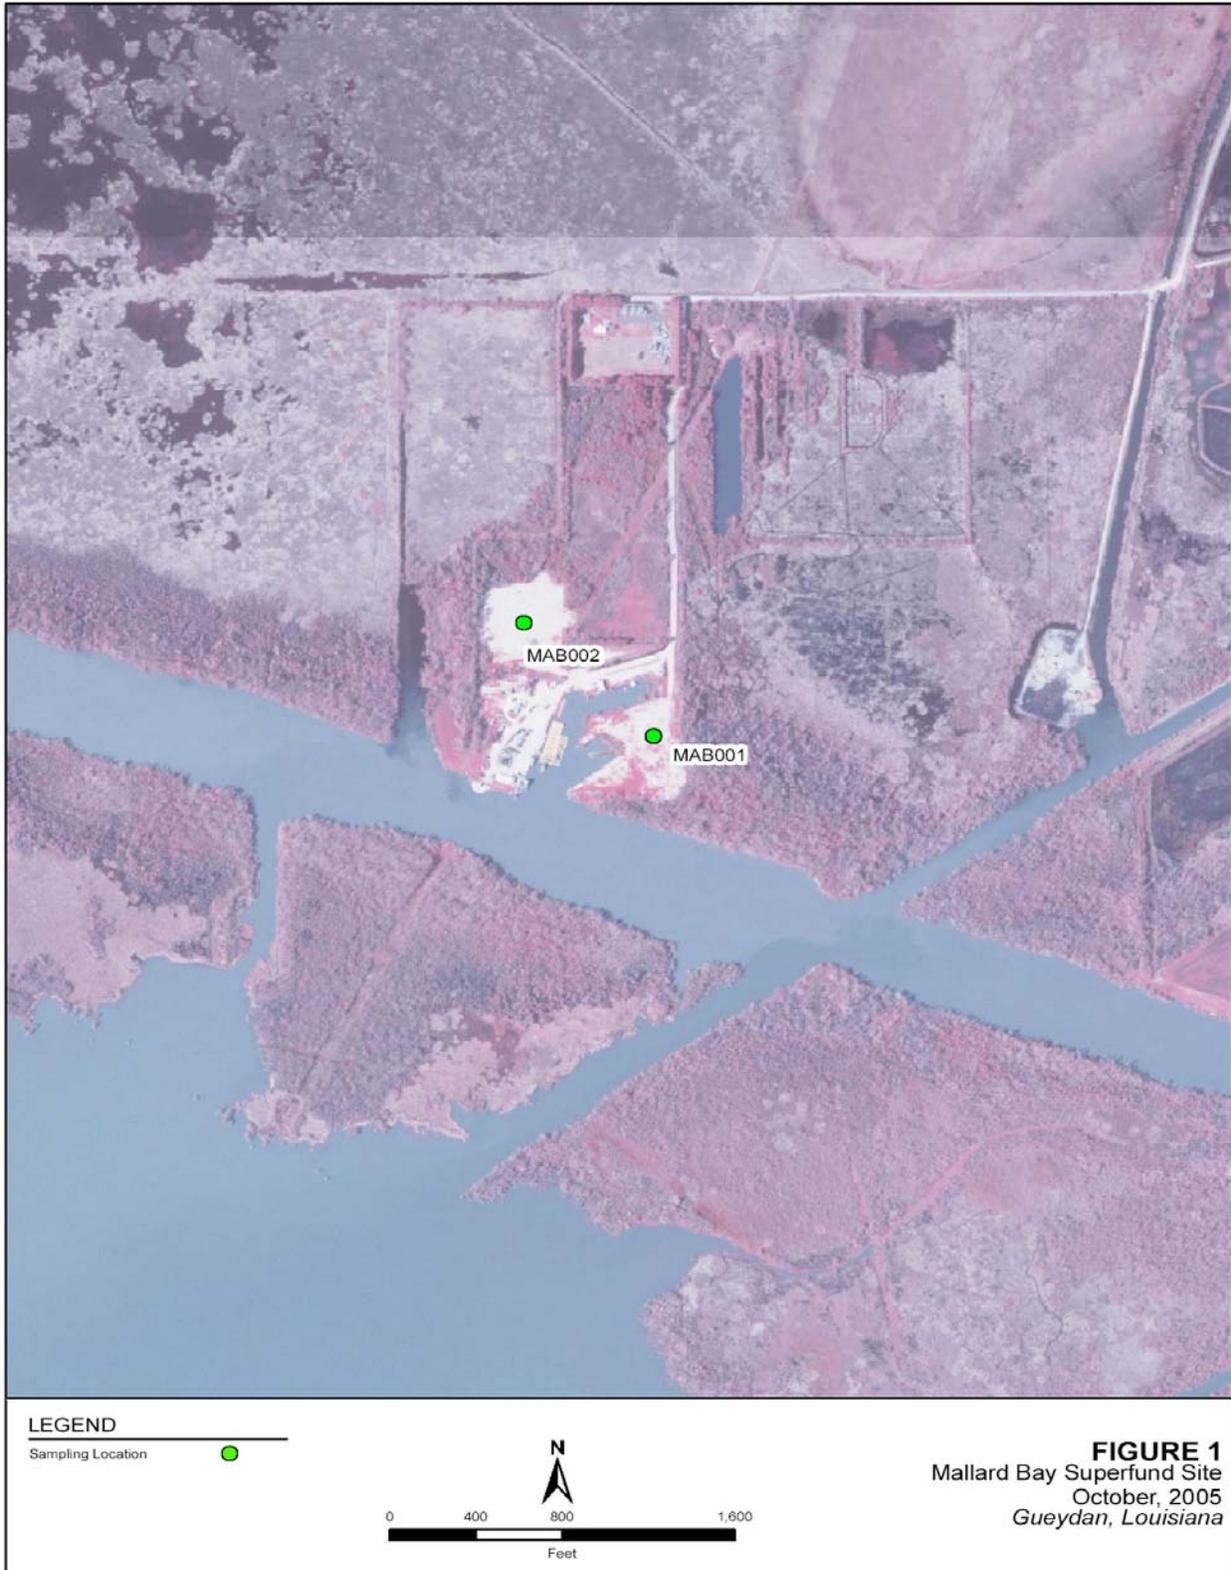
Figure 1: October 2005 soil sampling locations, Mallard Bay site. Cameron Parish, LA.

On October 14, 2005, EPA collected onsite surface soil samples from the eastern and western tracts at the Mallard Bay site [see figure 1]. All samples were analyzed for VOCs, SVOCs, mercury and total metals.

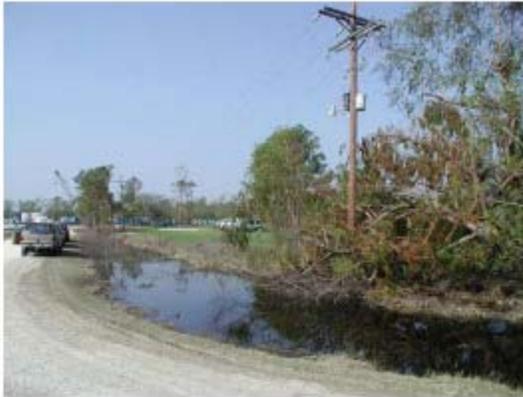
File Name: MallardBay West003.JPG
Date/Time Taken: 14 Oct 2005
Description: West Site, view to west.
[coordinates not recorded]

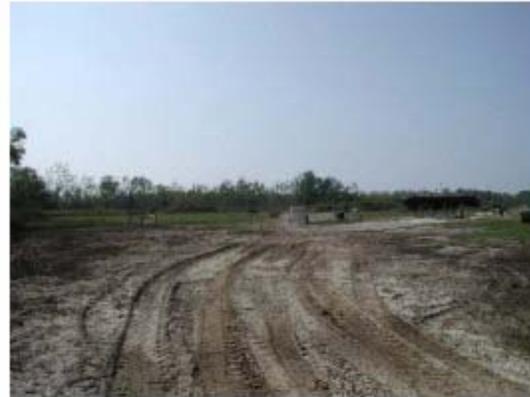
File Name: MallardBay East004.JPG
Date/Time Taken: 14 Oct 2005
Description: East Site, view to south from gate.
[coordinates not recorded]

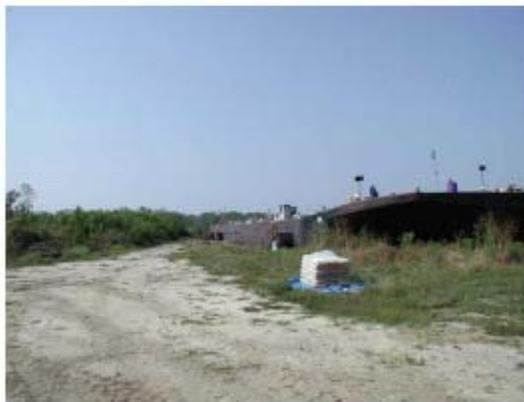
File Name: MallardBay East005.JPG
Date/Time Taken: 14 Oct 2005
Description: View to southwest from interior of East Site.
[coordinates not recorded]

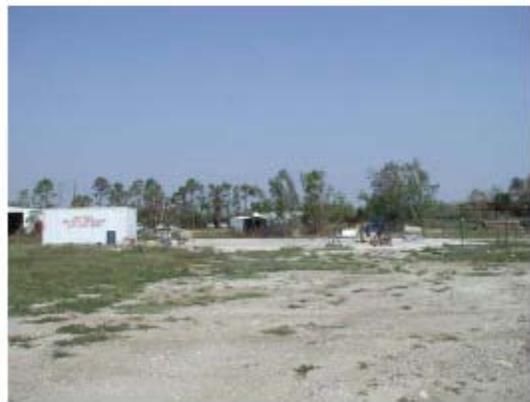
File Name: MallardBay East006.JPG
Date/Time Taken: 14 Oct 2005
Description: Old pad of processing plant, view to north.
[coordinates not recorded]

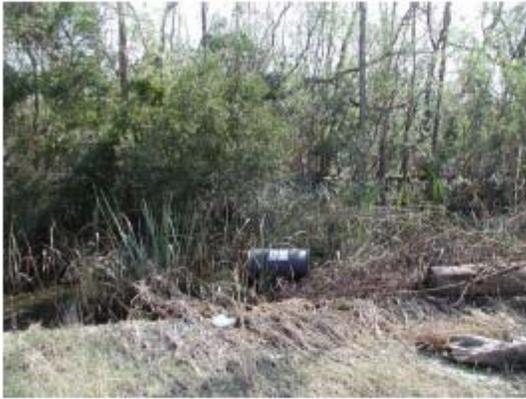
File Name: MallardBay Outside007.JPG
Date/Time Taken: 14 Oct 2005
Description: Drum beside road, north of East Site, view to southeast.
[coordinates not recorded]

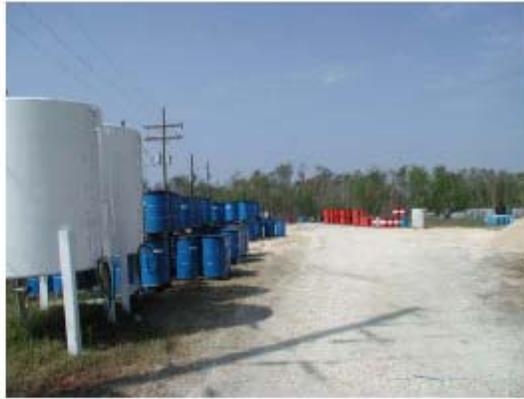
File Name: MallardBay West008.JPG
Date/Time Taken: 14 Oct 2005
Description: West site, view to west from gate.
[coordinates not recorded]

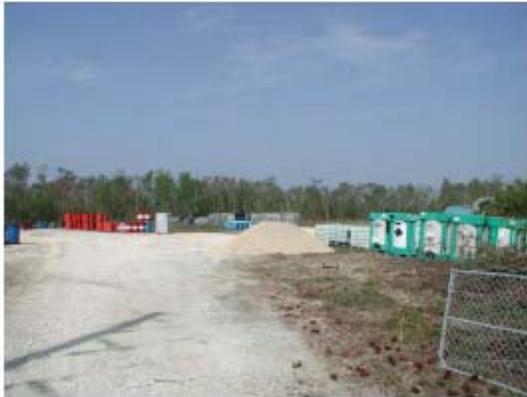
File Name: MallardBay West009.JPG
Date/Time Taken: 14 Oct 2005
Description: West site, view to northwest from gate.
[coordinates not recorded]

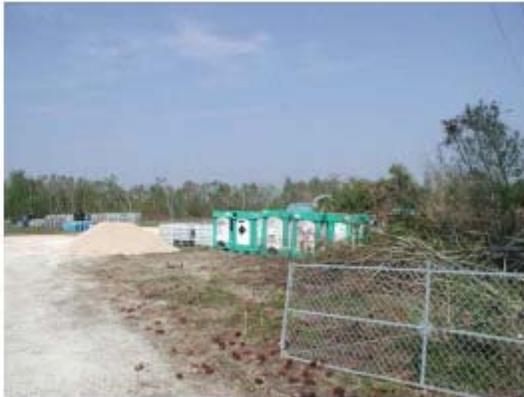
File Name: MallardBay West010.JPG
Date/Time Taken: 14 Oct 2005
Description: West site, view to north from gate.
[coordinates not recorded]

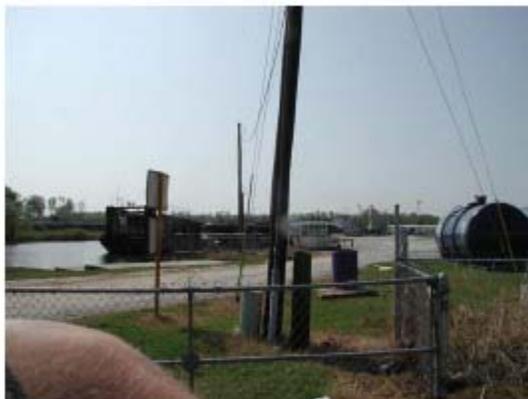
File Name: MallardBay Tal011.JPG
Date/Time Taken: 14 Oct 2005
Description: View to south, towards Talens and the water.
[coordinates not recorded]

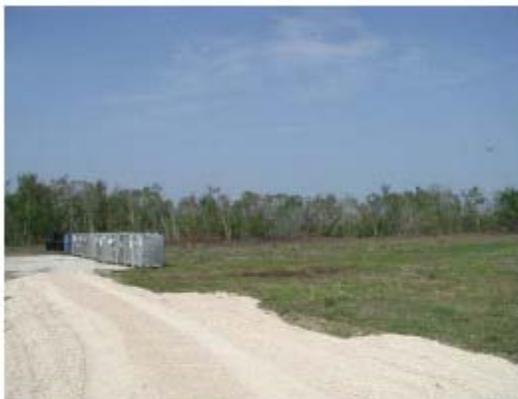
File Name: MallardBay West012.JPG
Date/Time Taken: 14 Oct 2005
Description: View to northwest from the middle of the West Site.
[coordinates not recorded]
