# Letter Health Consultation

MOLE LAKE SCHOOL

CRANDON, WISCONSIN

**Subject: Public Health Consultation for the former Mole Lake School**

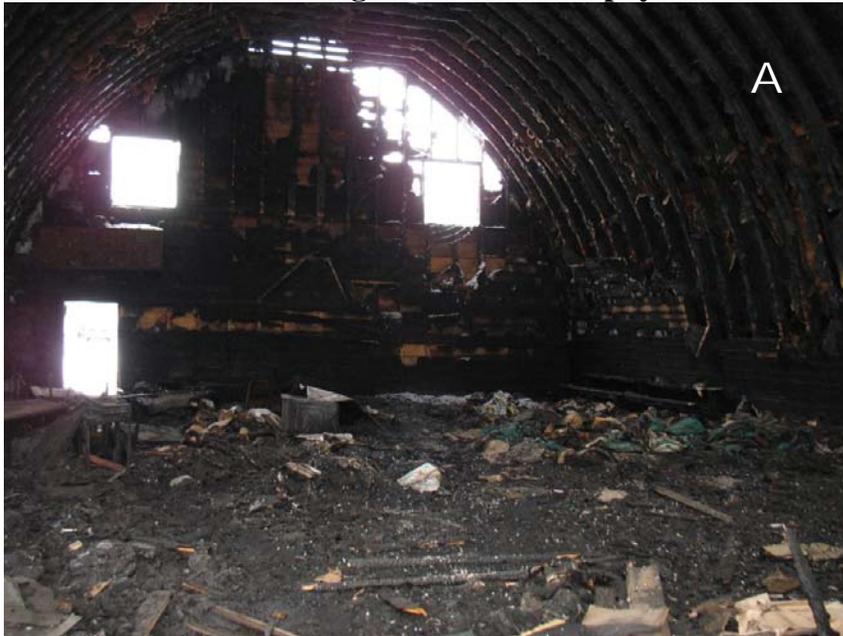
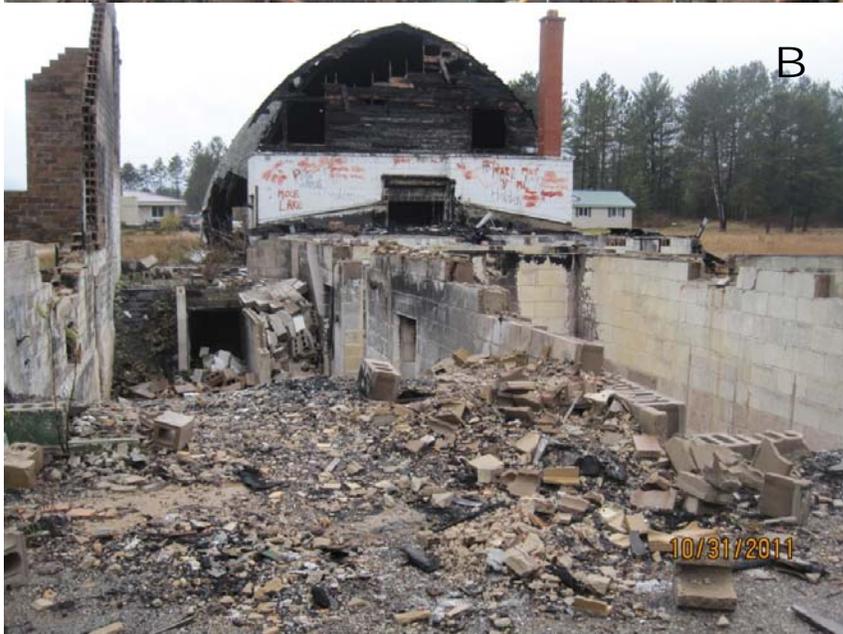
**Asbestos.** The initial site visit and final assessment by EPA and EPA START contractor Oneida Total Integrated Enterprises (OTIE) reported visible evidence of broken and weathered asbestos floor tiles inside the burned out structure (figure 2). The presence of

asbestos in the floor tiles is based upon an earlier report that excluded the presence of asbestos in ceiling tile, wallboard, felt, and floor runners.<sup>3</sup> The floor tiles represent asbestos-containing material (ACM) that was formerly non-friable, but should now be considered friable due to their broken and deteriorated state. The EPA/OTIE site assessment confirmed that the tiles and floor mastic contain 5-10% chrysotile, where concentrations greater than 1% meet the definition of ACM.<sup>4</sup> The 1% asbestos criterion is a regulatory definition that corresponds to the detection limit of the analytical method. It is used to make decisions regarding the disposition of asbestos-containing waste materials. The presence of broken and weathered ACM in building debris at the former school represents a potential for asbestos exposure to trespassers or workers handling the ACM. The ACM building debris should be removed to avoid this exposure potential.

**Figure 2. Interior (A) and exterior (B) of fire-gutted Former Mole Lake School showing asbestos tile and physical hazards.**

- Any asbestos-containing materials (ACM) in the building debris of the former school should be removed to limit its dispersion on-site and potentially off-site. ACM in the building debris should be safely collected and disposed of using workers trained and equipped in proper ACM-removal techniques, and in accordance with applicable removal and disposal rules.

- Removal of building demolition piles should include the removal of surface soil underlying and surrounding those piles to the extent needed to remove visible ACM building debris and prevent possible asbestos dispersion. These soils will require either further analysis to quantitatively verify asbestos content or preventive removal.

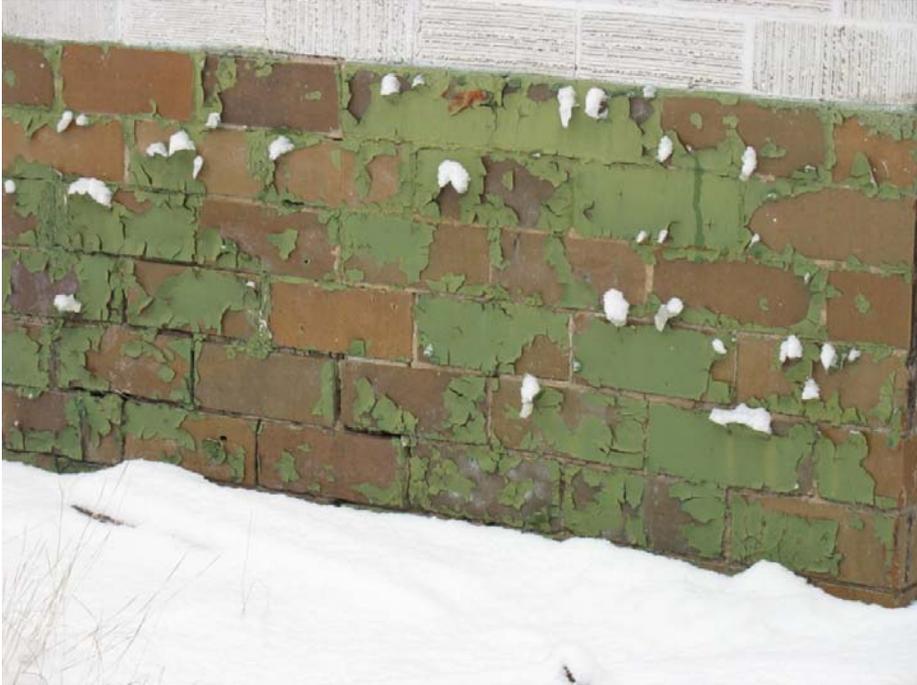
*Lead paint.* Heavily weathered paint is evident on the concrete block wall and the former wood gymnasium (figure 3). Paint chips were present in the paved and unpaved parts of the site. During the initial site visit by EPA, a portable X-ray fluorometer (XRF) was used to confirm that the paint contains lead. The XRF produced a reading  $\geq 1,000$  milligrams lead per kilogram of soil (ppm, or parts per million) at locations where chips were present, with a maximum reading of 11,112 ppm. Lead in soils (using XRF) on the property having no visible paint chips ranged from 9-216 ppm. In the follow-up assessment by the EPA contractor (EPA/OTIE), paint chips were collected for lab analysis; these confirmed flaking lead paint throughout/from the building debris. Analysis of soil containing paint chips from around the perimeter of the building revealed lead concentrations ranging from 9 to 35,577 ppm. Significantly, several of the elevated readings were at soil locations 20 feet in each direction from the building footprint, including a reading of 915 ppm around the children's play area.

**Figure 3. Deteriorating lead-based paint on lower exterior wall of former school building, Mole Lake, Wisconsin.**

- Lead-contaminated soil should be removed and disposed of, followed by the installation of clean soil and covering vegetation sufficient to interrupt exposure to any residual lead in soil.

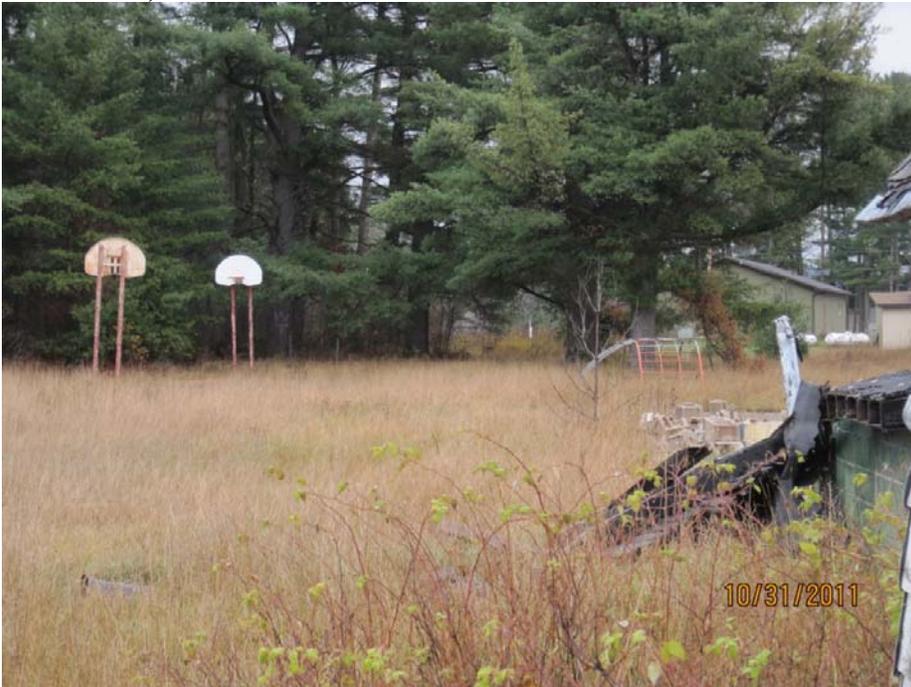
property, and there are at least 25 neighboring residences within 1,000 feet of the site. The nearest residences are across the street. The adjacent lot is a recreational ball field and playground (figure 4). Playground facilities remain on the site property. The grounds are freely accessible and are attractive to trespass by children, youth, and adults. The property has no fence and is freely accessible to trespass. There is evidence of trespassing such as graffiti and beer bottles.

**Figure 4. Playground area adjacent to former school building, Mole Lake, Wisconsin**

- Pending removal of the gutted building, Tribal officials should restrict access to the damaged building site to avoid exposure to unauthorized people visiting the site.
