# Health Consultation

PESTICIDE CONTAMINATION IN A HOME  
TENNESSEE DEPARTMENT OF AGRICULTURE  
LOUDON, LOUDON COUNTY, TENNESSEE

APRIL 19, 2007

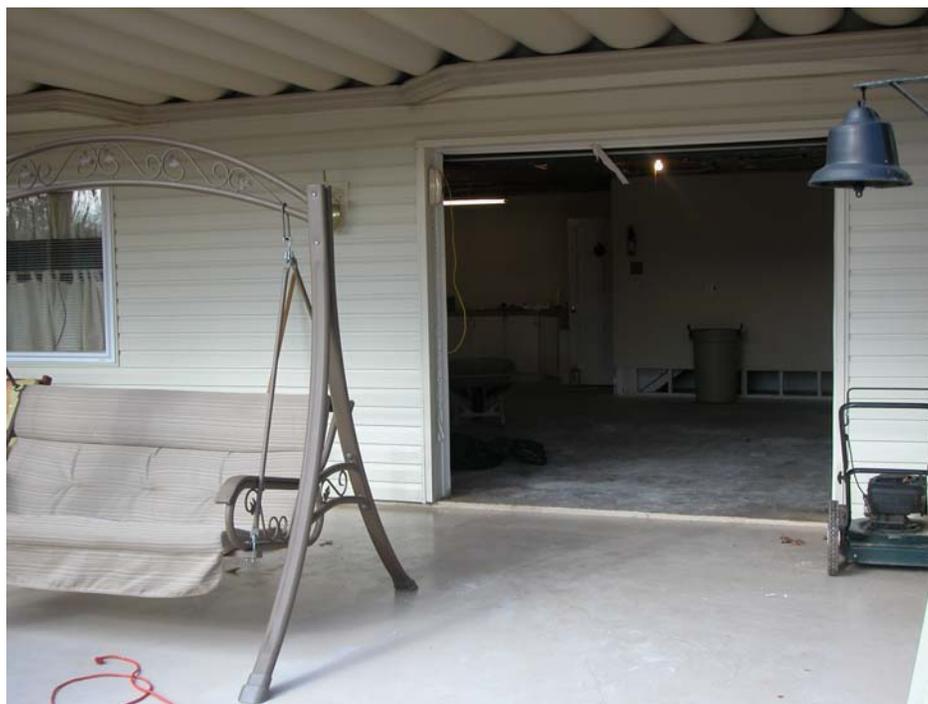
**Figure 1. View of the basement from the patio at the back of the house.**

The house in Loudon County, zip code 37774, was bought from the previous owner through a real estate agent. The home is estimated to be less than 10 years old. It is located on a lot that slopes from front to back, providing a basement that is above ground on the back. The backyard adjoins a golf course fairway. The back wall has several windows, an exterior door, and a garage-style door. The basement is not used as a garage; rather it is more like a half-functional living space. The garage is on the front of the house. The garage-style door is used for a golf cart. See Figure 1 for a view of the basement from the patio.

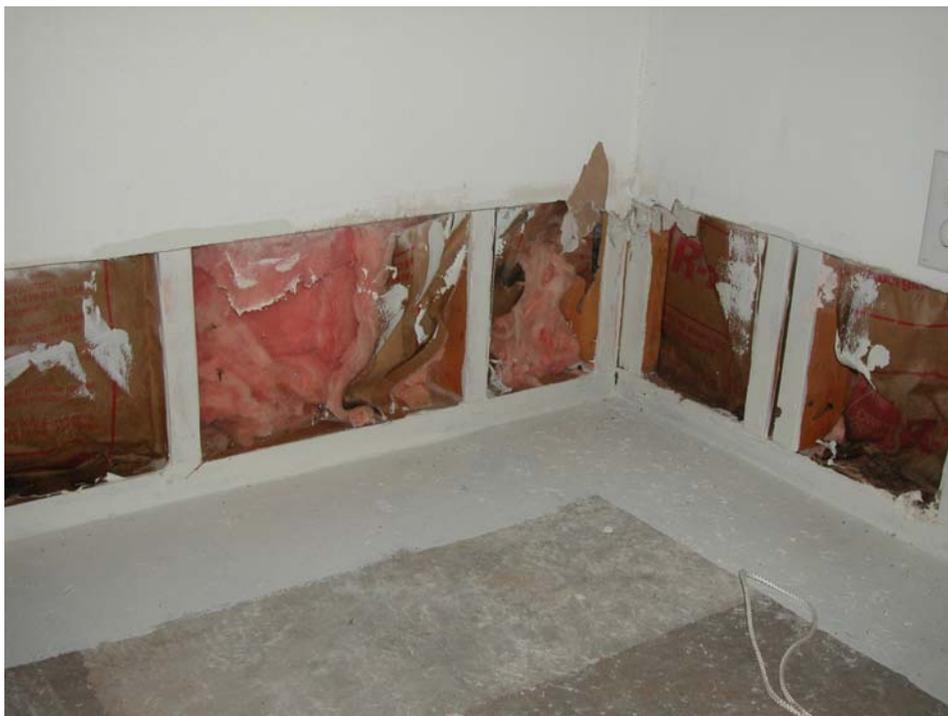
**Figure 2. View of the drywall removal from the bottom 12 inches of the walls.**

EPA emergency response returned on November 21 to collect confirmatory air samples. Unfortunately, pesticides were still present in the air of the basement at a concentration of 0.03 ppm or  $379\ \mu\text{g}/\text{m}^3$ . At that time, the fiberglass shower and all bathroom fixtures were removed, as well as all the drywall in the bathroom. Remaining concrete block walls and studs were coated with a sealant in order to encapsulate any remaining pesticide. See Figures 3 and 4 for before and after pictures.

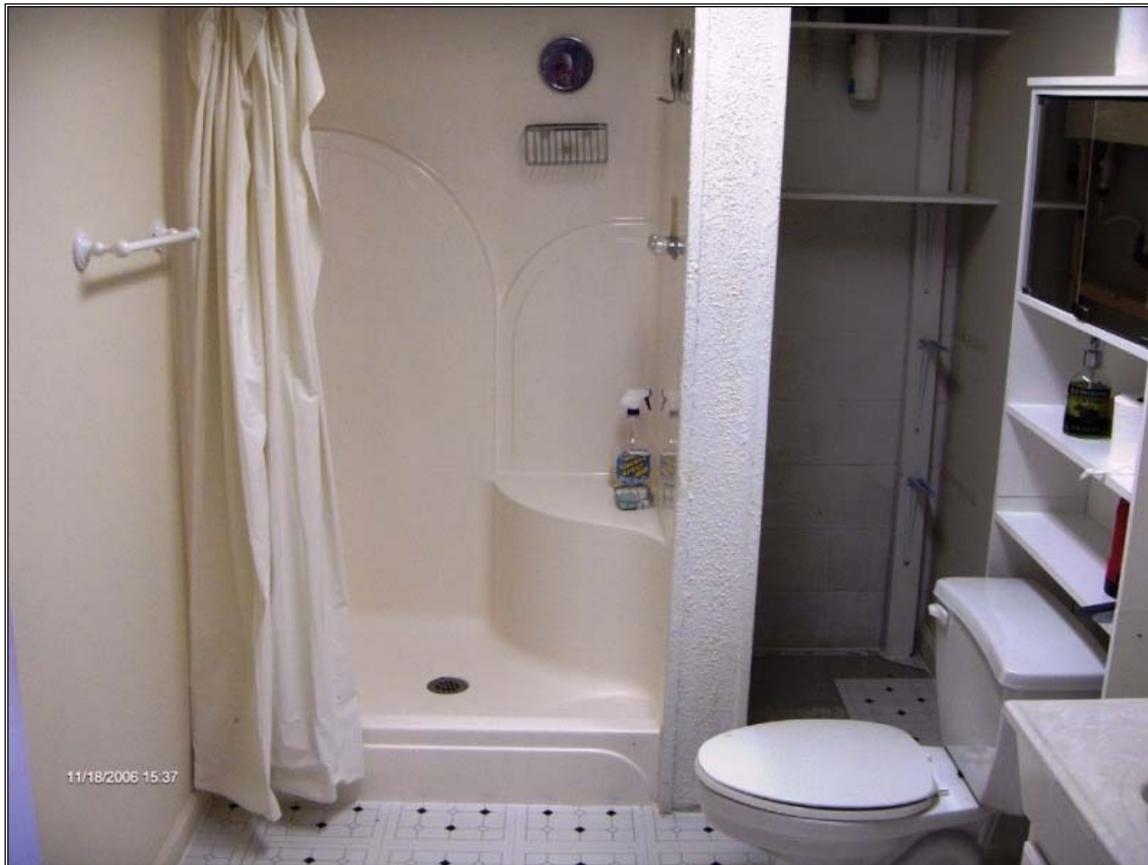
**Figure 3: Basement bathroom before remediation**

**Subject:** View facing east of bathroom in basement.

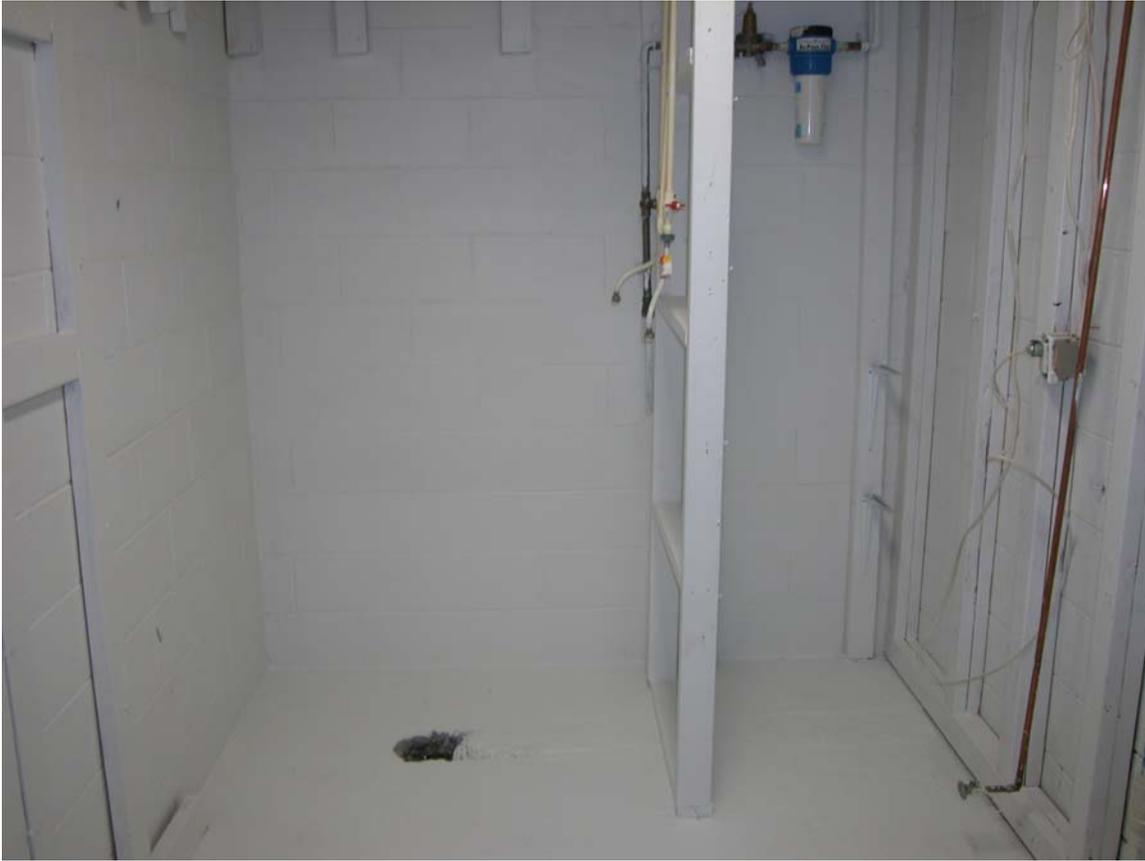
**Figure 4. Basement bathroom after remediation**

Results of air sampling on December 7, 2006, after the removal of the shower and bathroom dry wall, showed concentrations of diazinon in the basement of 0.38 ppb ( $4.7 \mu\text{g}/\text{m}^3$ ) and 0.54 ppb ( $6.7 \mu\text{g}/\text{m}^3$ ), compared to the intermediate EMEG of  $9 \mu\text{g}/\text{m}^3$ . Two days later, on December 9, 2006, no diazinon was detected in the air. After this result, the basement was determined to be clear of pesticides and safe for use. EEP sent a letter to the couple explaining this (Bashor 2007).
